## **Finance Committee Regular Meeting**

## CAPITAL REQUEST MEMO

**To:** Sudden Valley Community Association Board of Directors  
**From:** Jo Anne Jensen, General Manager  
**Date:** September 26th, 2024  
**Subject:** Capital Request – #2 Golf Bridge Repair

**RE:** Sudden Valley Golf Course Bridges Inspection and Reporting

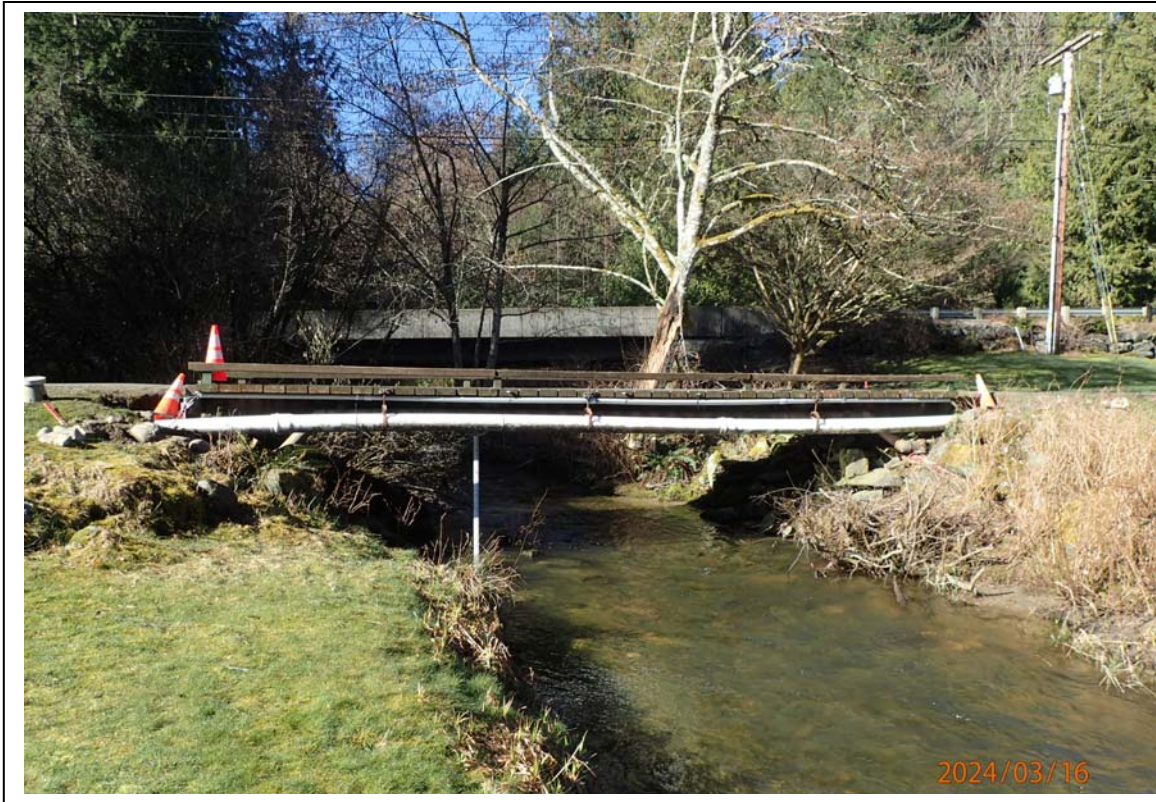
Photo No.: 1

Description: GC BR 1 elevation looking SW upstream. New creek vertical flood gage at the left.

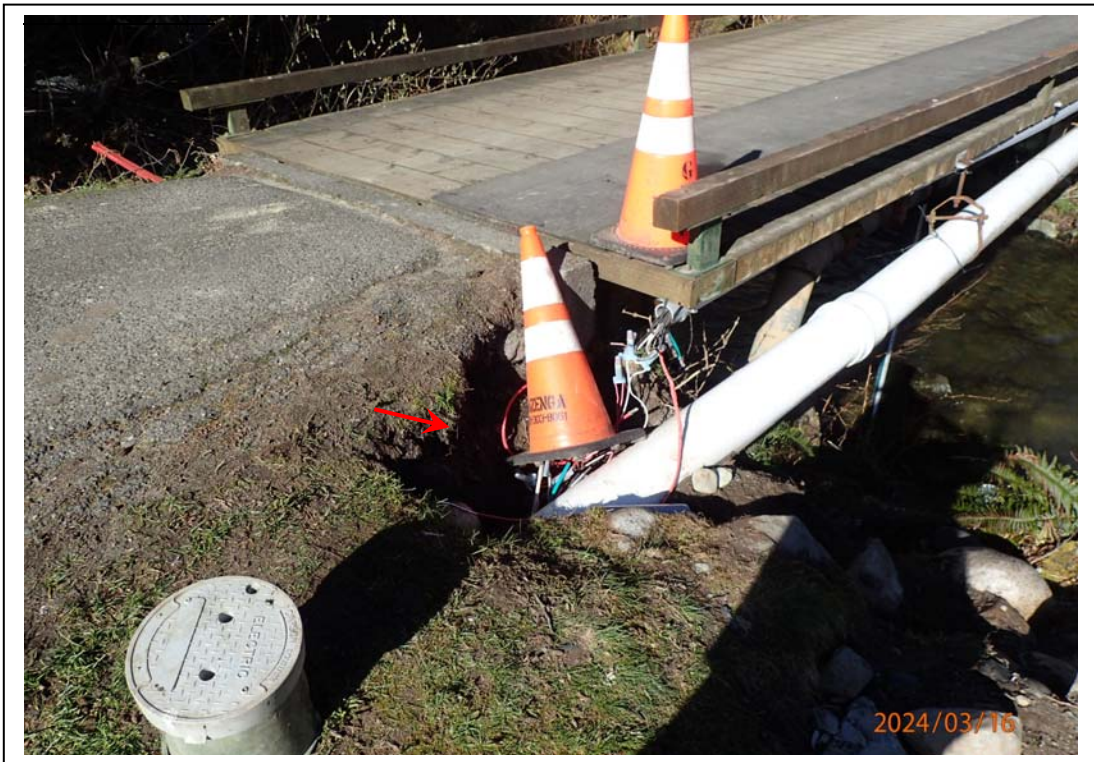
Photo No.: 2

Description: Approach paving hole and on-going conduit/wiring modifications, similar repairs required at both ends of the bridge.

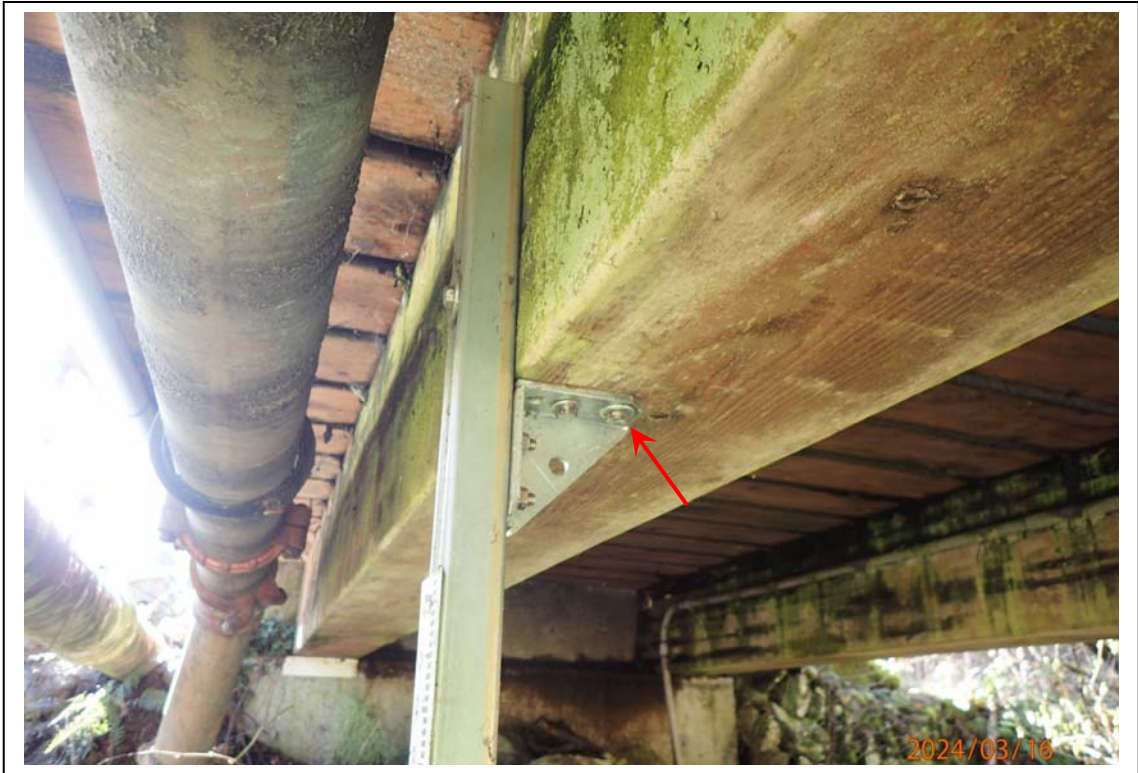
Photo No.: 3

Description: View of East girder in satisfactory condition. Steel bolts must be removed at the top of floodway gage to prevent debris build-up and damage to the timber girders during flooding.

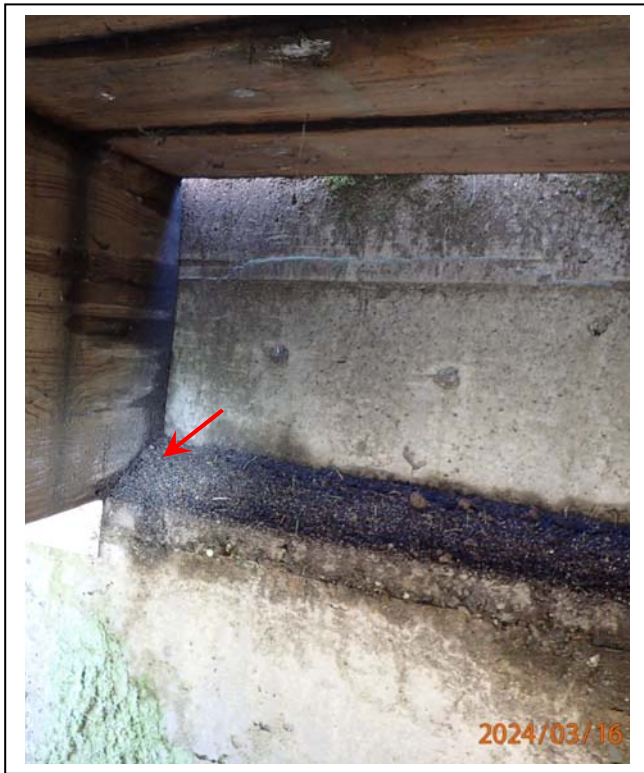
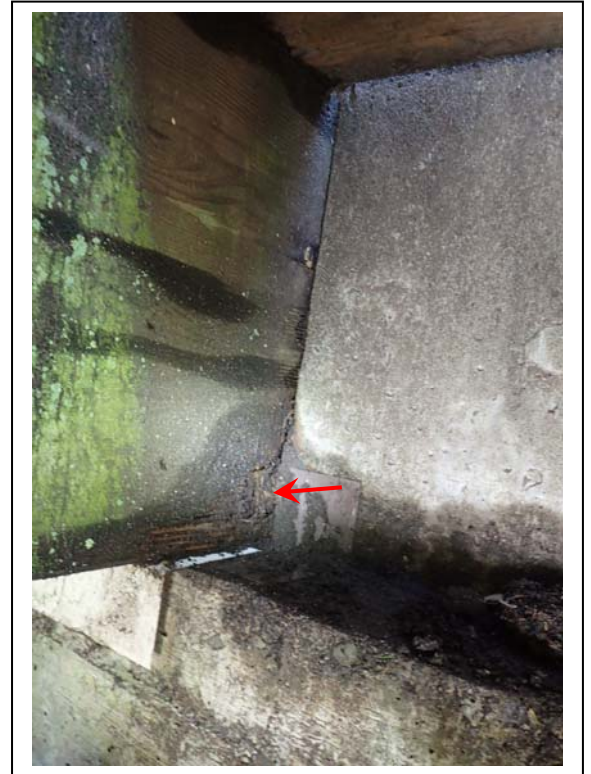
Photo No.: 4

Description: Significant wet soil accumulation at typical concrete pier seat causing girder decay.

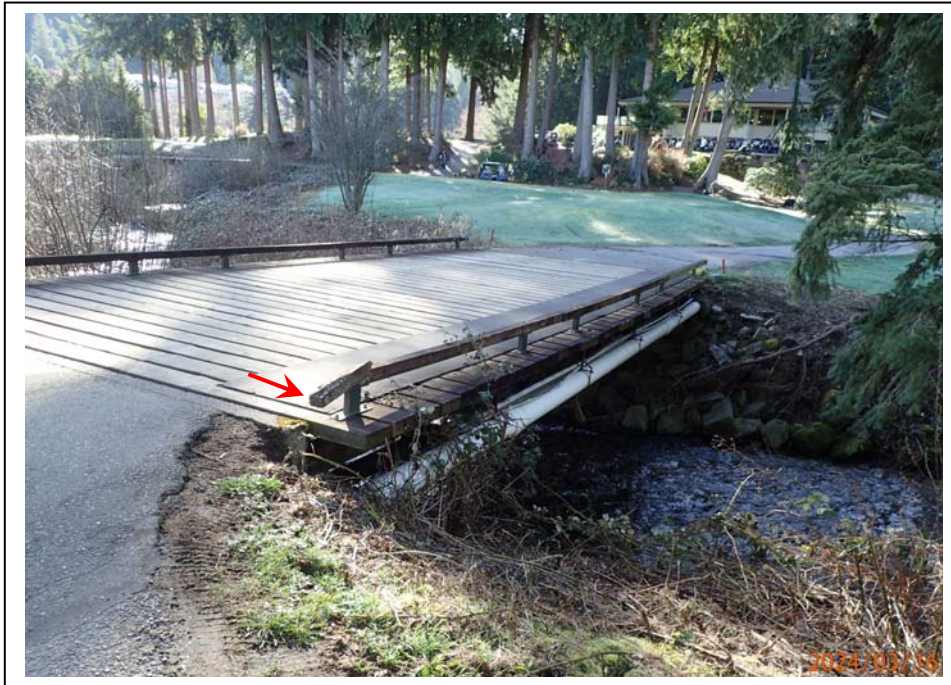
Photo No.: 5

**GC BR 2** is a much wider bridge at 18'-2" out-to-out and functions as the primary route for patron golf carts and equipment crossings. The superstructure is supported by four (4) timber rough sawn 10"x16" girders, but is in poor condition as the two west girders have splits and the central west girder contains internal decay and support crushing. Sagging is apparent at the west exterior of the bridge (see photos) and a Repair Plan & Detail is included in **Appendix B**. All utility support is focused on the west exterior girder and the three utility support anchors pulled free during the last major flooding still require repair. Furthermore, wet soil must be removed from the concrete bearing seats as it has impacted the girders causing timber decay. Review of the foundations shows the concrete piers in good condition, except for a needed north abutment scour hole repair. Adequate riprap protection is in place, but hand adjustment of the rock to correct shifting during the last flooding is recommended. The curb railing also remains damaged at the northwest corner and must be replaced. Irrigation utilities are located more than 2-feet below the bottom of the girder and in the future should be adjusted up to locate in between the girders to improve the creek's floodway and share the weight between girders.

Description: GC BR 2 wide timber deck with midspan sag along west exterior edge (center of photo). Replace the damaged last timber rail segment in the northwest corner.

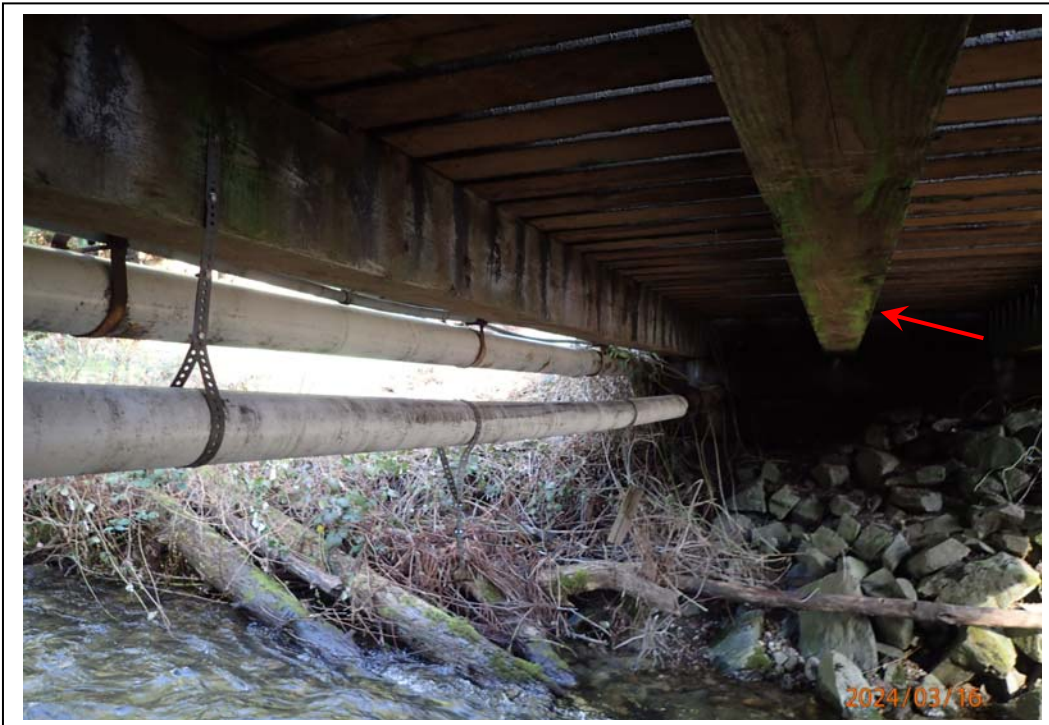
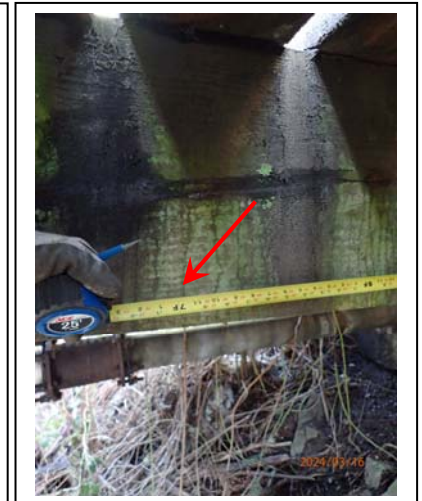
Photo No.: 6

Description: Continue to monitor the west exterior timber girder mid-depth split and now also the first interior girder rot at 7-ft from north the abutment. Also, noted for repair is the two missing utility hanger supports shown hanging below at the inside edge of west exterior girder.

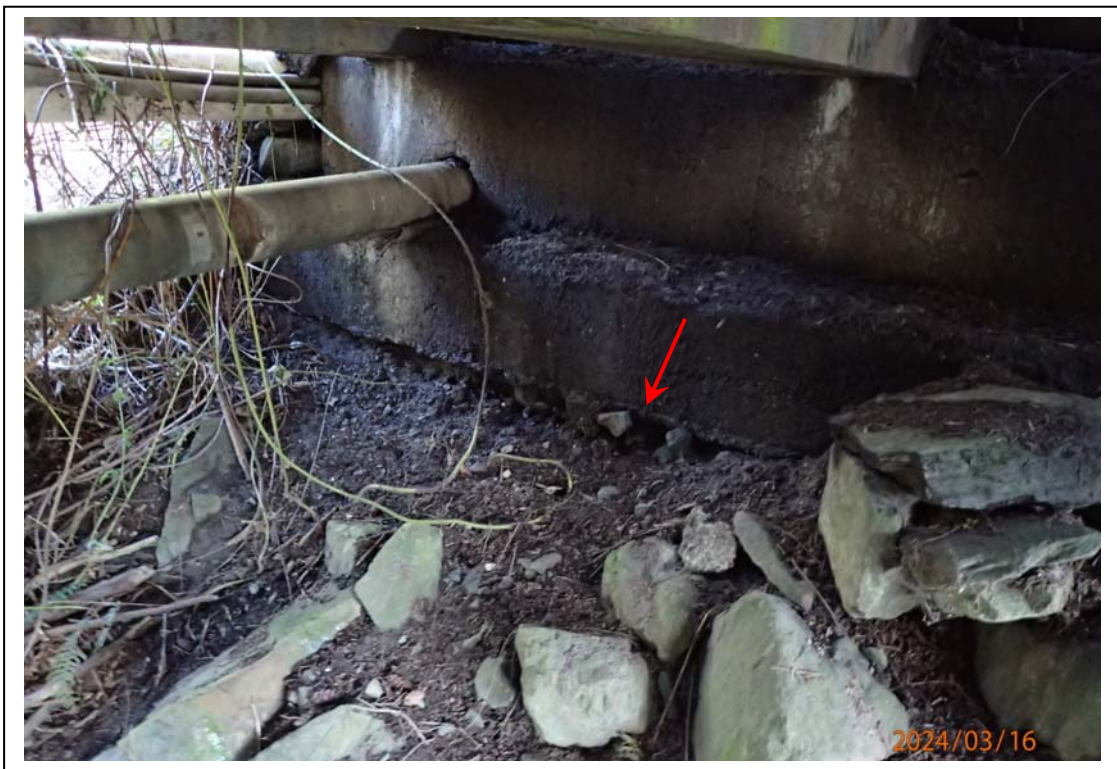
Photo No.: 7

Description: Large ~5'wide by 2'deep by 6"tall scour hole below the North abutment concrete footing. Remove loose material, cast solid with low shrink concrete, cover w/ hand placed riprap.

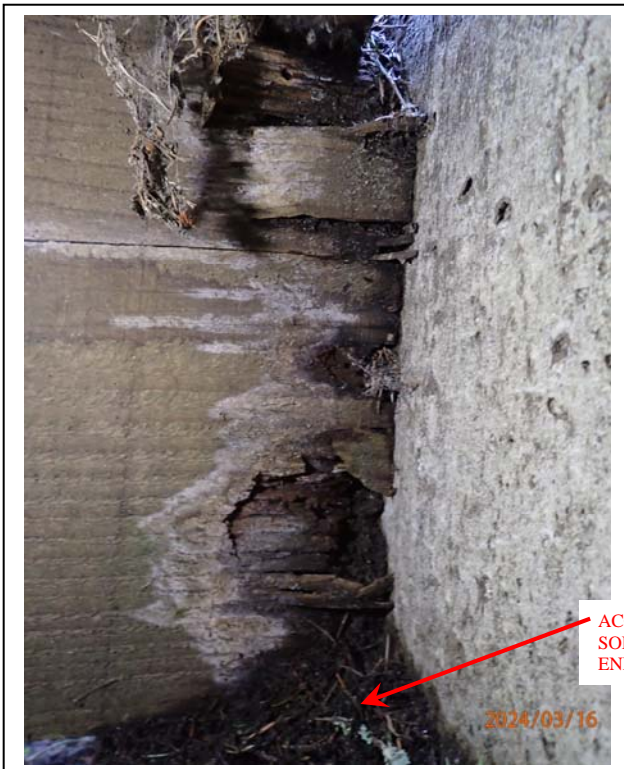
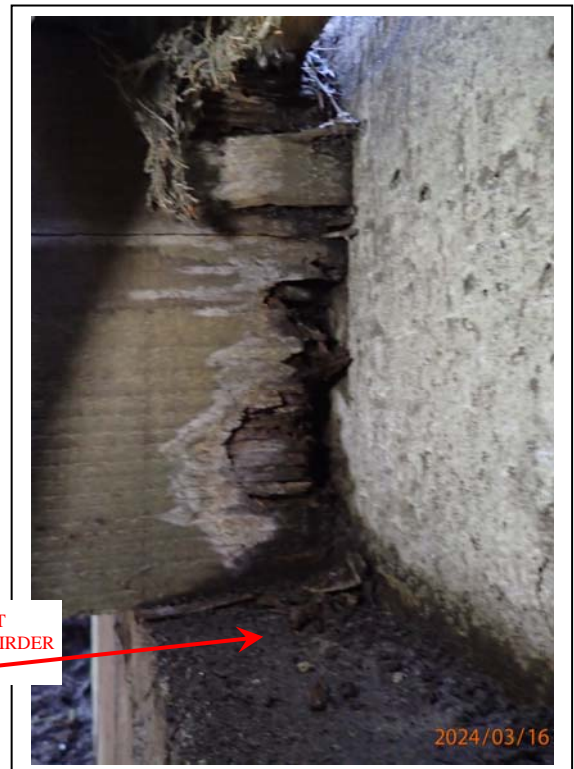
Photo No.: 8

ACCUMULATION OF WET SOIL/DEBRIS AGAINST GIRDER ENDS AND REMOVAL

Description: First interior timber girder from the west. Significant decay and end deterioration observed at the South abutment caused by wet soil accumulation and contact. Remove soil at each concrete pier seat and limit timber contact to moist soil using a heavy roofing paper wrap.

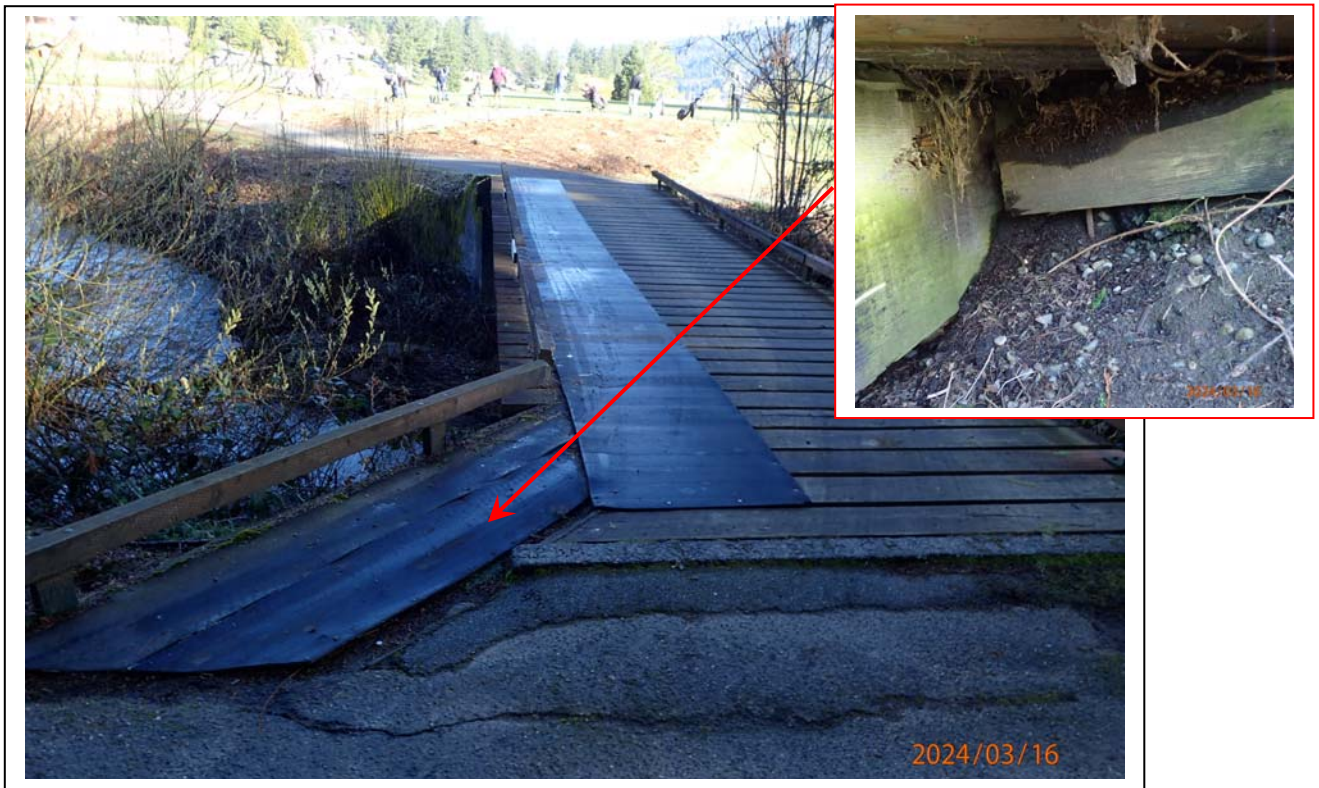
Photo No.: 9 \_\_\_\_\_

Description: View along satisfactory west rail and southwest corner buildout. Inset below shows the widening is loose and deteriorating from wet soil contact. Remove soil and reconnect timber.

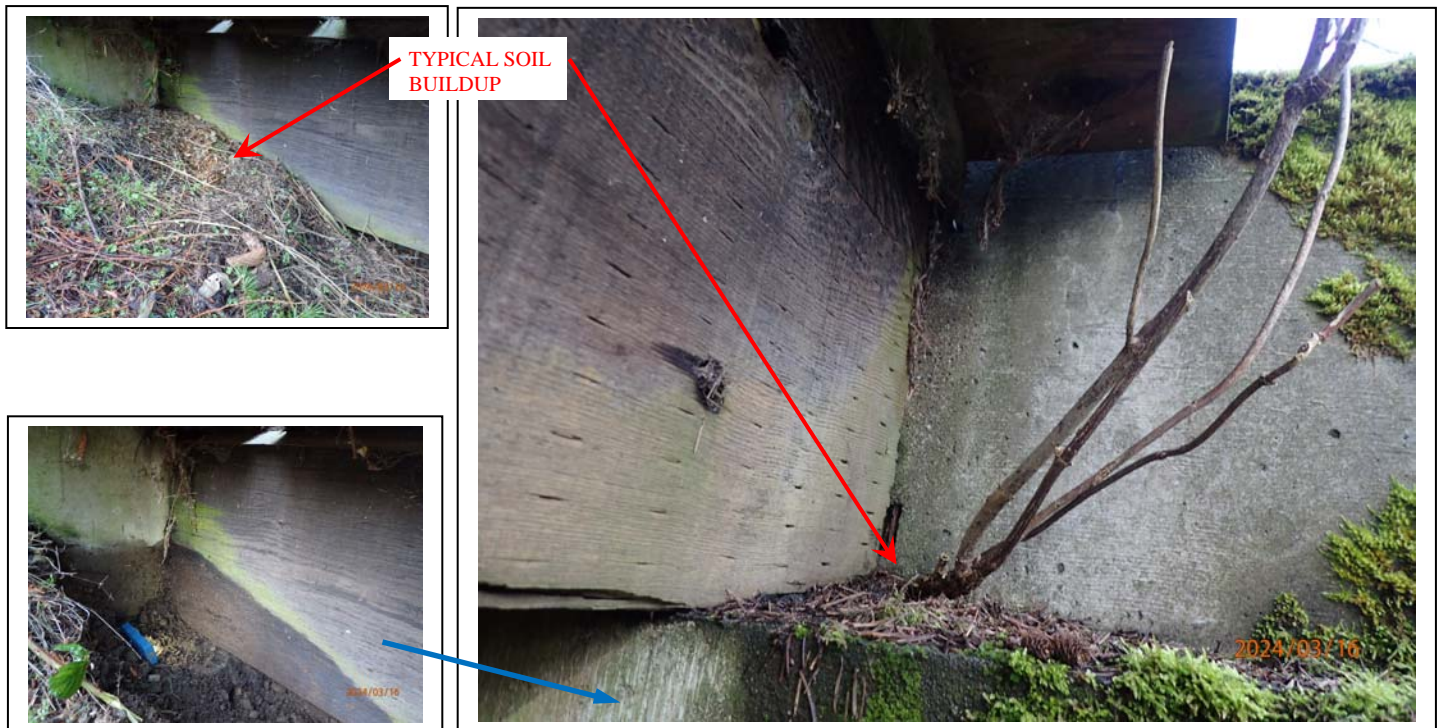
Photo No.: 10 \_\_\_\_\_

**GC BR 3** this bridge is the longest timber structure at 41'-4" and is about 5-feet longer than the next timber bridge on the golf course system. The two girders for this bridge were inspected in fair condition with no defects or decay noted and each have a unique 16-foot over lapping four bolt splice. This bridge also has the largest vertical flood clearance at approximately 8'-6" between the bottom of girder and water surface. The triangular southwest corner deck system is currently starting to loosen (see photo) and should be repaired to continue to augment the cart path width and facilitate cart movement. Wet soil has accumulated against the timber supports at this south end of structure and must be moved away from the existing timbers. A tree and other plant material have also grown on the north concrete seat impacting the timber girders and must be removed. The concrete substructure were in good condition with heavy riprap protection at the south abutment, while the north abutment is well back from the creek with more sparse riprap.

Description: View below the bridge of fair condition superstructure with timber girder contact to moist wet soil accumulating at both the south and north abutments. Remove soil and include a protective wrap of girder ends with heavy roofing paper or metal flashing.

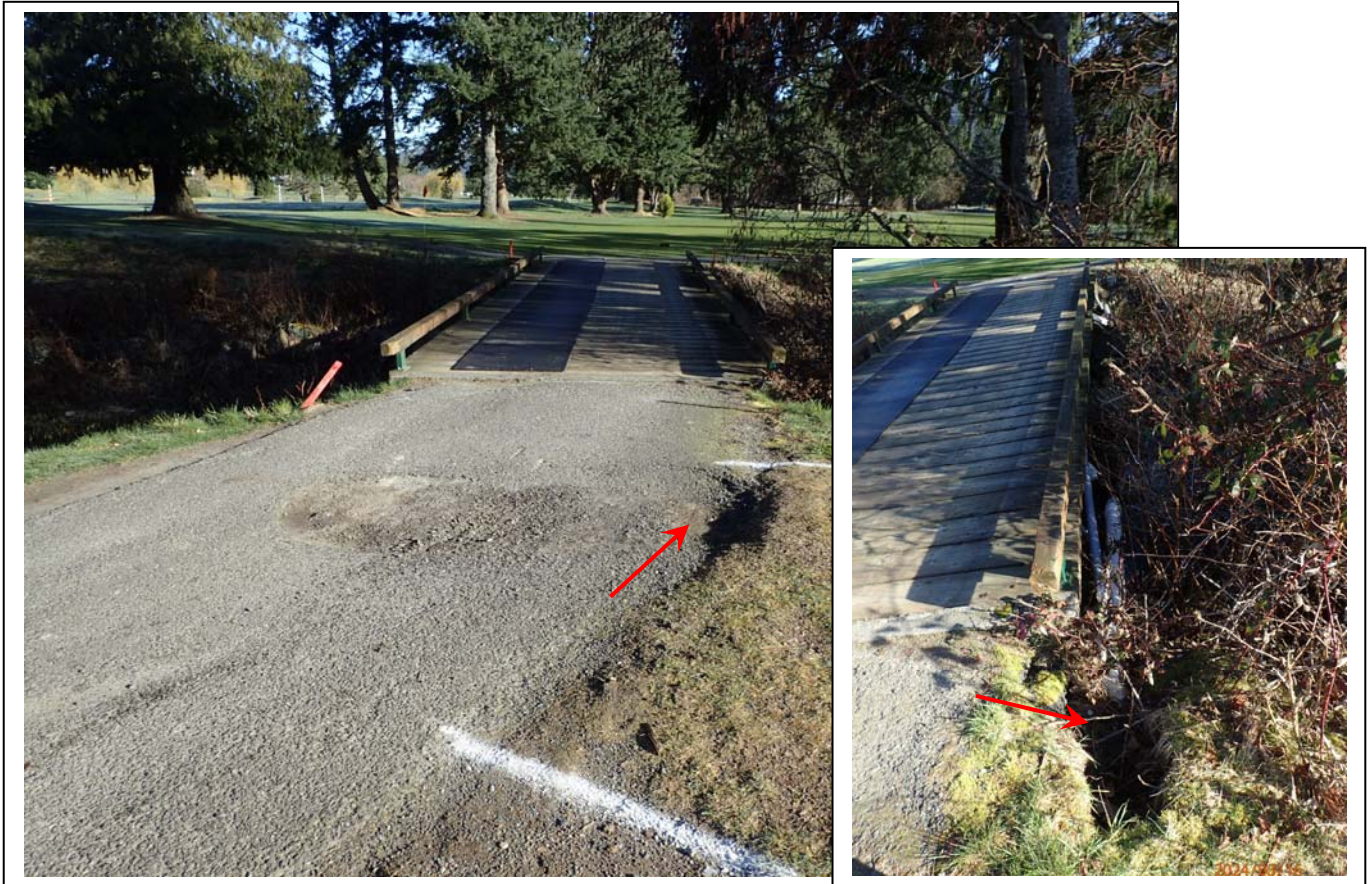
Photo No.: 11 \_\_\_\_\_

**GC BR 4** is a two (2) glulam girder system in good condition. The south east asphalt approach has a significant pothole that needs repair as well as a utility/conduit hole at the SE approach fill. The concrete substructures are also in good condition, but require continued maintenance to remove moist soil that is collecting on the pier seat against the existing timber girders. Moving the soil away it was discovered that carpenter ants were present at this bridge and using the moist soil to wood contact. Adequate riprap protection is present at both abutments and appeared effective.

Description: View of glulam bridge and deck with new replacement rails. South approach pavement has two potholes that require patching and the utility excavation work backfilled.

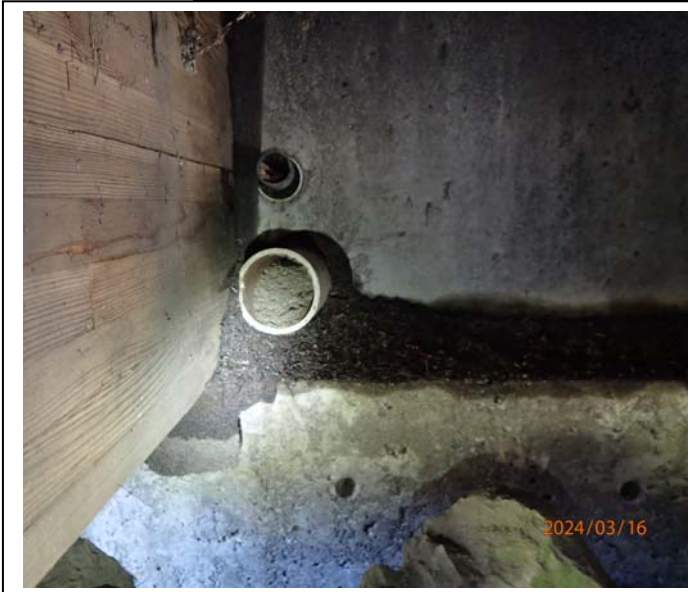
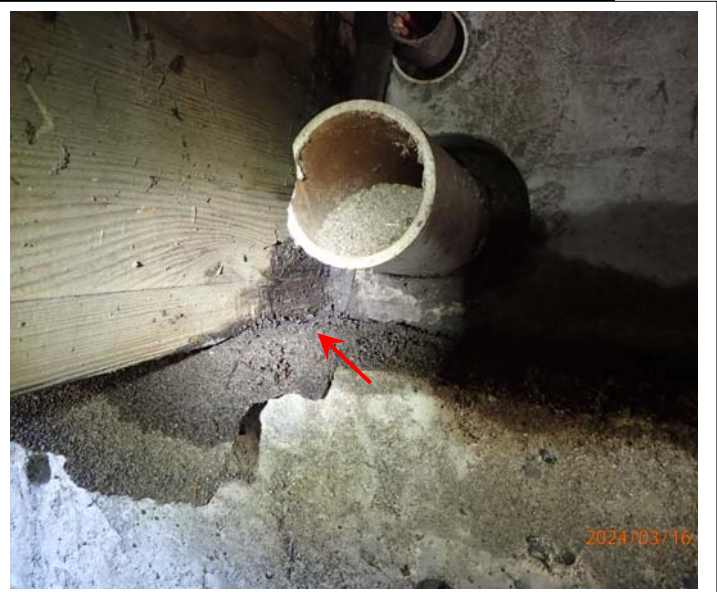
Photo No.: 12 \_\_\_\_\_

Description: Timber decay noted after removal of moist soil accumulated, typical at each concrete abutment seat. Also, carpenter ant activity was noted at this abutment seat and girders.

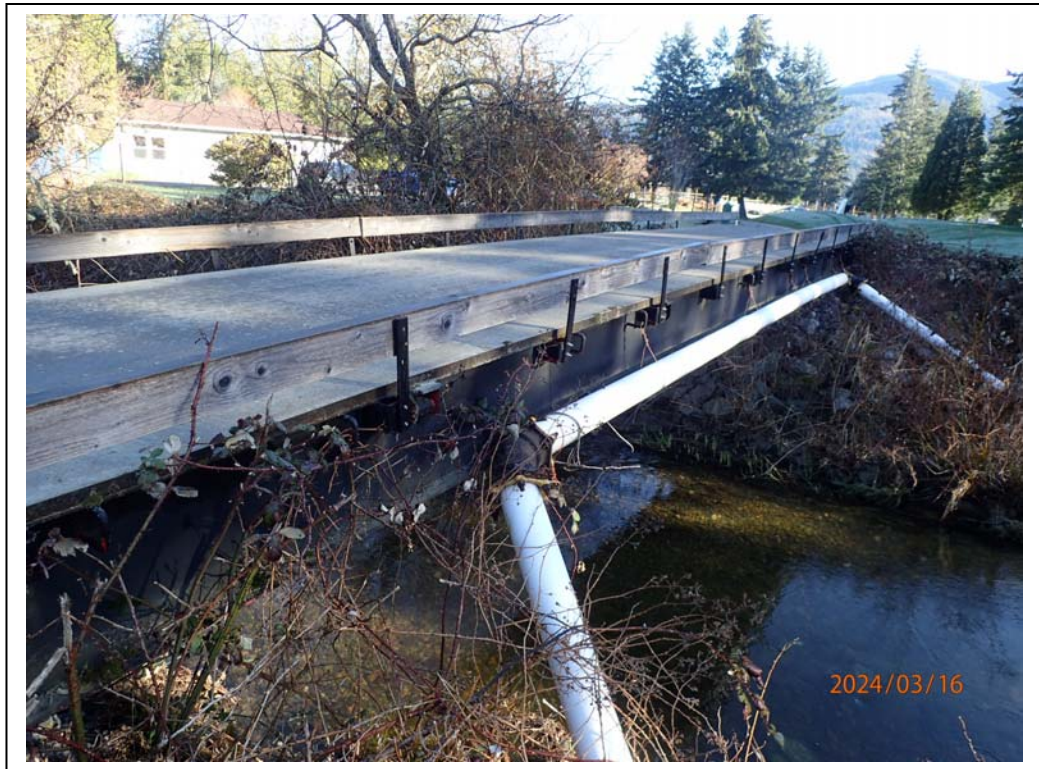
Photo No.: 13

Description: Bridge in good condition, and view of downstream elevation. Timber curb bolts were corrected by maintenance. Replace rope utility support ties with permanent steel strap materials.

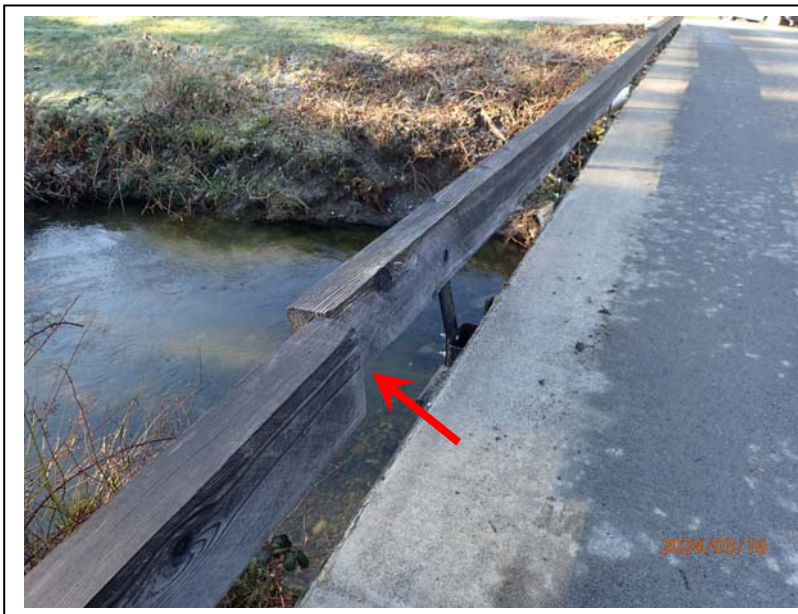
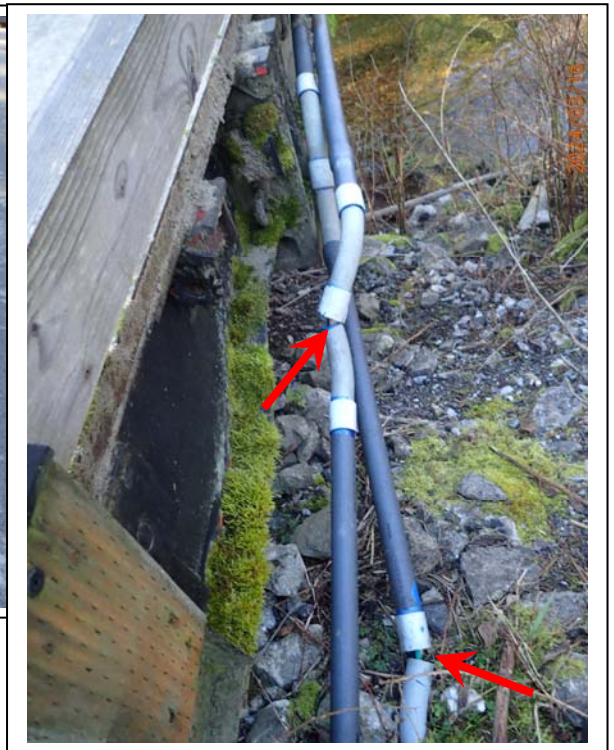
Photo No.: 14

Description: Cart or equipment impact to upstream timber curb rail. Align back into position with timber member at the outside of the splice. Repair separated conduits along north bridge edge.

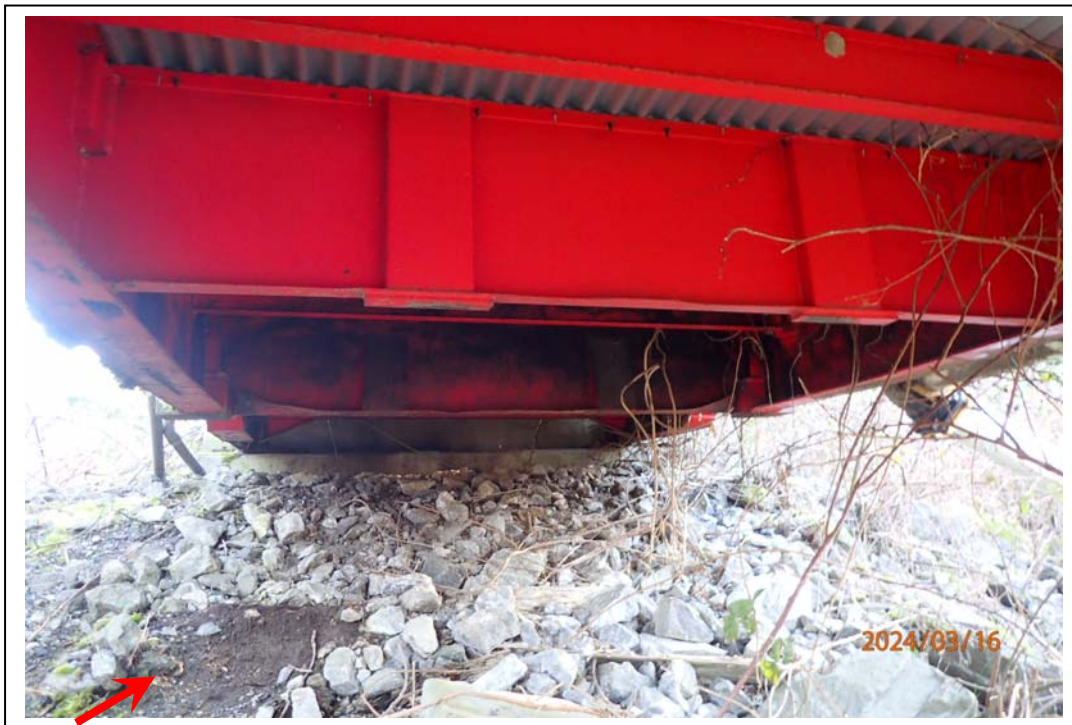
Photo No.: 15

Description: View below bridge of galvanized corrugated deck above. Girders in good condition.  
Note bare patch at upstream edge requiring adjustment of the hand placed riprap protection.

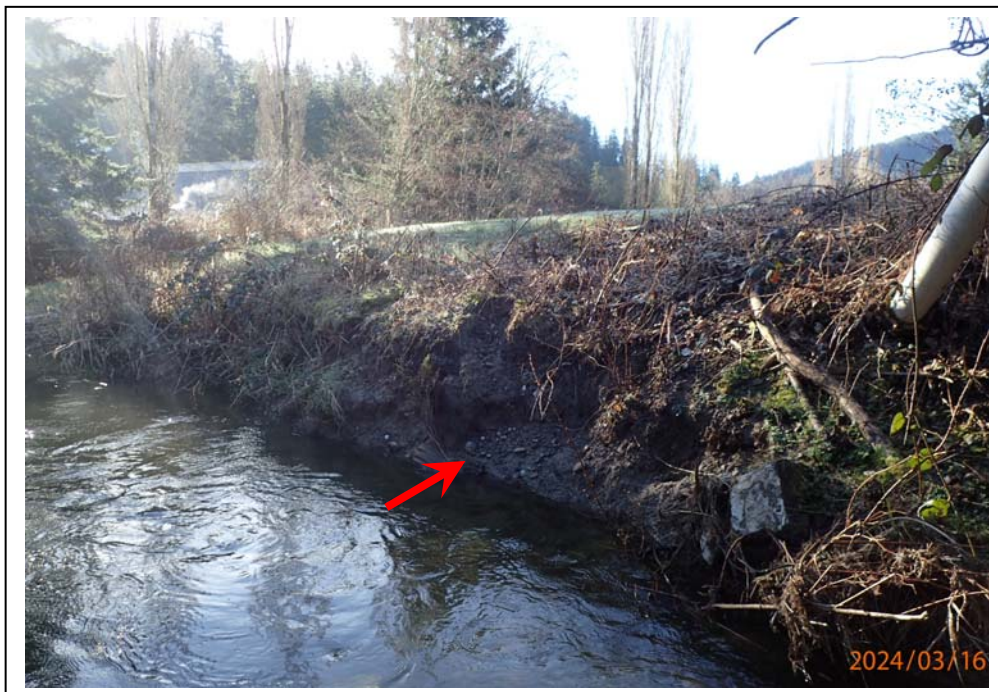
Photo No.: 16

Description: Adjacent upstream scour hole along Austin Creek in need of repair to prevent the  
remaining slope from unraveling during higher flow flood waters conditions.

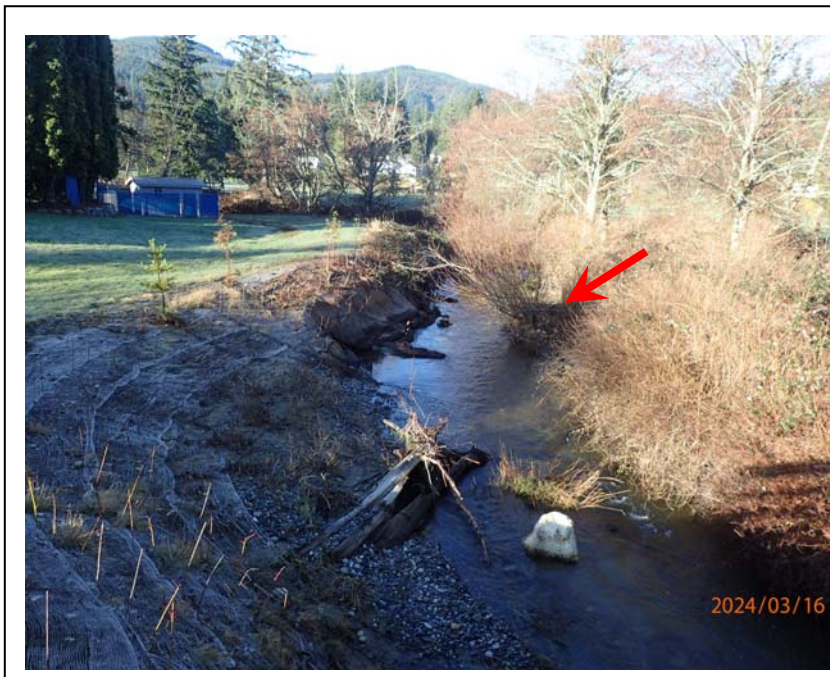
Photo No. 18

Description: View looking upstream from the bridge's southwest corner at creek edge repairs with erosion control mats staked coir logs, and plantings. Recommend trimming overgrown brush and tree that pushed the last river flooding to washout the south end of the bridge.

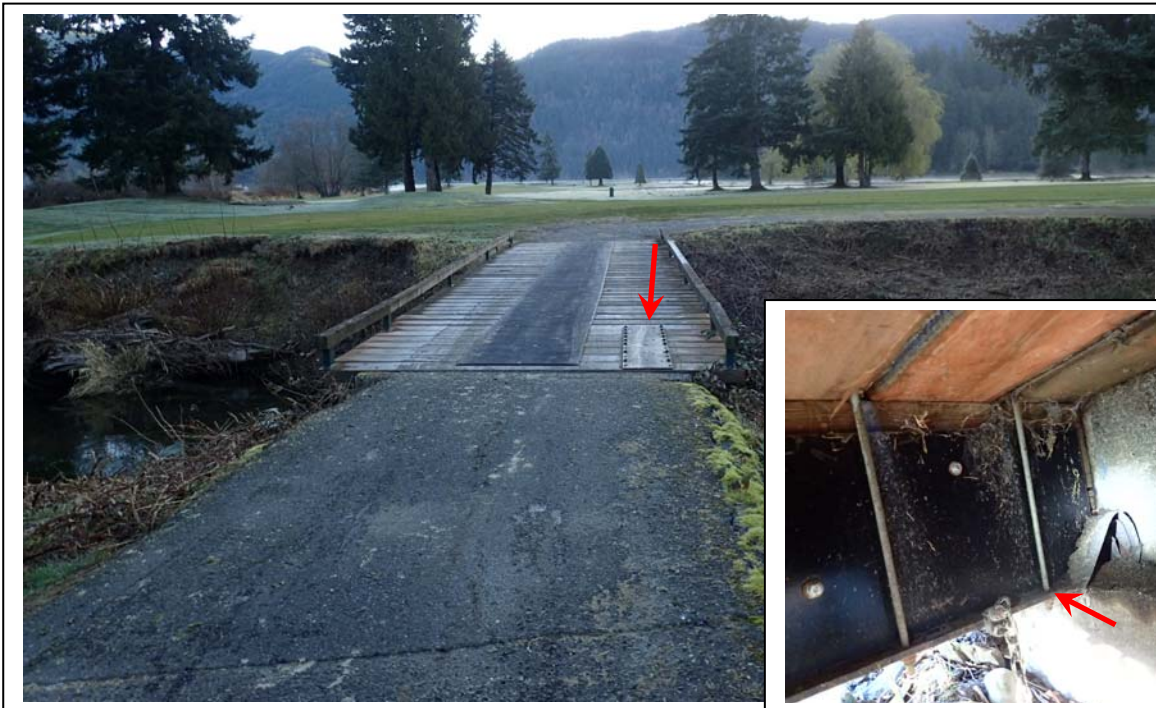
Photo No.: 21

**GC BR 7** is a two (2) girder glulam timber bridge that was repaired successfully with a steel plate and rod clamping system of the south girder. The approach roadway to the bridge requires some additional gravel edge repair due to unraveling and additional asphalt to better match width of the existing bridge. The bridge supports a 6-inch utility irrigation line along the inside of the northeast girder and there are two smaller conduits that are currently in disarray with open wires and require repair. The accumulated moist soil/debris at both abutment seats should also be removed to maintain the girders in satisfactory condition. The substructure is in fair condition due to significant soil erosion at the southeast and northwest corners of the bridge where woody debris and other fill materials should be incorporated to correct the creek edge and protect against future unraveling.

Description: Successful steel repair to the longitudinal glulam girder. Viewed of steel plate/bolts from above and inset is the system as viewed below. Continue to remove moist soil at pier seat.

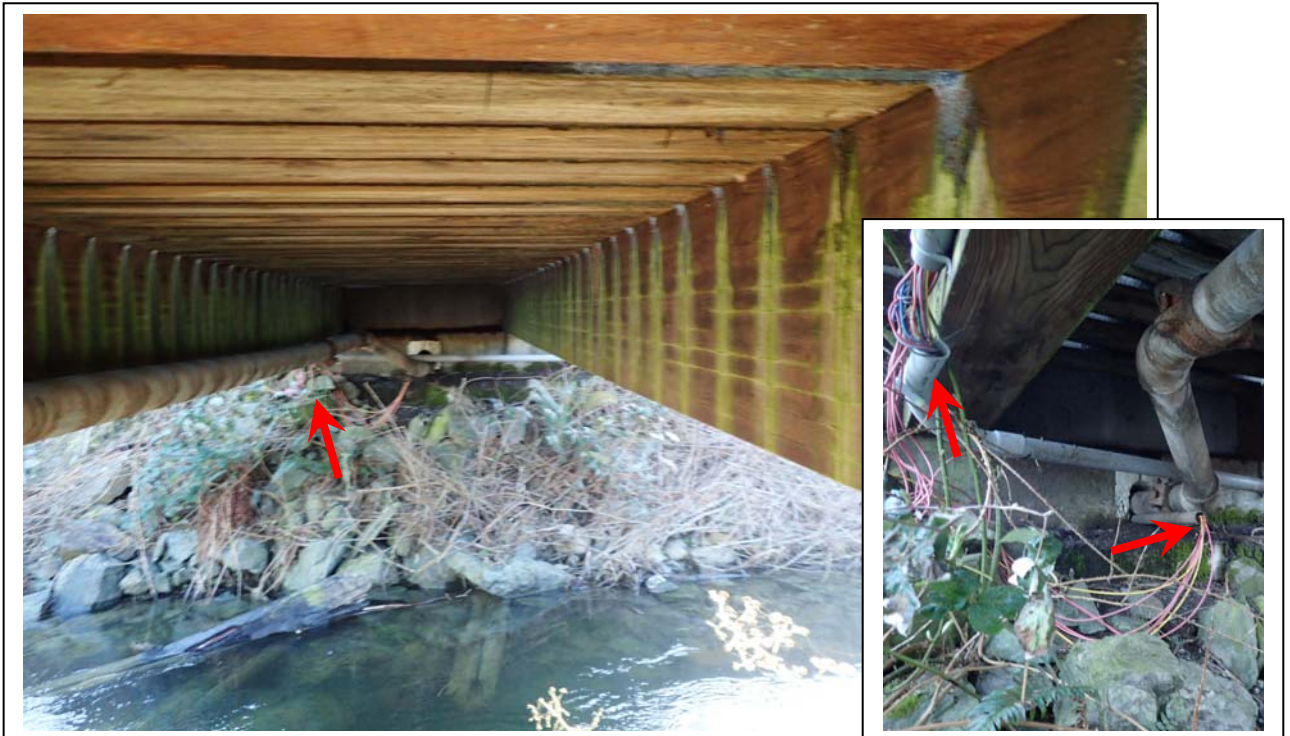
Photo No.: 22

Description: View across the creek from below with timber glulam girders in fair condition and normal weathering. Waterline supported at left and lots of exposed wires from conduit work. Riprap protection is in place and satisfactory condition for the east approach.

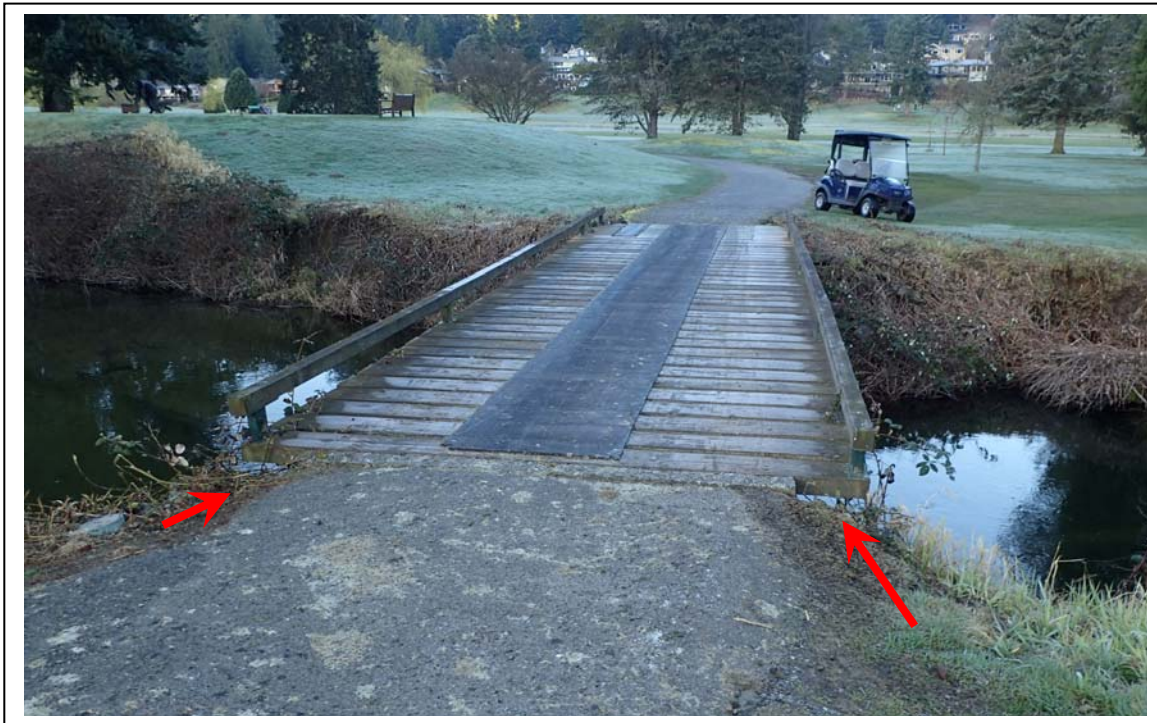
Photo No.: 23

Description: View east showing typical erosion at edges that narrow the path creating a drop off.

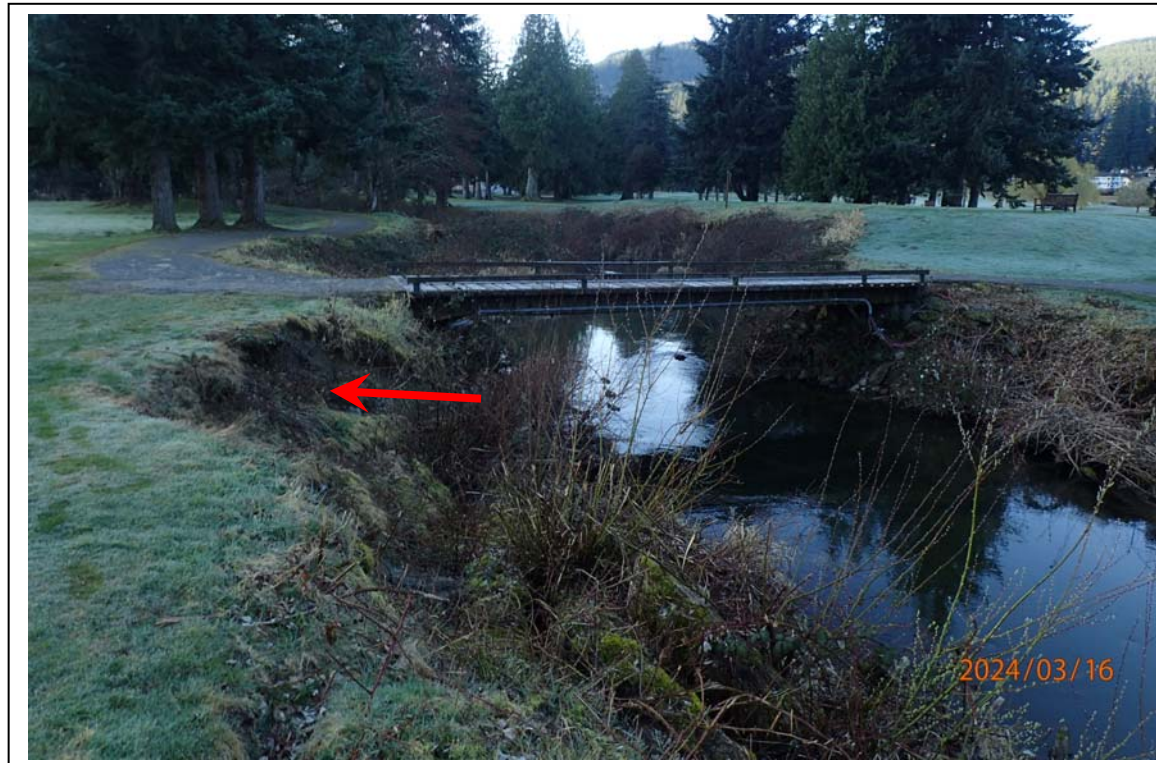
Photo No.: 24

Description: Local log debris in the floodway is significantly improved, but open soil edge erosion of the creek is little changed. Continue plantings and material protection improvements.

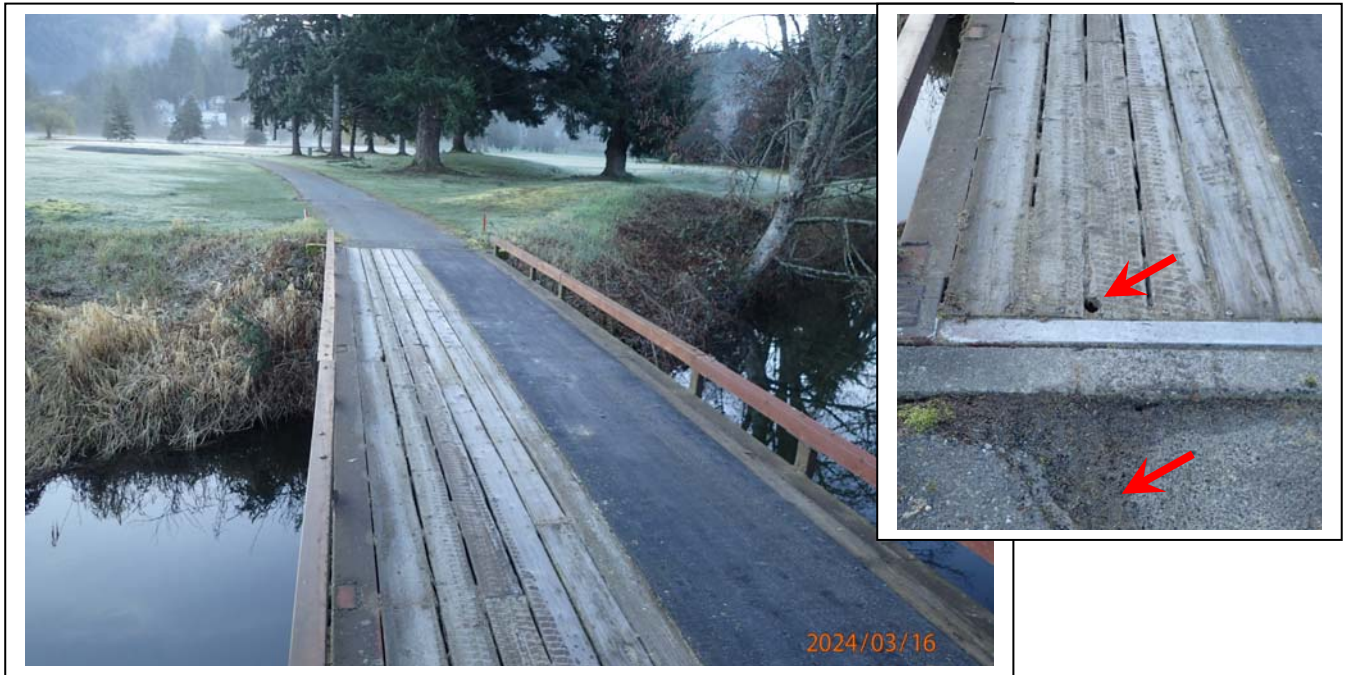
Photo No.: 25

**GC BR 8** is a narrow steel box car bridge in fair condition. The curbs were recently repaired, but the timber decking at the east end is soft, deteriorated, and in need of maintenance. Since last inspection, the conduit location was improved and mostly brought up onto edge of south girder, but still is within the floodway at the southeast corner and the plastic straps will become brittle in the sun and should be replaced with permanent steel straps along the girder. The substructure is in satisfactory condition. At the west abutment some rock and riprap is in place and the creek is flowing immediately along its face. The east abutment by contrast is located back from the creek and protected with adequate riprap and no scour is apparent.

Description: New bridge rail timber repairs since last inspection. A west approach pothole repair is required to limit damage to the longitudinal timber decking deck boards needing replacement.

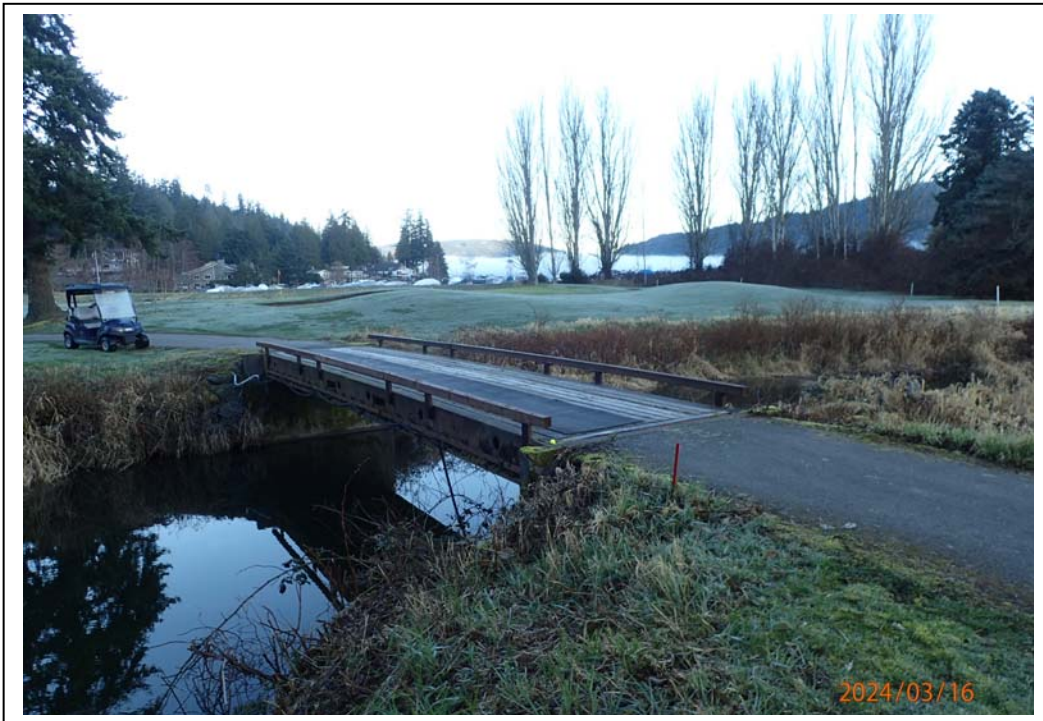
Photo No.: 26

Description: Elevation view of fair condition steel box girder. Concrete pier in satisfactory condition with riprap protection at the lead and tailing corners for the piers. GC BR8 has a narrow cross section at 8-feet, but is adequate for intended access.
