## **Finance Committee Regular Meeting**

## CAPITAL REQUEST MEMO

**To:** Sudden Valley Community Association Board of Directors  
**From:** Jo Anne Jensen, General Manager  
**Date:** September 26th, 2024  
**Subject:** Capital Request – #2 Golf Bridge Repair

**RE:** Sudden Valley Golf Course Bridges Inspection and Reporting

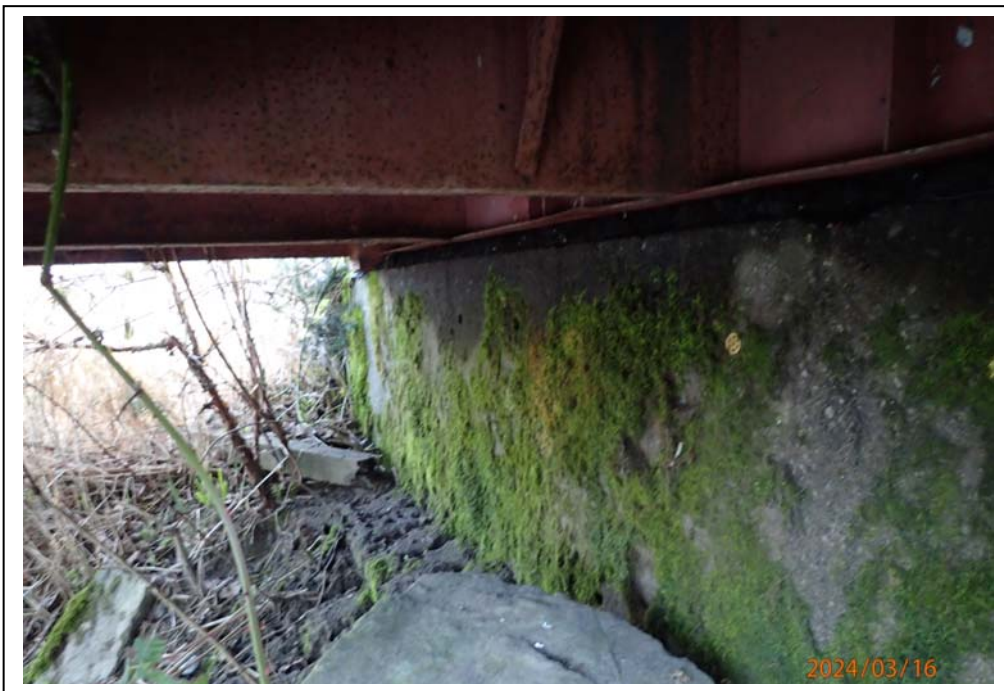
Photo No.: 27

Description: Typical underside view of steel box girders showing surface rust throughout but with limited measured section loss.

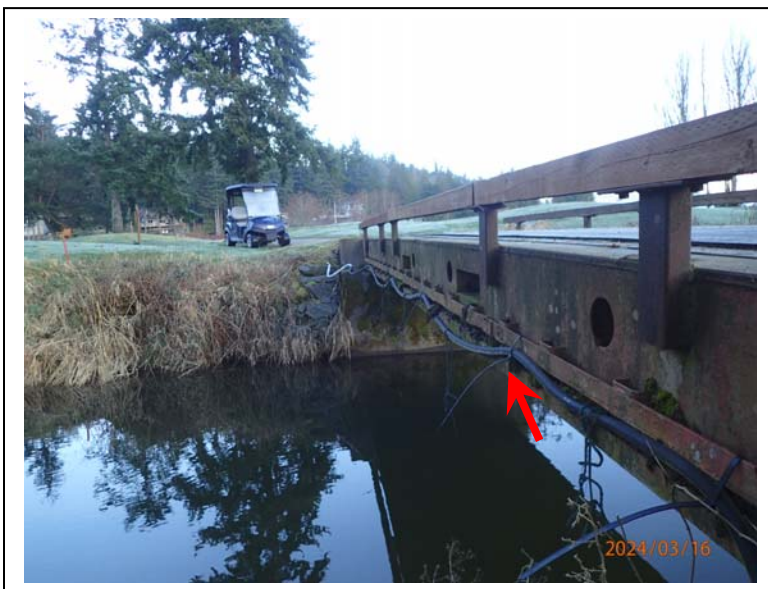
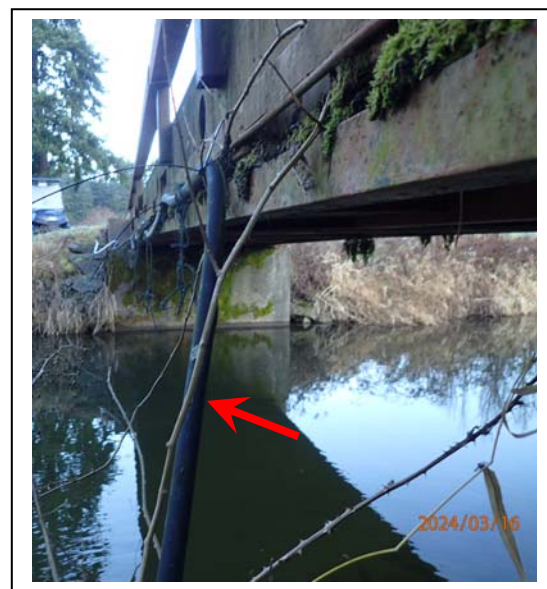
Photo No.: 28

Description: Conduit utility supports are significantly improved with multiple support points and most all locations above the bottom of the girder. The conduit end condition, shown at right, continues to hang below and obstruct the floodway. Recommend correction with steel strap supports and also the replacement of the short-term plastic supports, when possible, including raising all conduit locations to above the bottom of the steel box girder.
