Scope: This is a written summary of findings during site visits focused on the existing condition of play surfacing at each of seven playgrounds in Sudden Valley, and deficiencies in the play surfacing that may exist outside of U.S. Consumer Product Safety Commission guidelines and ASTM Standards for Public Playgrounds.

Method: Susan Willhoft, PLA, assisted by Pam Andrews of PNW Services, conducted site visits of seven playground on February 24, 2022. PLA used a checklist found on following pages to review playground surfacing. Surface Type was identified, Test Pits dug to check surfacing depths, drainage and containment were visually observed, ADA access type, if any, identified. PLA used U.S. Consumer Product Safety Commission (CPSC) guidelines and ASTM Standards for Public Playgrounds to evaluate the playground surfacing. These Guidelines and Standards are developed from National Injury Data, Industry Experience, Risk Management and Litigation, and Anthropometrics.

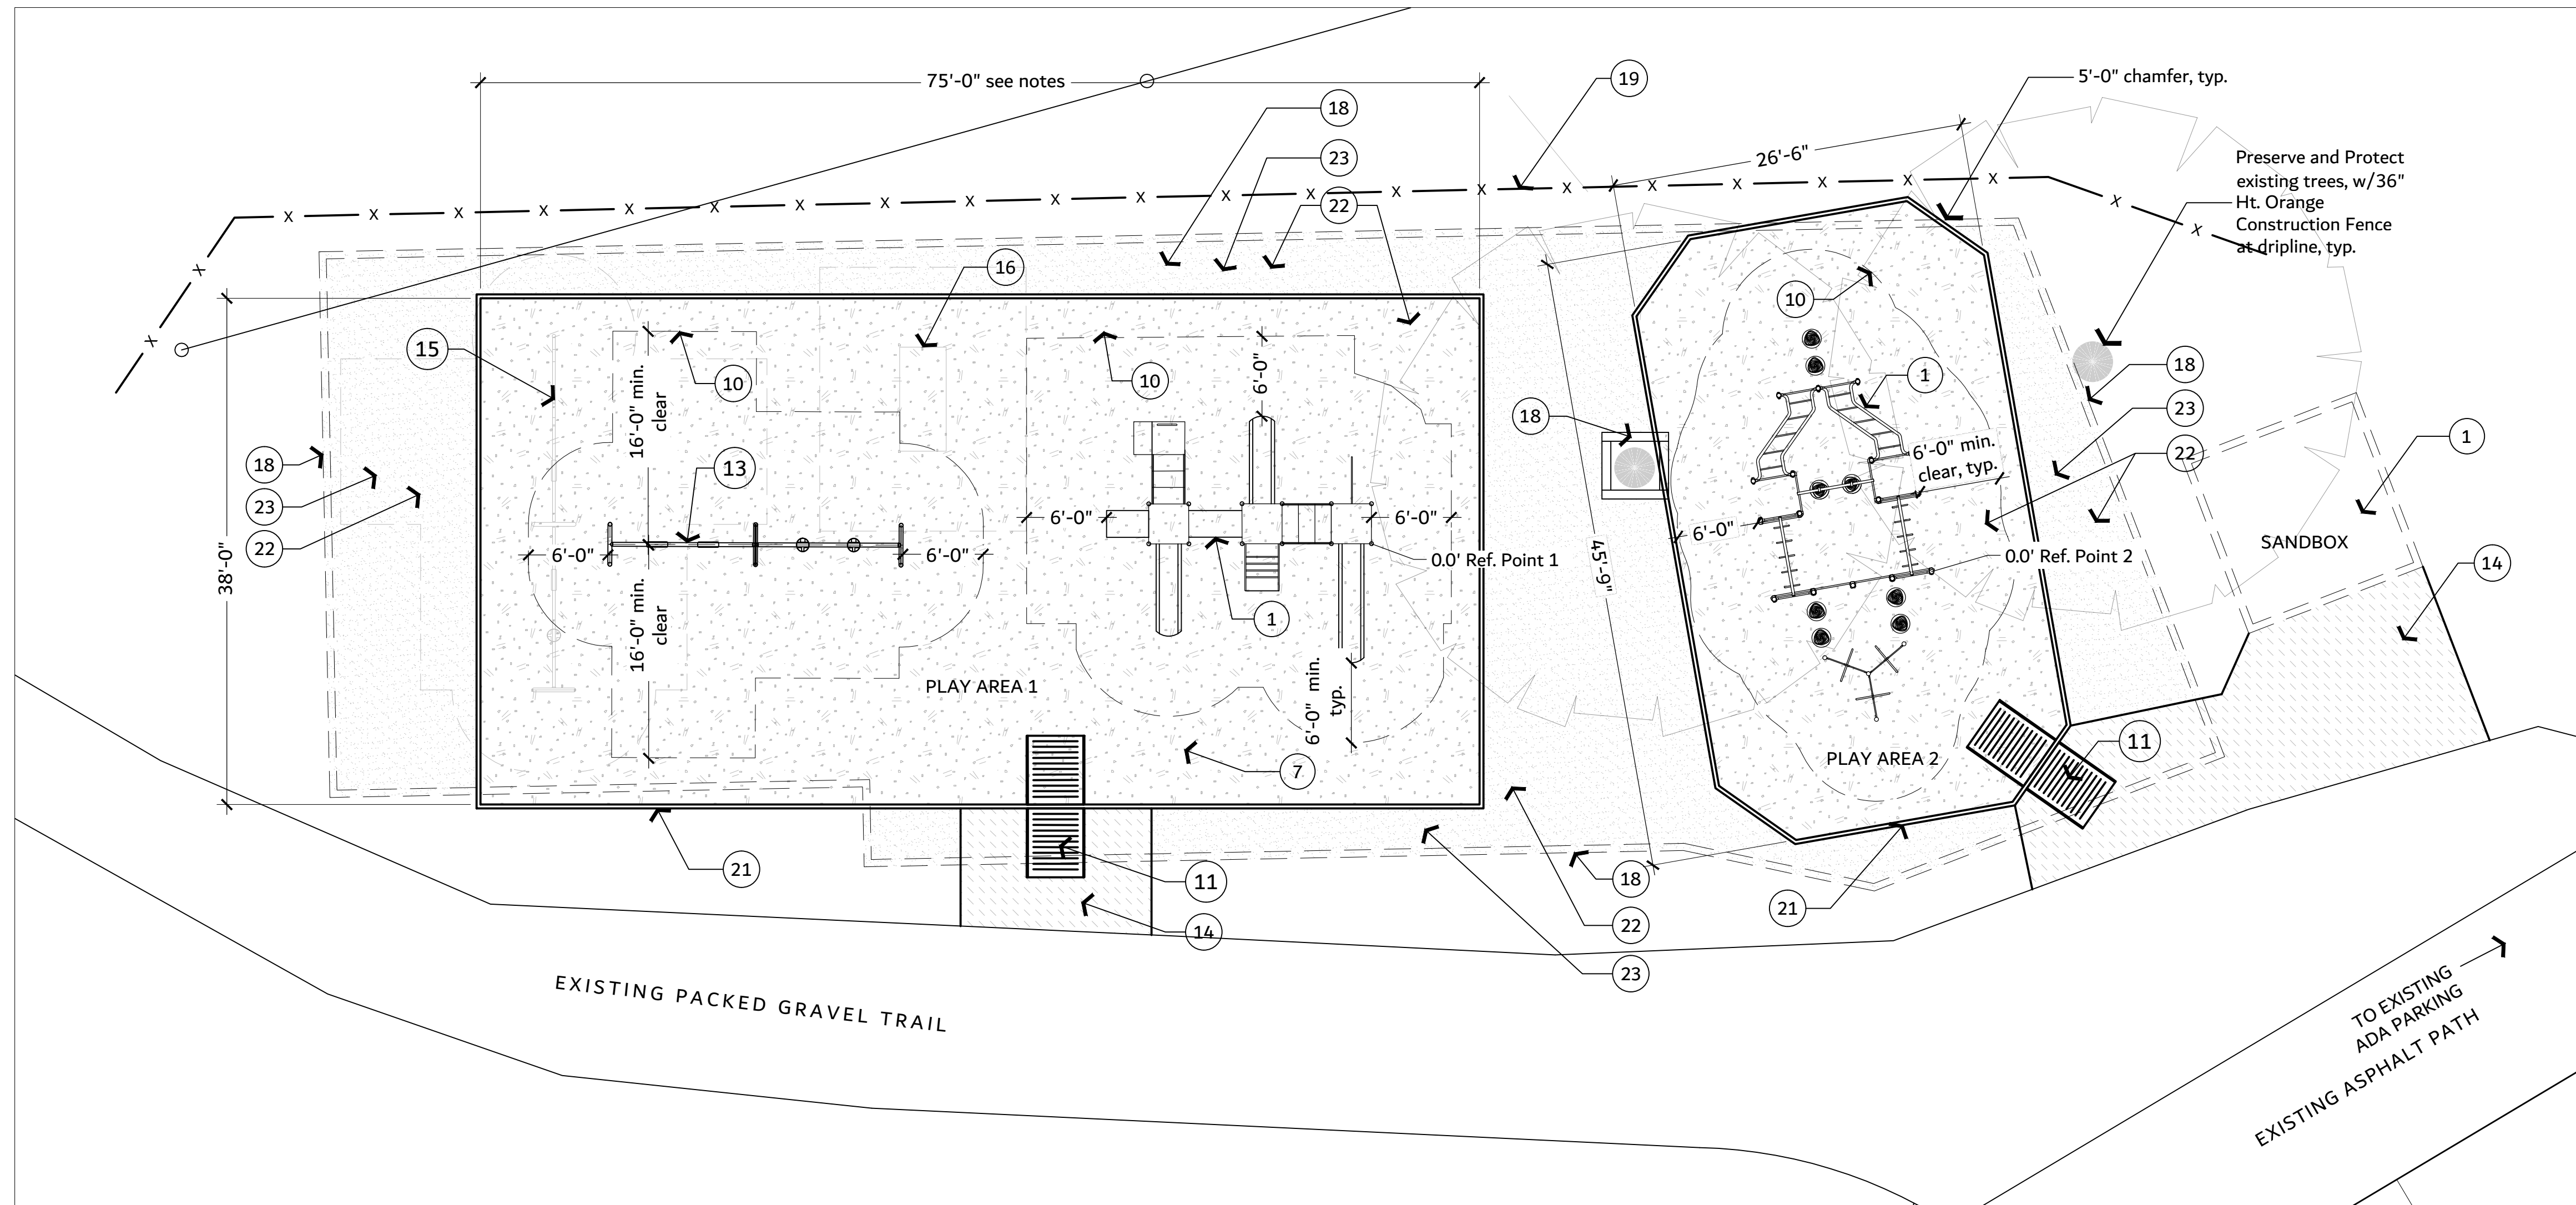
**2 Layout Plan**  
1/8" = 1'-0"

2022 Playground ADA Improvements include: ADA accessible surfacing, Leveling header for surfacing containment and for meeting ASTM fall zone requirements, Accessible route surfacing over existing driveway from street to playground. Related work includes: Repair and Relocate existing swing. The existing swing needs to be reset so the the playground can be one level. Relocating the swing will also economize the area to add play surfacing material.

7. New Playground Header is pre-fabricated plastic system. Ramp should fit integrally with plastic prefab. edging system, sold by Wildwood Playgrounds. Equal ramp/edging options can be submitted for approval.

8. Install temporary construction fencing to prevent children from playing on equipment when no fall surfacing is in place.
9. Coordinate with Owner and swing manufacturer for playground area dimensions. Swing shown is ParkPlay Freestanding 2-bay arch swing, 3-1/2" O.D.

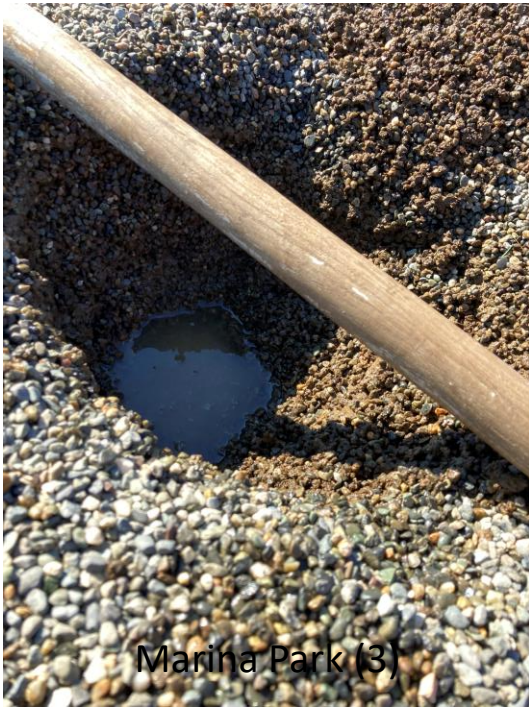
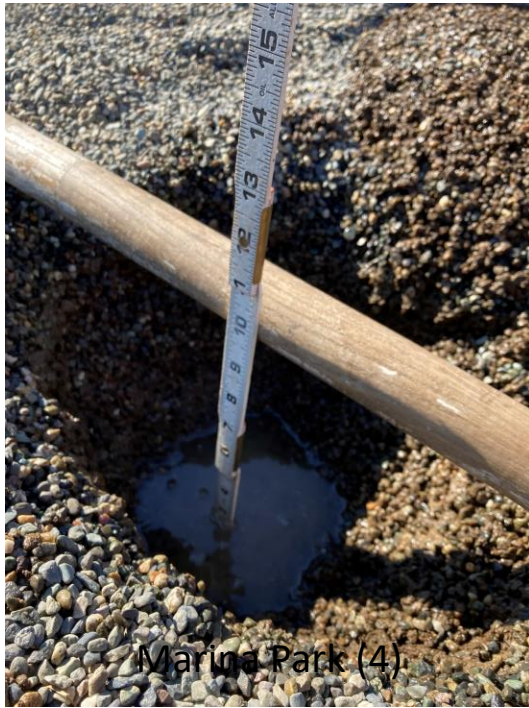
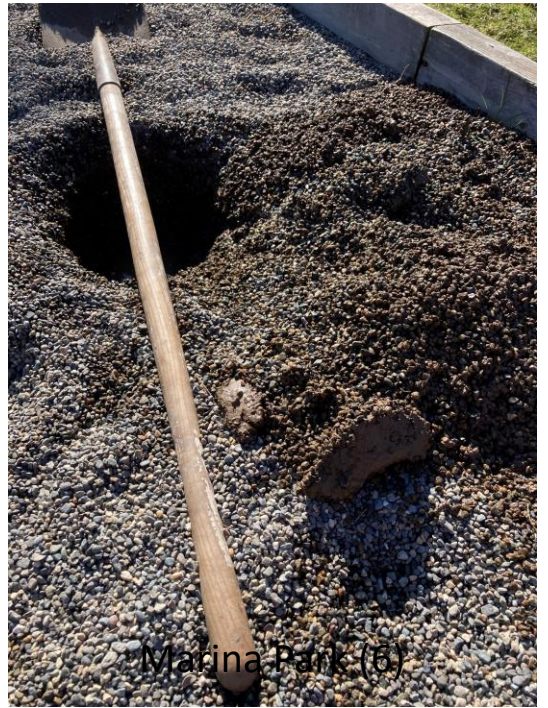
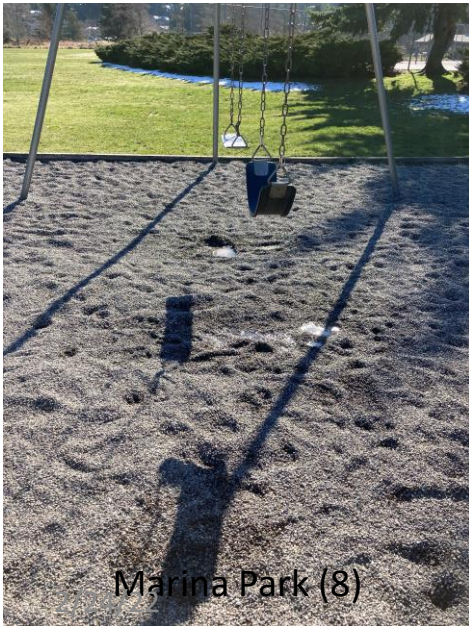
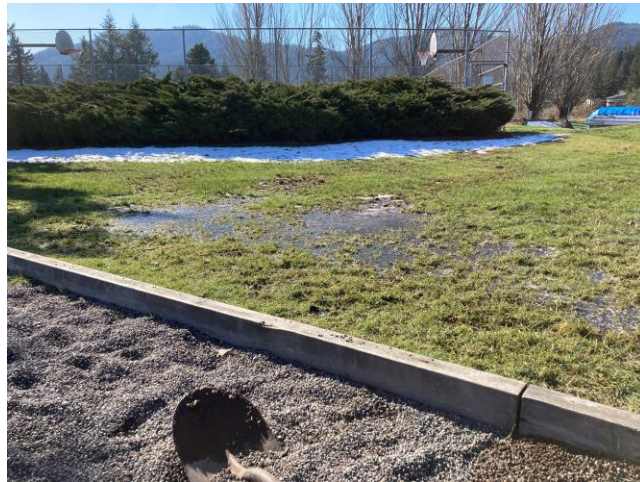
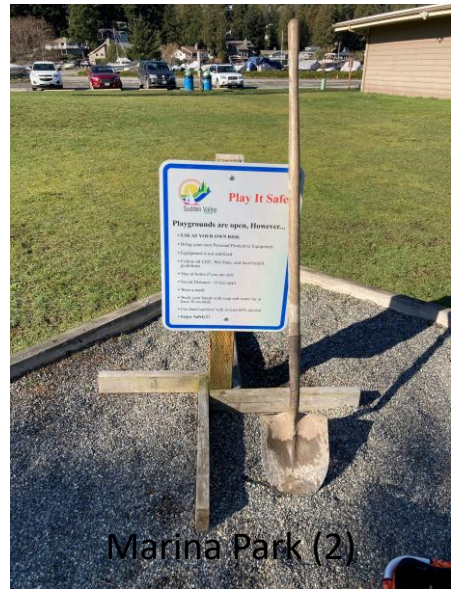
Marina Park Playground

1. Use Zones too short on all sides of this swing structure.
2. Containment: Retaining wall has variable top of wall elevation.
3. Drainage: Standing water visible under swing seats. Puddles observed uphill of timber wall.
4. 9" depth pea gravel had 4" of standing water in test pit. 4" depth pea gravel material was mixed with mud.
5. Sandboxes do not require safety surfacing.

1. Improve drainage to flow around use zone and retaining wall to eliminate standing water within the playground safety surfacing.
2. Size Use Zones per ASTM and CPSC recommendations.
3. Replace Pea Gravel with a type of Playground Safety Surfacing that meets or exceeds the Fall Height requirements for this equipment.
4. Improve retaining wall to hold full depth of playground safety surfacing used.
5. ADA Accessibility laws have changed for public playgrounds. Further study of compliance to ADA laws are recommended as the playgrounds are upgraded and replaced.
6. Add Playground sign per ASTM1487 (current version), Section 14. Contact playground rep. for more information.

- a. Recommend Owner review swingset footings for stability as the structure footings appear loose.
- b. Recommend Owner review sandbox retaining wall wood for rot and erosion on the lakeside of the sandbox.
- b. Loose hardware requires maintenance. Example is S-hooks on swings. Contact manufacturer's rep. for information.
- c. Loose-filled Playground surfacing requires regular ongoing maintenance to maintain required depth and remove contaminants.
- e. This site is on the Lake Whatcom Shoreline. Reviewing permit requirements is recommended for future improvements.
