## **Finance Committee Regular Meeting**

## CAPITAL REQUEST MEMO

**To:** Sudden Valley Community Association Board of Directors  
**From:** Jo Anne Jensen, General Manager  
**Date:** September 26th, 2024  
**Subject:** Capital Request – #2 Golf Bridge Repair

**RE:** Sudden Valley Golf Course Bridges Inspection and Reporting

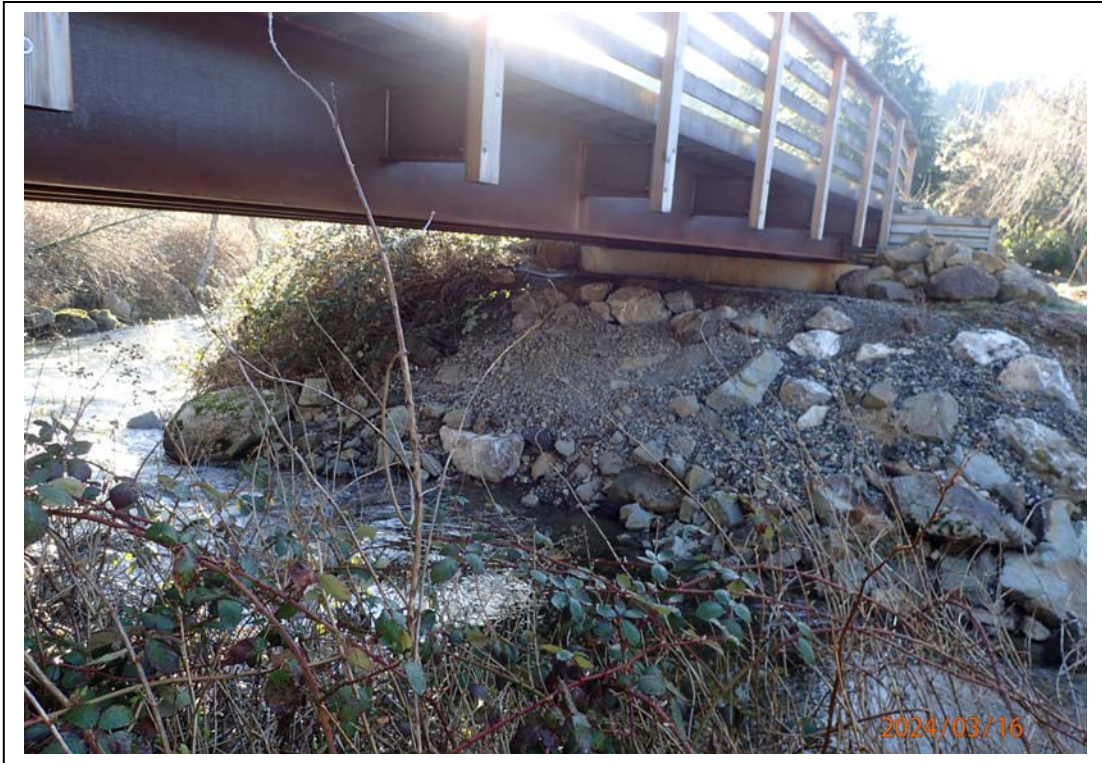
Photo No.: 19

Description: Upstream steel girder bridge and rail elevation looking southeast across the creek.

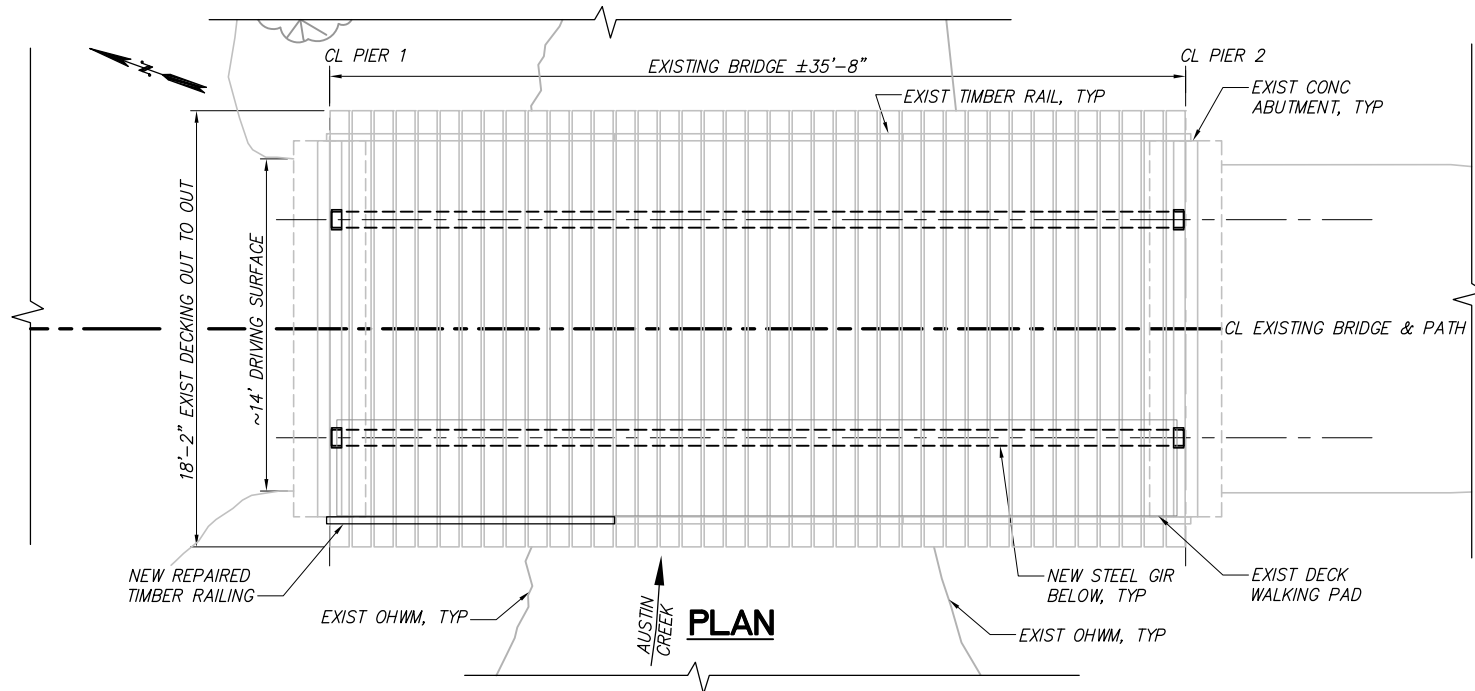
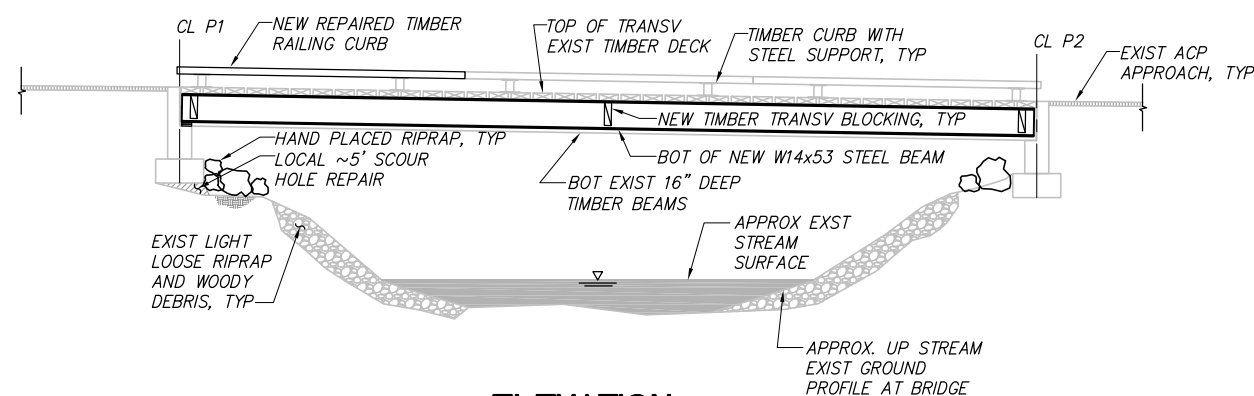
**PLAN**

**GC BR 2** is a much wider bridge at 18'-2" out-to-out and functions as the primary route for patron golf carts and equipment crossings. The superstructure is supported by four (4) timber rough sawn 10"x16" girders, but is in poor condition as the two west girders have splits and the central west girder contains internal decay and support crushing. Sagging is apparent at the west exterior of the bridge (see photos) and a Repair Plan & Detail is included in **Appendix B**. All utility support is focused on the west exterior girder and the three utility support anchors pulled free during the last major flooding still require repair. Furthermore, wet soil must be removed from the concrete bearing seats as it has impacted the girders causing timber decay. Review of the foundations shows the concrete piers in good condition, except for a needed north abutment scour hole repair. Adequate riprap protection is in place, but hand adjustment of the rock to correct shifting during the last flooding is recommended. The curb railing also remains damaged at the northwest corner and must be replaced. Irrigation utilities are located more than 2-feet below the bottom of the girder and in the future should be adjusted up to locate in between the girders to improve the creek's floodway and share the weight between girders.
