Scope: This is a written summary of findings during site visits focused on the existing condition of play surfacing at each of seven playgrounds in Sudden Valley, and deficiencies in the play surfacing that may exist outside of U.S. Consumer Product Safety Commission guidelines and ASTM Standards for Public Playgrounds.

Method: Susan Willhoft, PLA, assisted by Pam Andrews of PNW Services, conducted site visits of seven playground on February 24, 2022. PLA used a checklist found on following pages to review playground surfacing. Surface Type was identified, Test Pits dug to check surfacing depths, drainage and containment were visually observed, ADA access type, if any, identified. PLA used U.S. Consumer Product Safety Commission (CPSC) guidelines and ASTM Standards for Public Playgrounds to evaluate the playground surfacing. These Guidelines and Standards are developed from National Injury Data, Industry Experience, Risk Management and Litigation, and Anthropometrics.

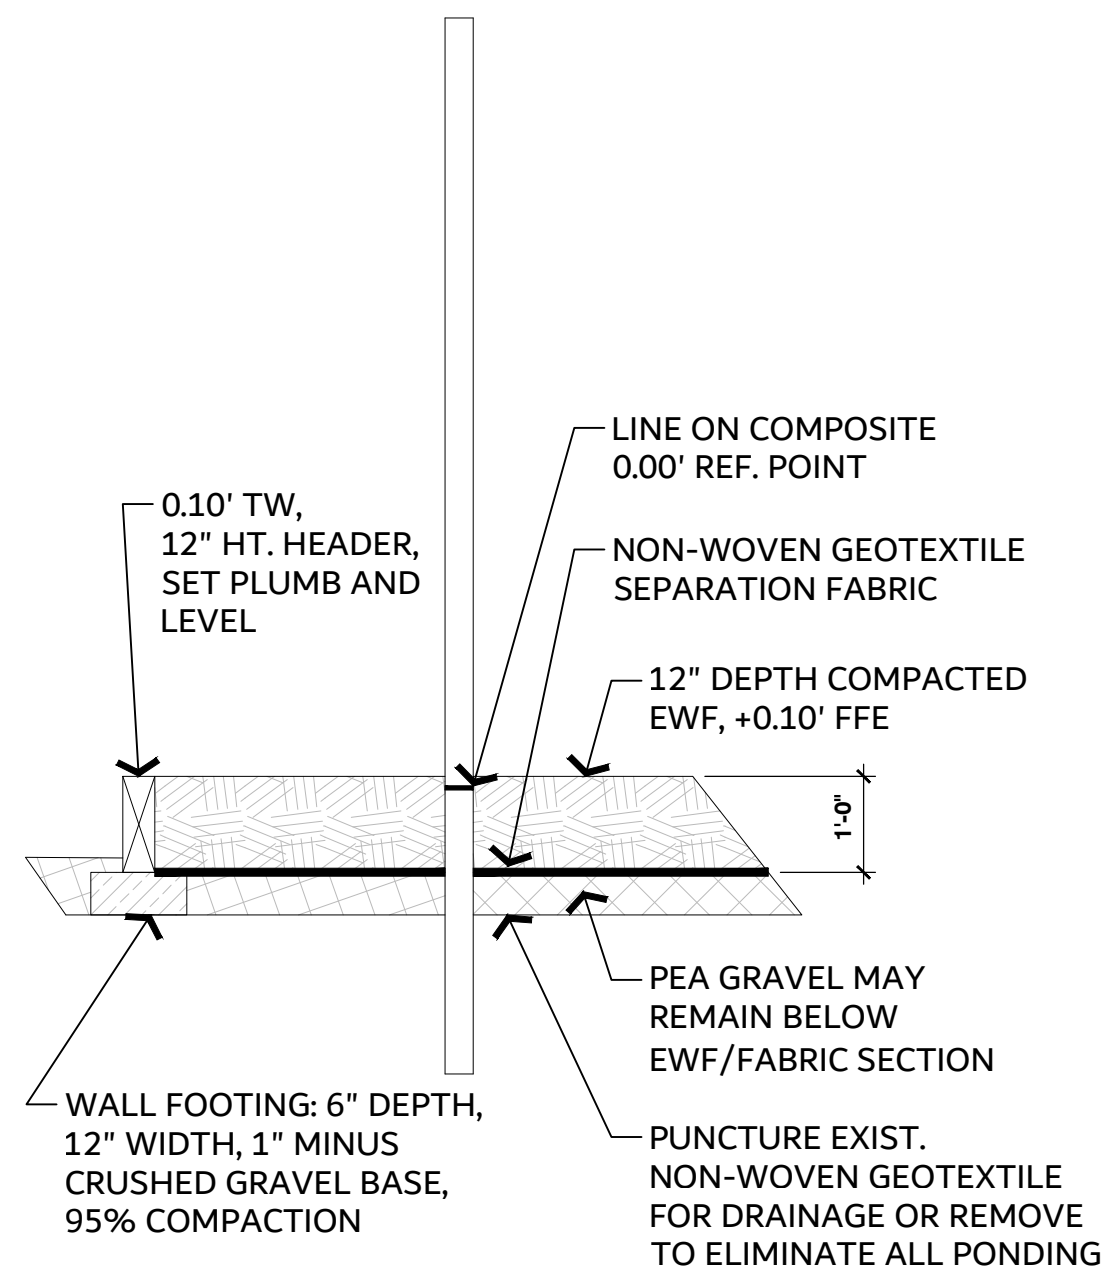
**1 REC. CORR. PARK PLAYGROUND DETAIL**  
1/2" = 1'-0" P-2022-SUD-40

7. New Playground Header is pre-fabricated plastic system. Ramp should fit integrally with plastic prefab. edging system, sold by Wildwood Playgrounds. Equal ramp/edging options can be submitted for approval.

8. Install temporary construction fencing to prevent children from playing on equipment when no fall surfacing is in place.
9. Coordinate with Owner and swing manufacturer for playground area dimensions. Swing shown is ParkPlay Freestanding 2-bay arch swing, 3-1/2" O.D.
