# **Sudden Valley Community Association**

## **Finance Committee Meeting**

## 10 Barn View Court Demolition Permit Shorelines Exemption Project Narrative

SUDDEN VALLEY COMMUNITY ASSOCIATION (SVCA)  
SITUATE IN A PORTION OF THE NE 1/4, SW 1/4 SECTION 5, TOWNSHIP 37 NORTH, RANGE 4 EAST OF W.M. SUDDEN VALLEY, WHATCOM COUNTY, WASHINGTON  
10 BARN VIEW COURT (BARN 6) DEMOLITION PERMIT (DEMO-XXXX)

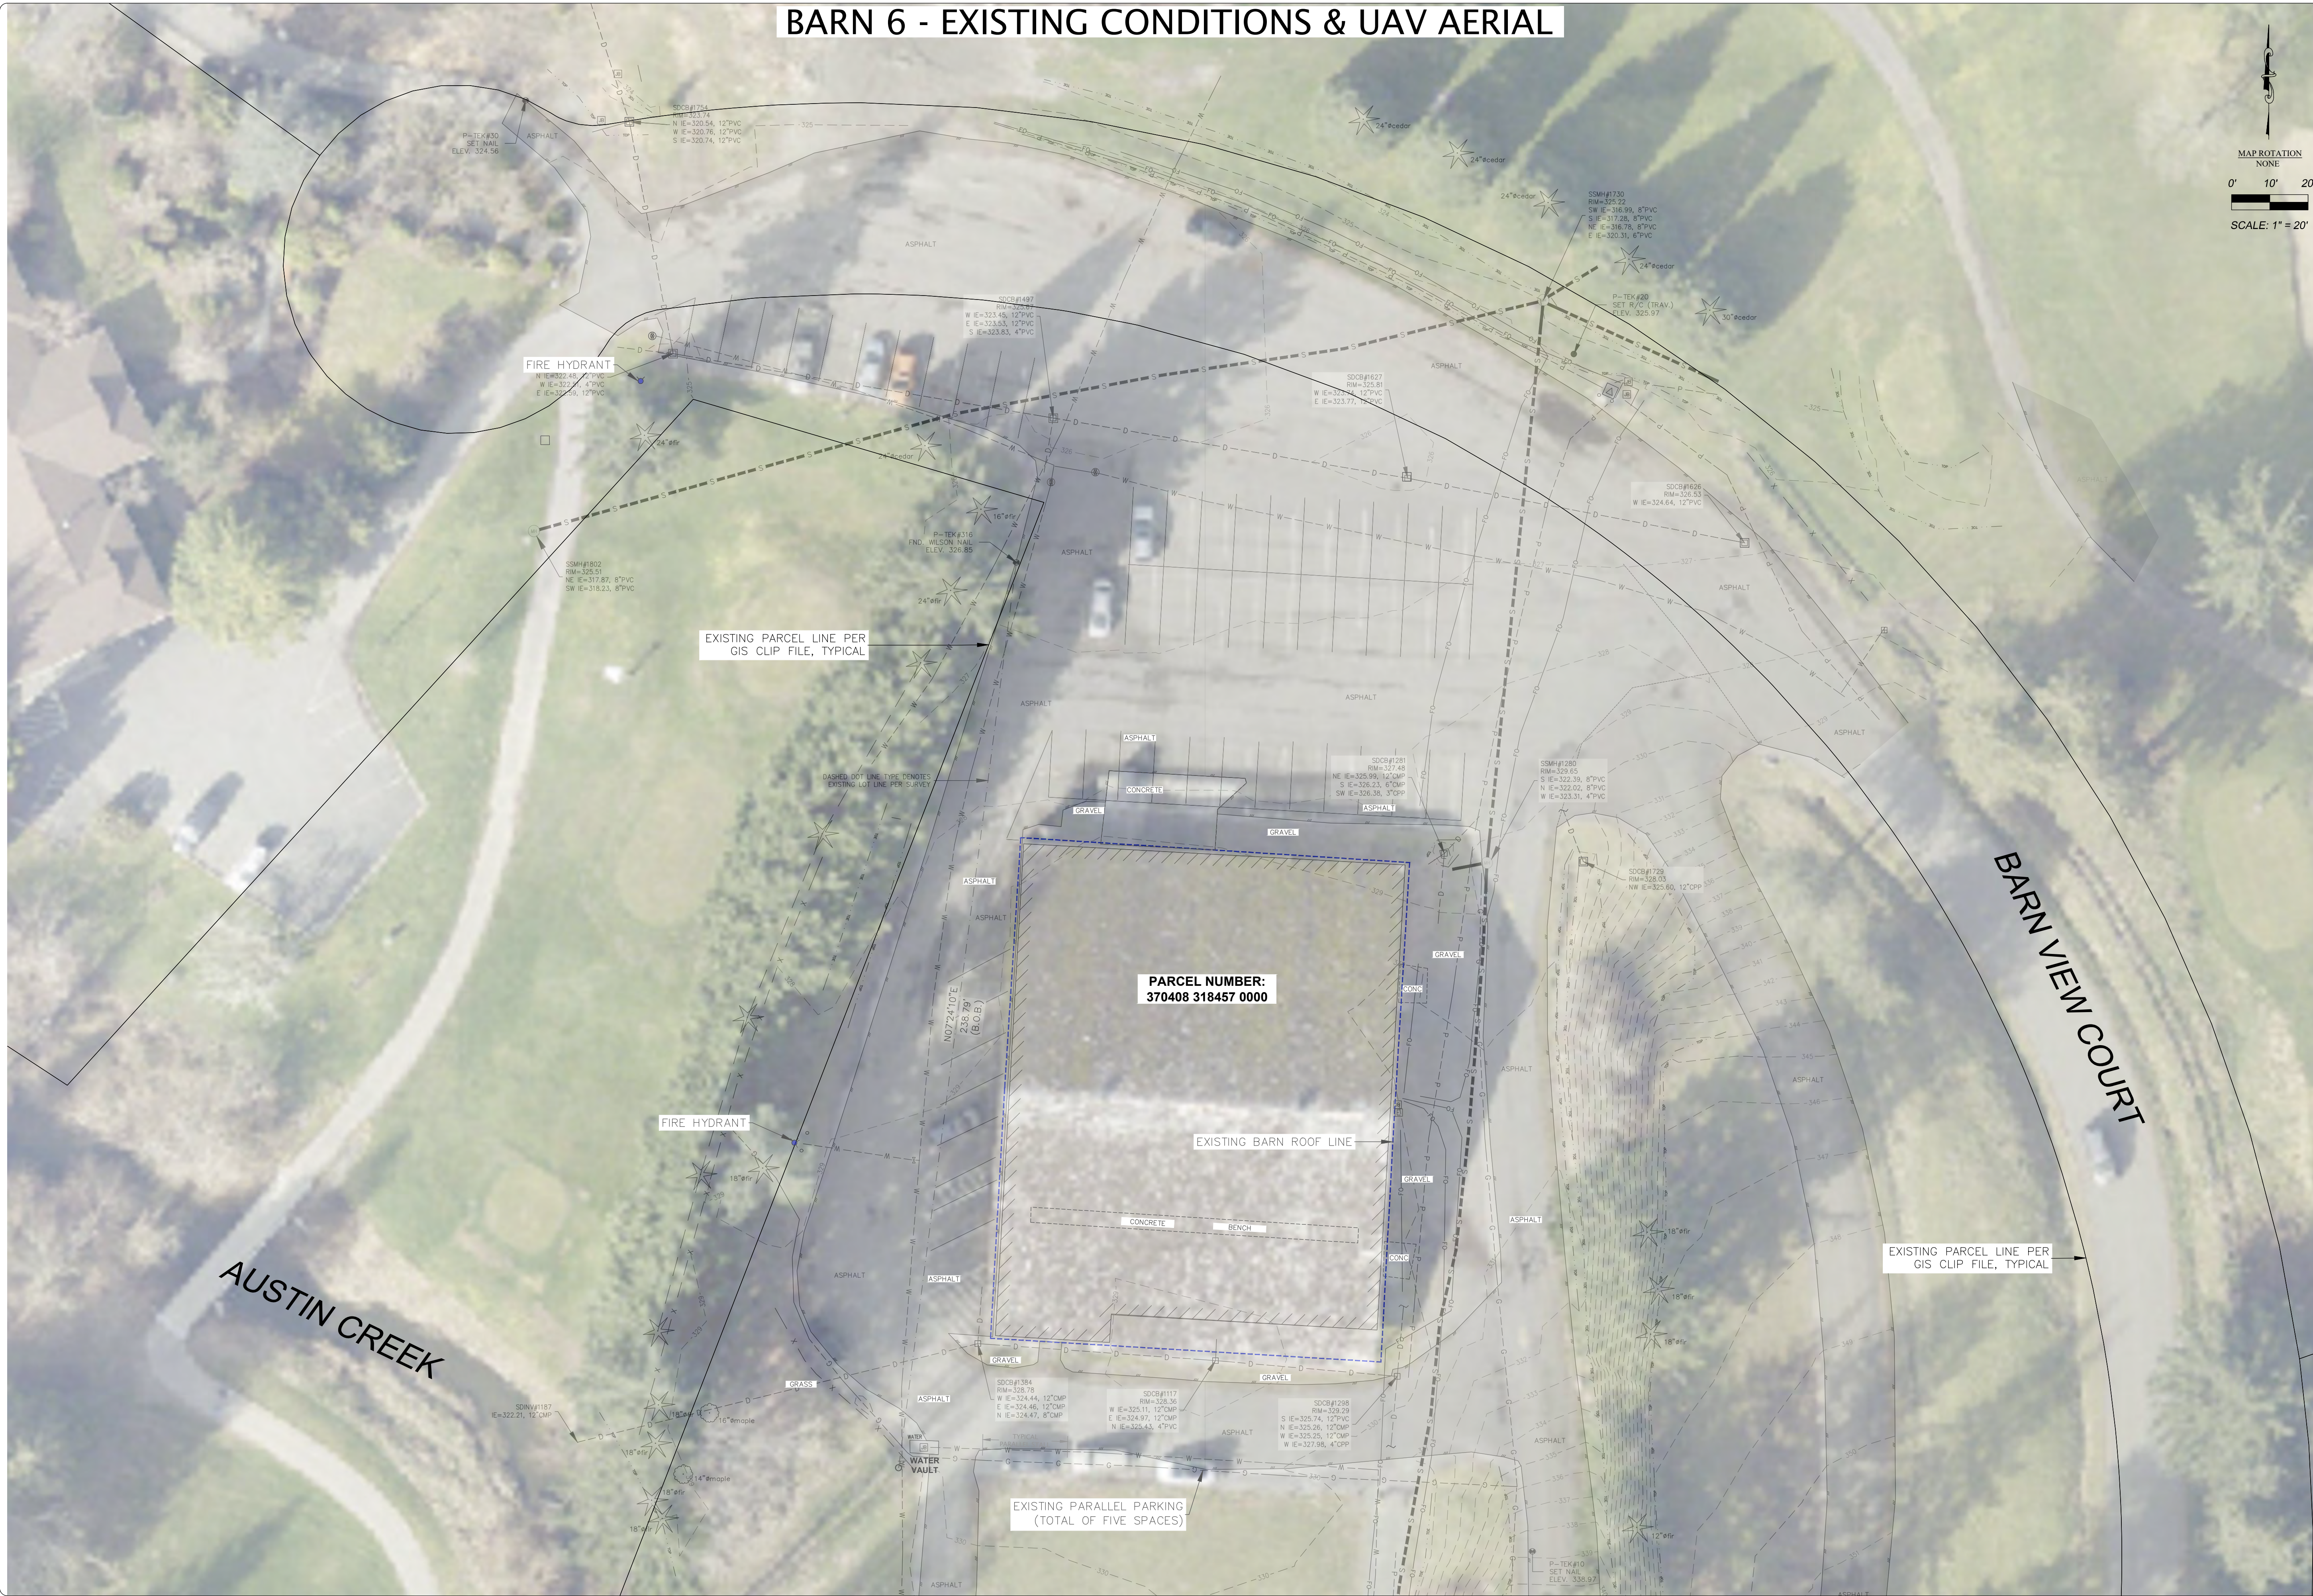
BARN 6 - EXISTING CONDITIONS & UAV AERIAL

SVCA BARN 6 - DEMOLITION PERMIT  
DEMOLITION PERMIT - XXXX  
EXISTING CONDITIONS & UVA AERIAL

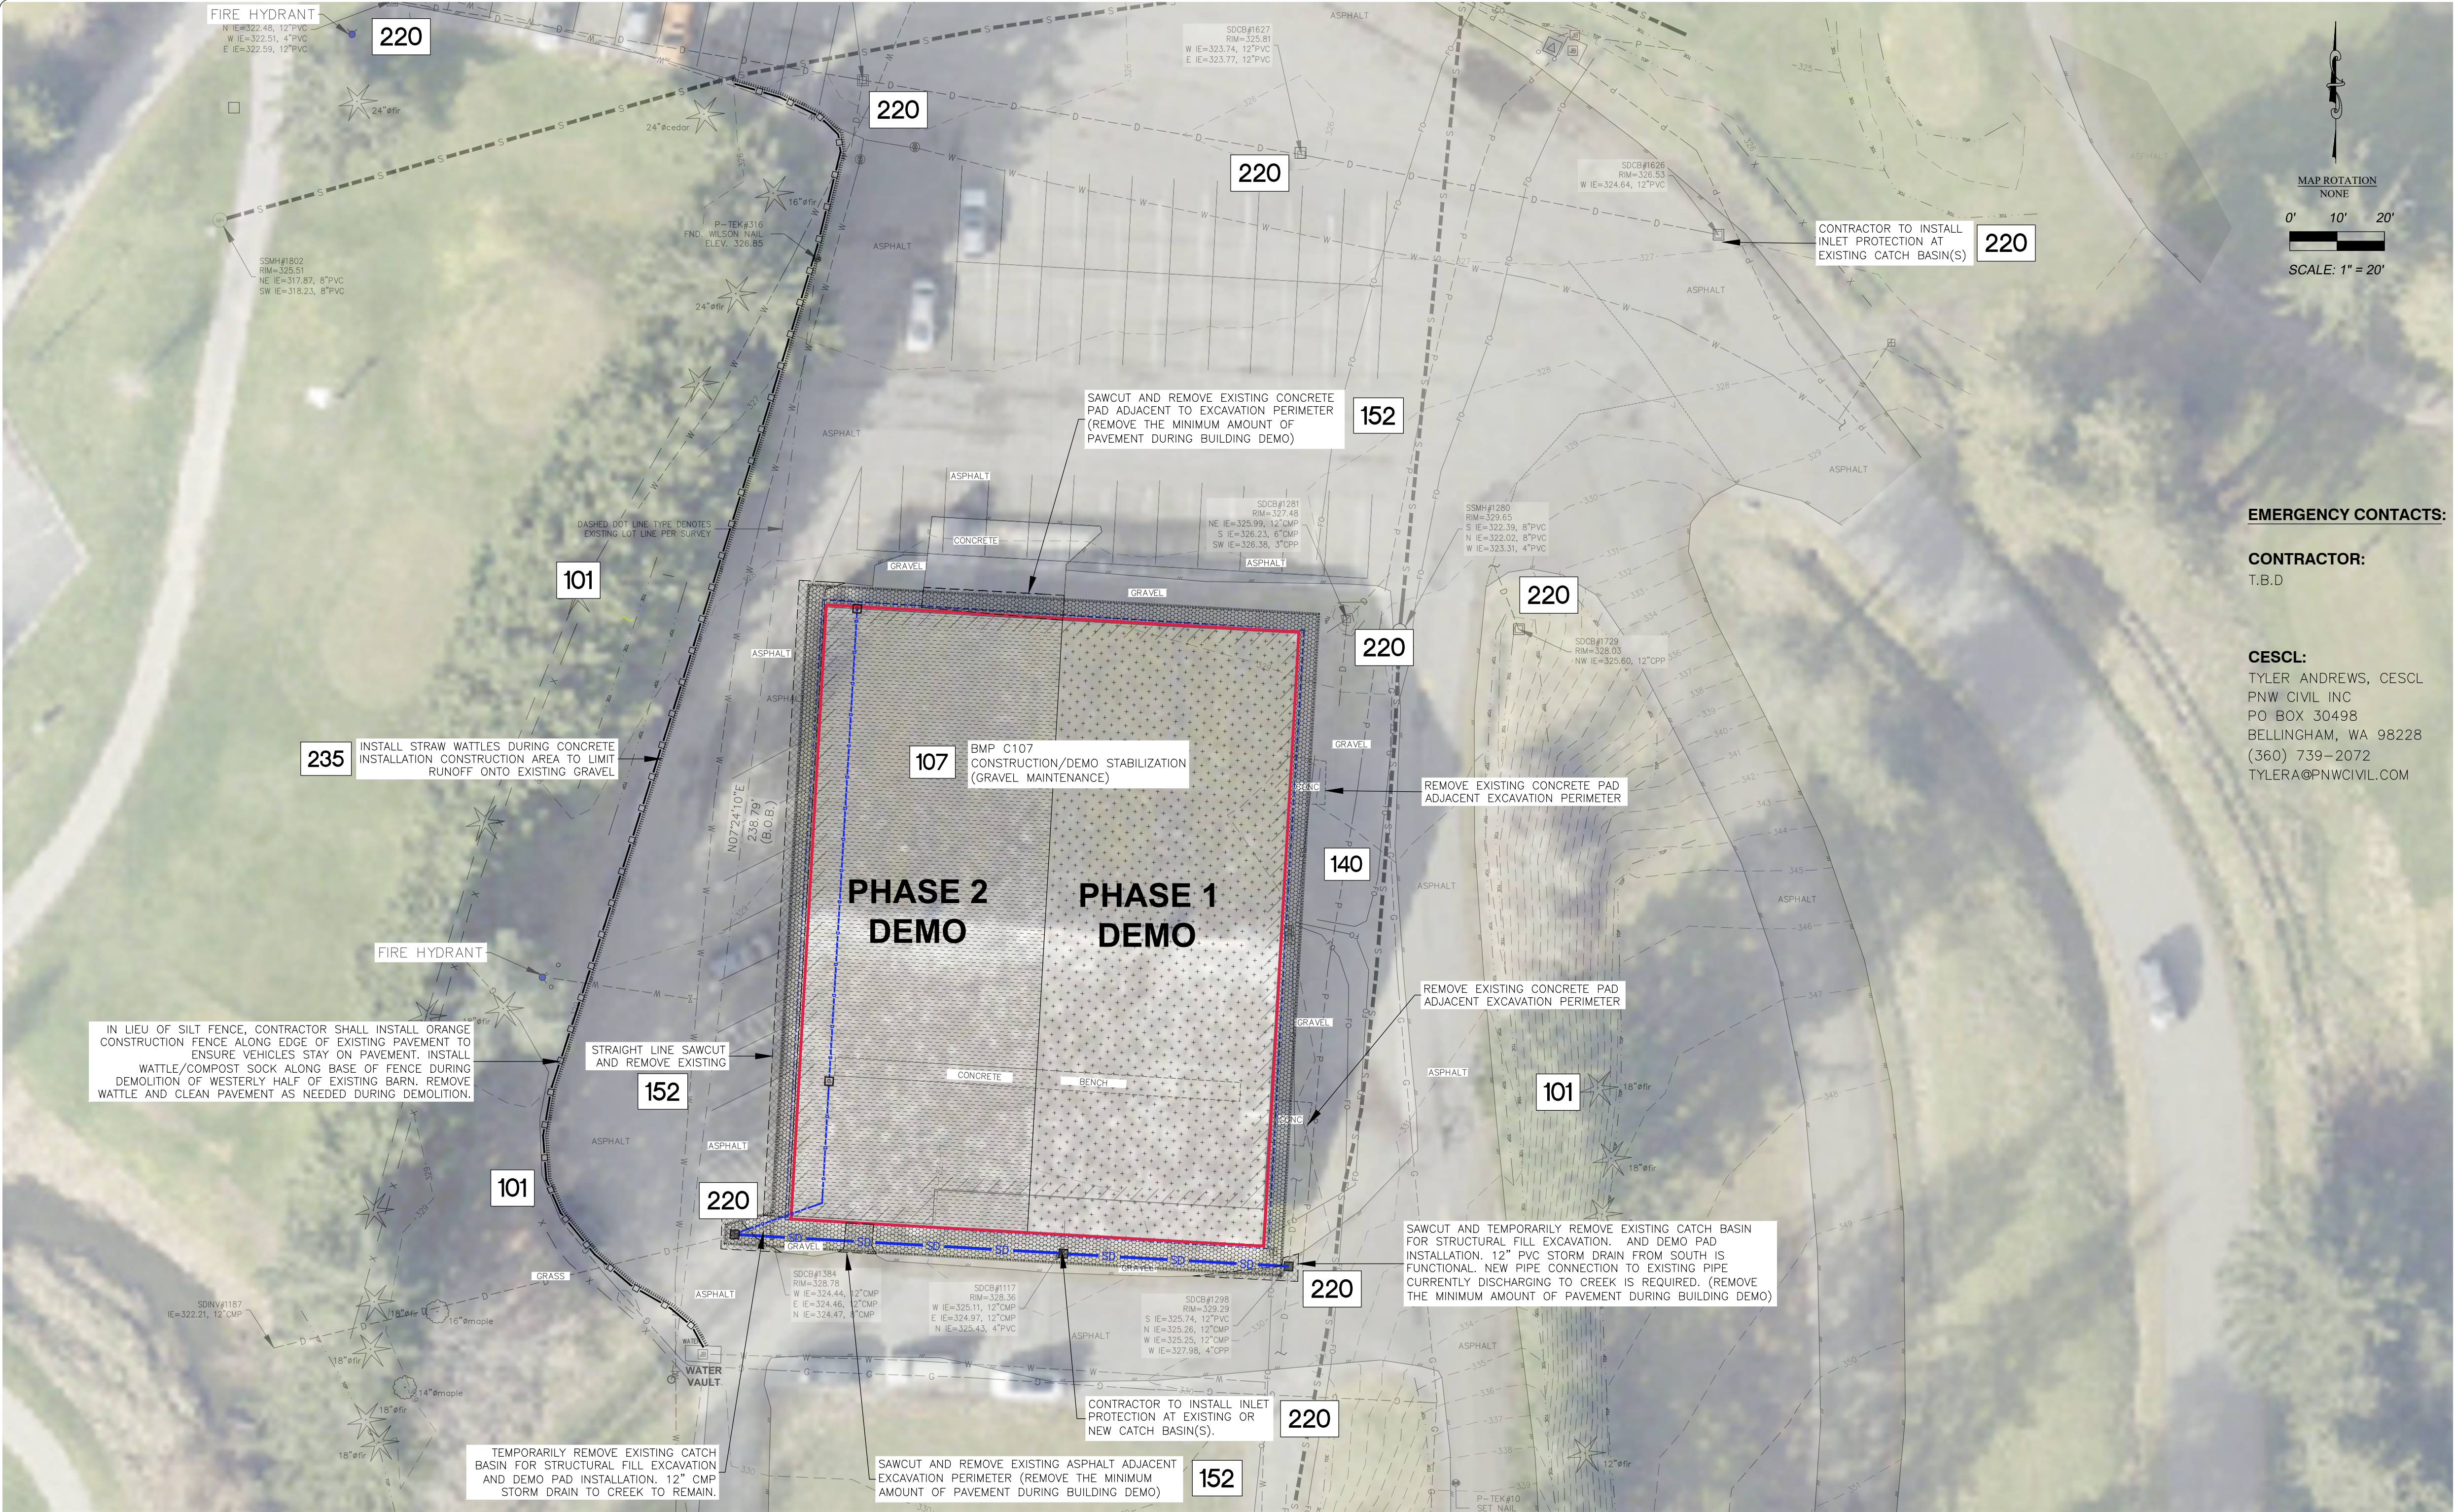
**SVCA BARN 6 - DEMOLITION PERMIT**  
**DEMOLITION PERMIT - XXXX**  
**TEMPORARY EROSION & SEDIMENTATION CONTROL (TESC) PLAN**  
**10 BARN VIEW COURT, SUDDEN VALLEY, WASHINGTON**

5. PRESERVE SURROUNDING NATIVE VEGETATION.
  6. DEPENDING ON WEATHER CONDITIONS, EROSION ISSUES MAY ARISE. INSPECT AND MAINTAIN INSTALLED ESC ITEMS AND BE PREPARED FOR THE POSSIBLE NEED FOR ADDITIONAL ESC MEASURES. CONTACT THE ENGINEER FOR ESC RECOMMENDATIONS.

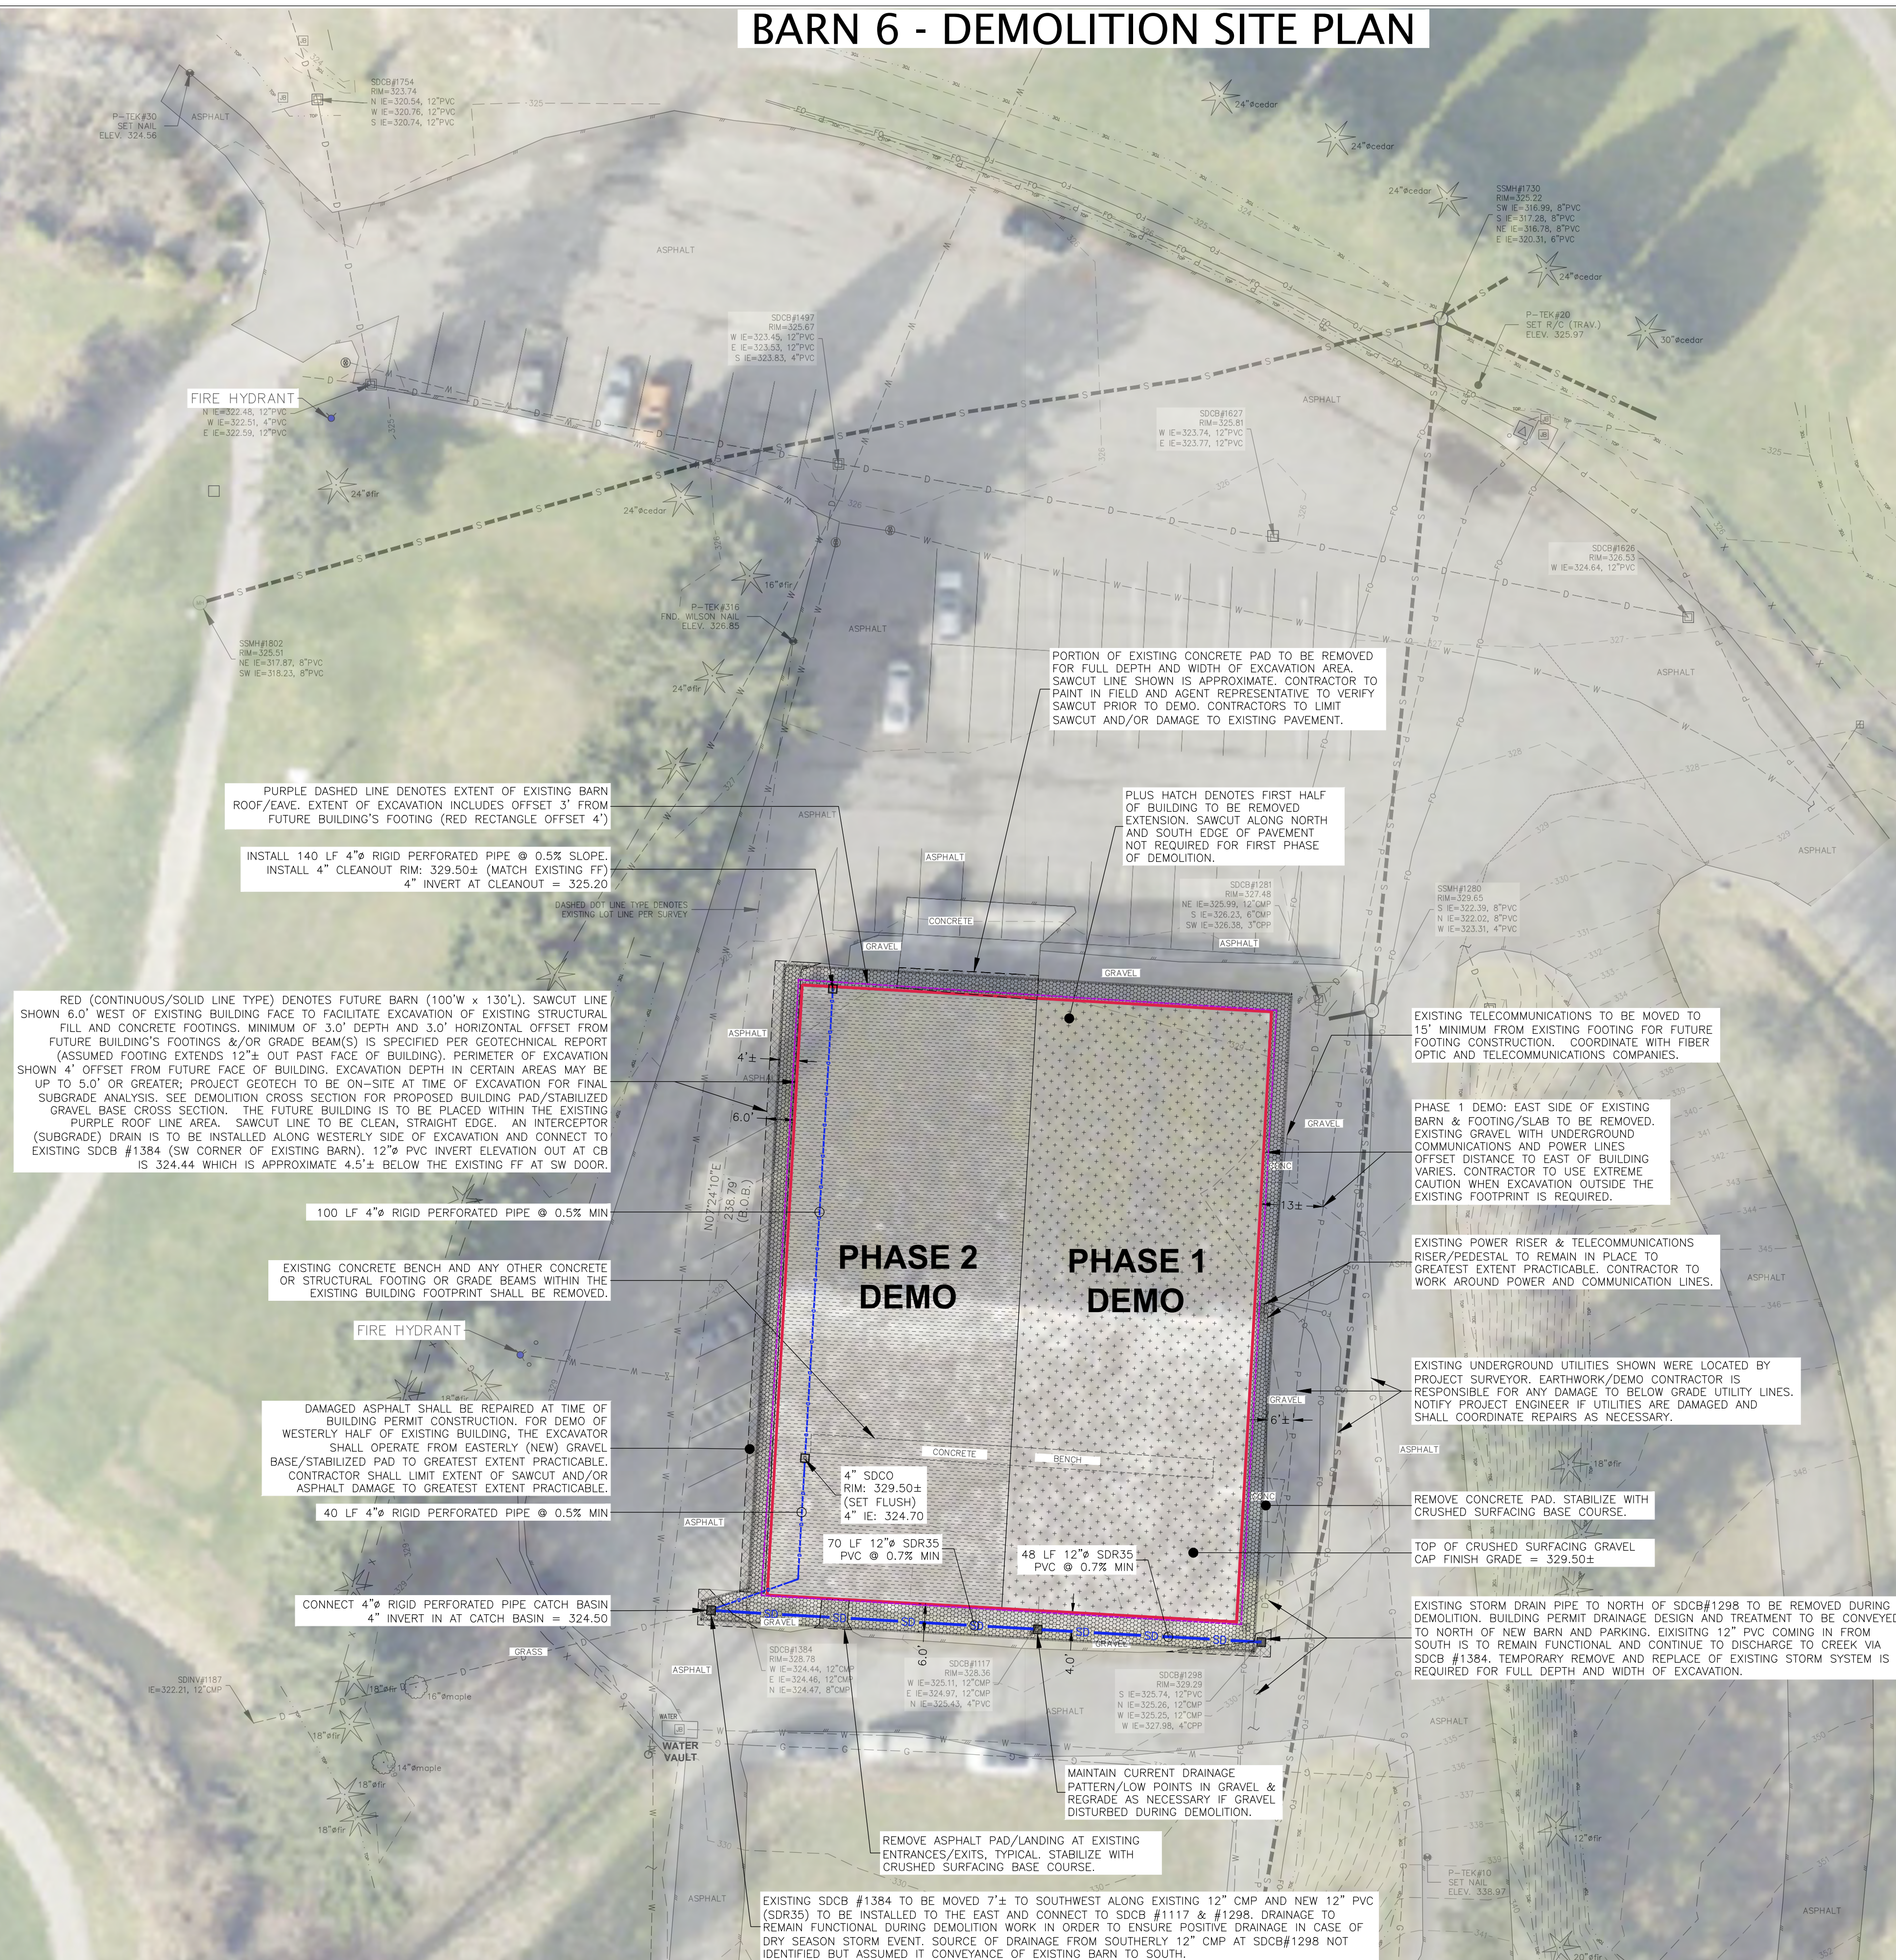
DEMO NOTES:

- THE BUILDING WAS ABATED IN 2018 FOR LEAD AND ASBESTOS.
- THE REFRIGERANT DRAINED IN 2017 FROM THE OLD ICE SKATING RINK.

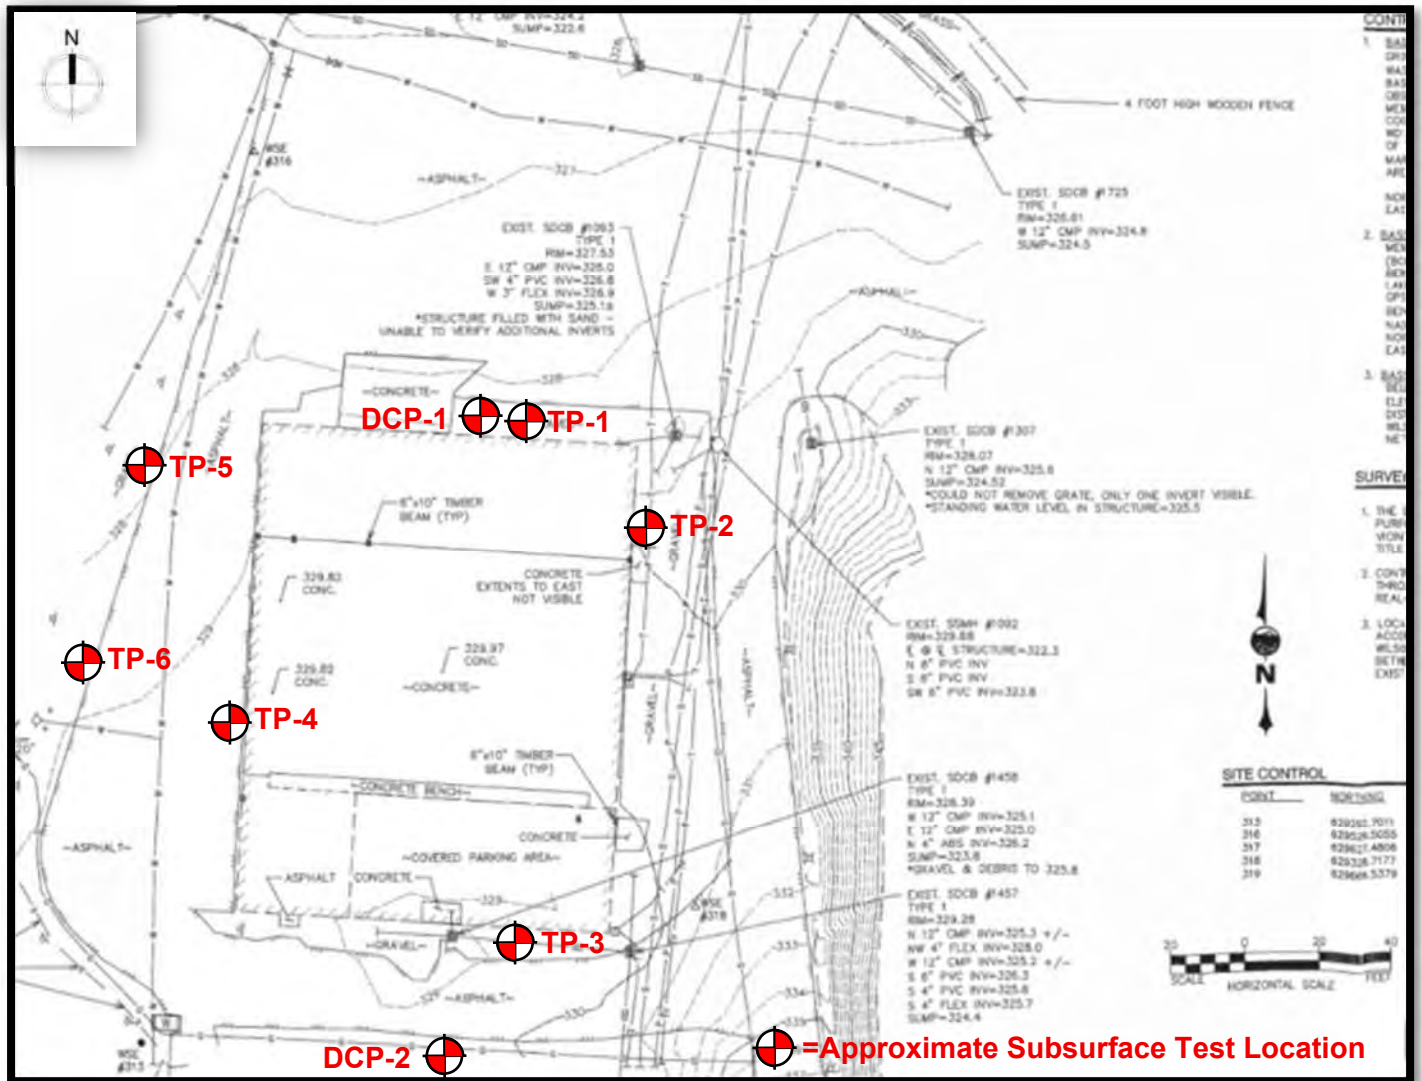
Figure 3A: *Site and Exploration Plan* showing the existing barn, underground utilities and approximate subsurface exploration locations on March 27 and April 10, 2026. Image courtesy of PNW Civil, Inc., 2026.

The *Regional Map* and *Vicinity Map* can be found in Figures 1 and 2 at the end of this report. A *Site and Exploration Plan* showing subsurface exploration locations is found as Figures 3A and 3B. A *Geologic Hazard Map* is provided as Figure 4. A USCS chart is provided as Figure 5.

Please reference Figures 3A and 3B – *Site and Exploration Plan* for approximate locations of our subsurface testing. Detailed logs of the subsurface exploration can be found at the end of this report.

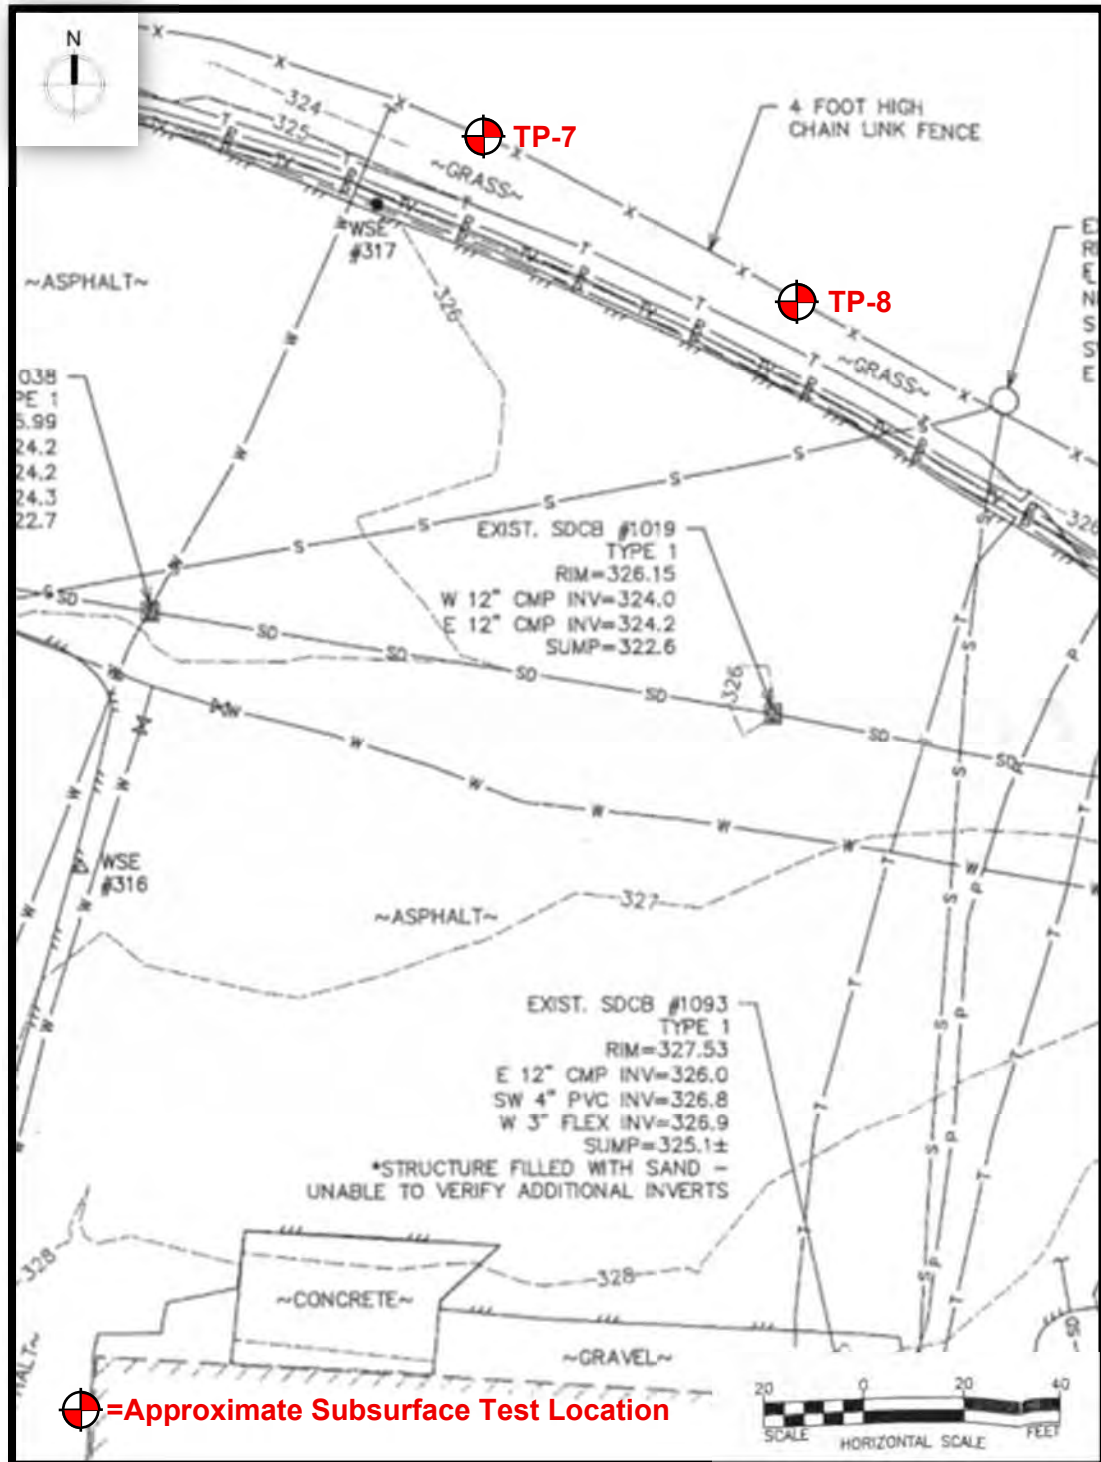
Figure 3B: *Site and Exploration Plan* showing the existing barn margin, northern asphalt parking area and approximate subsurface exploration locations on April 16, 2026. Image courtesy of PNW Civil, Inc., 2026. Scale is approximate.

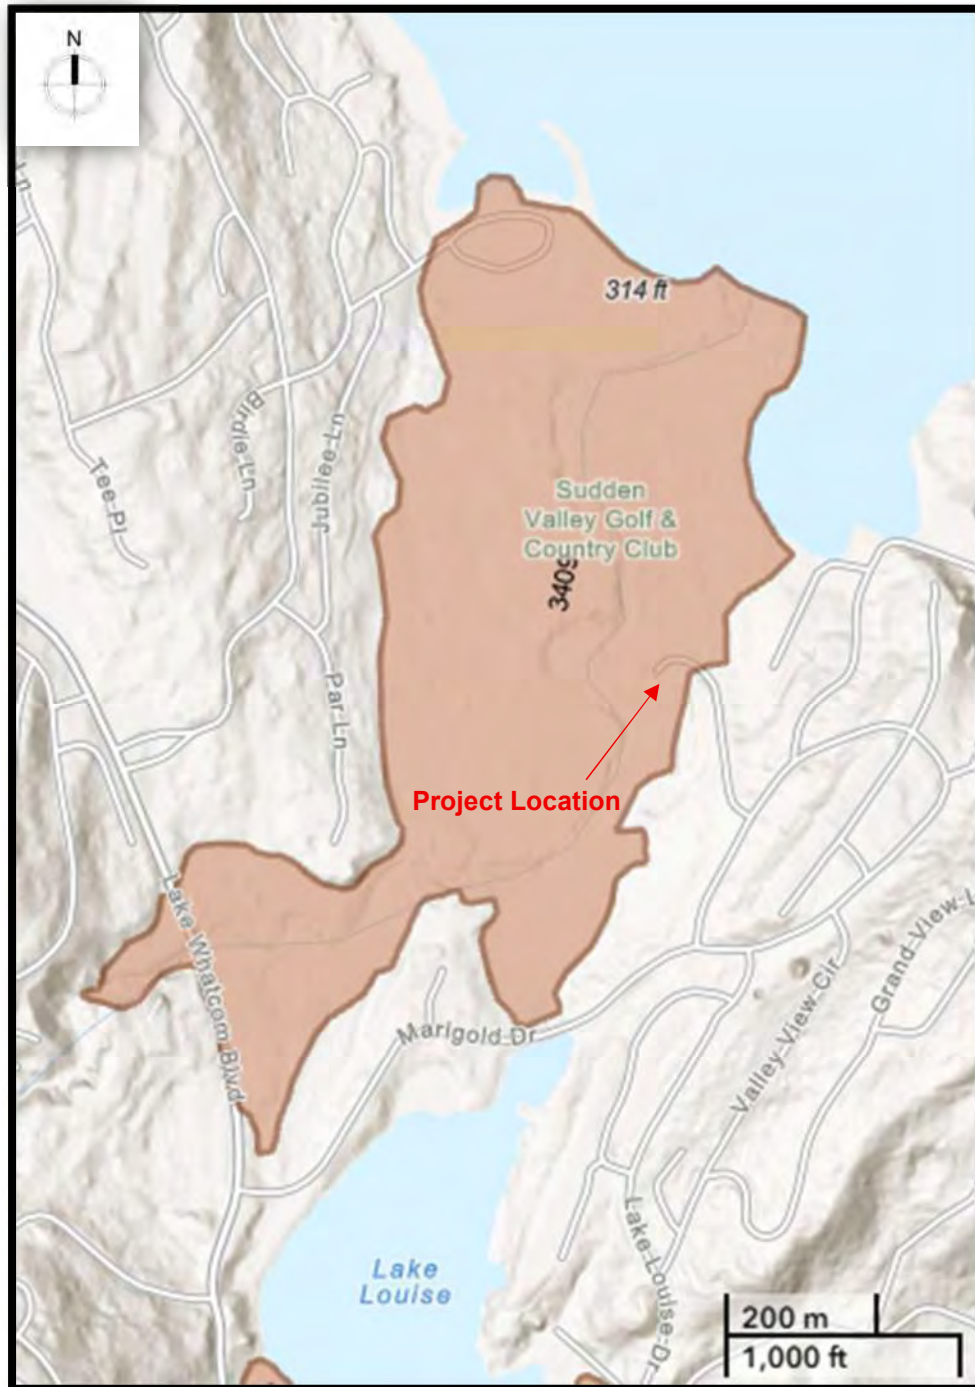
Figure 4: *Geologic Hazard Map* showing the Austin Creek alluvial fan hazard in brown in relation to the project site. Image courtesy DNR Geologic Information Portal, 2026.

Figure 4: *Geologic Hazard Map* showing the Austin Creek alluvial fan hazard in brown in relation to the project site. Image courtesy DNR Geologic Information Portal, 2026.

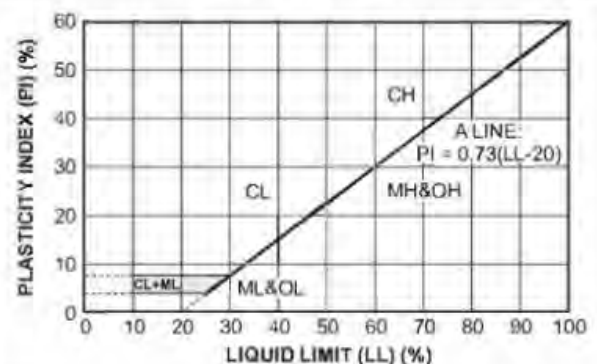
Figure 5: Unified Soil Classification System (USCS) Chart.

Figure 5: Unified Soil Classification System (USCS) Chart.

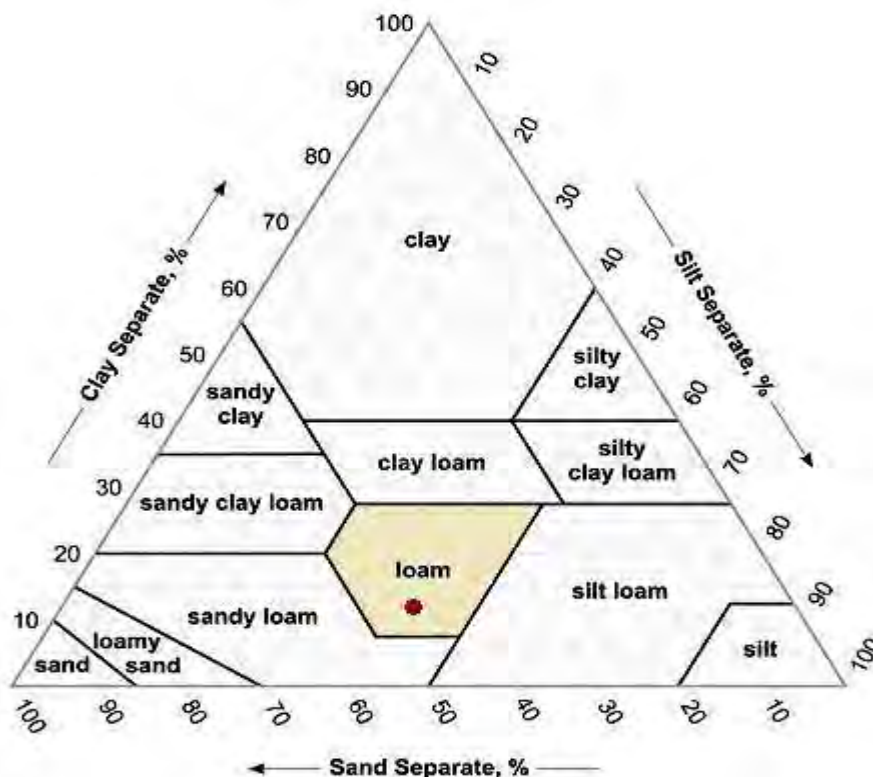
Soil Texture Classification: Loam

Sand: 46%      Silt: 42%      Clay: 12%

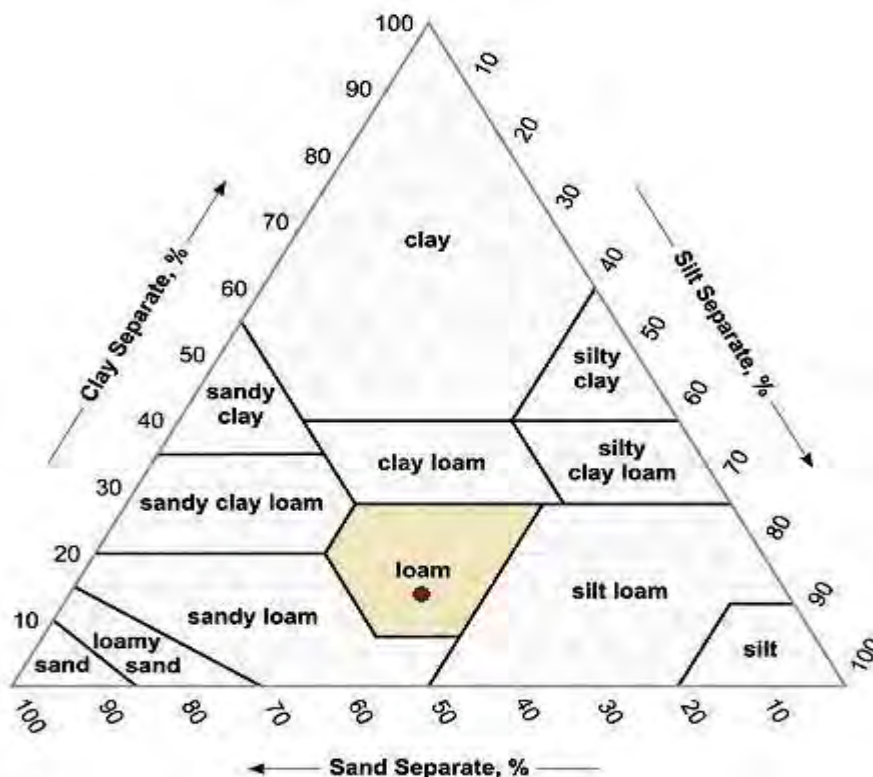
Soil Texture Classification: Loam

Sand: 44%      Silt: 42%      Clay: 14%

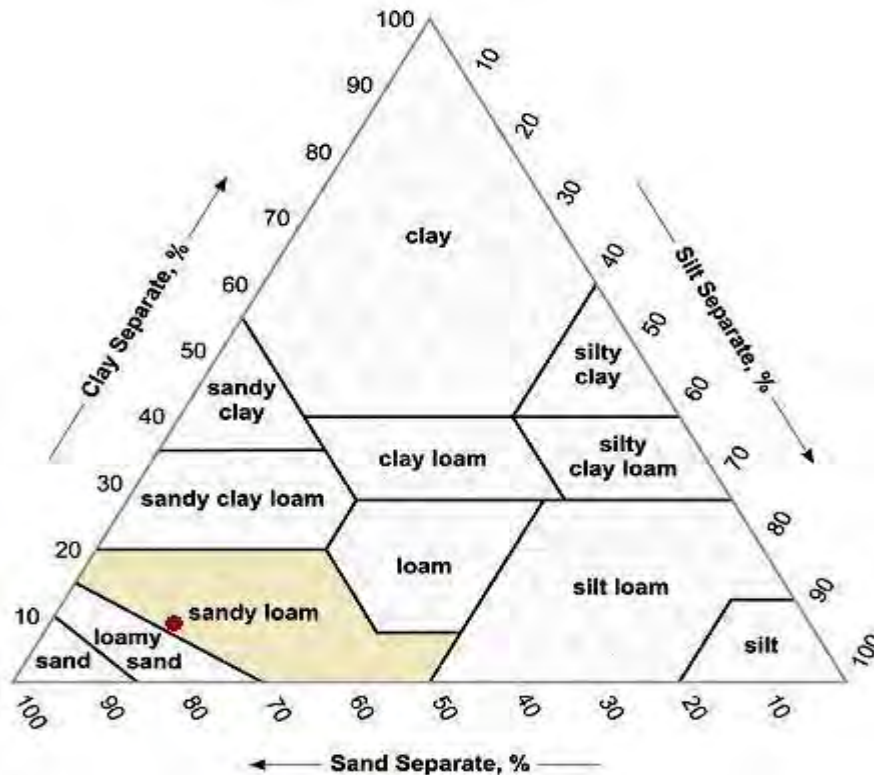
Soil Texture Classification: **Sandy Loam**

Sand: 76%      Silt: 15%      Clay: 9%

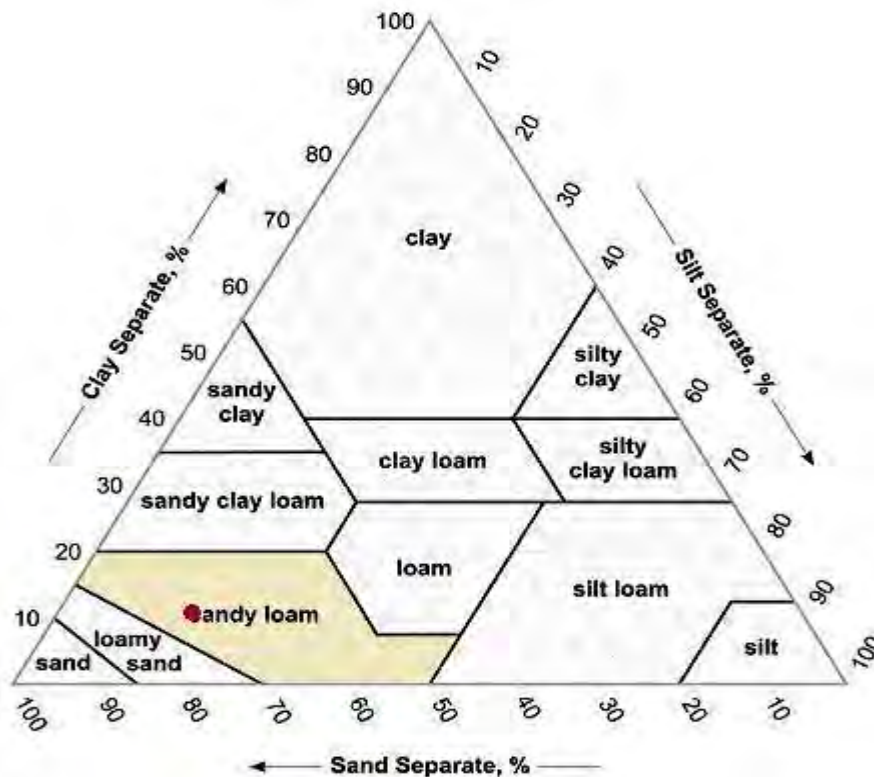
Soil Texture Classification: **Sandy Loam**

Sand: 73%      Silt: 16%      Clay: 11%

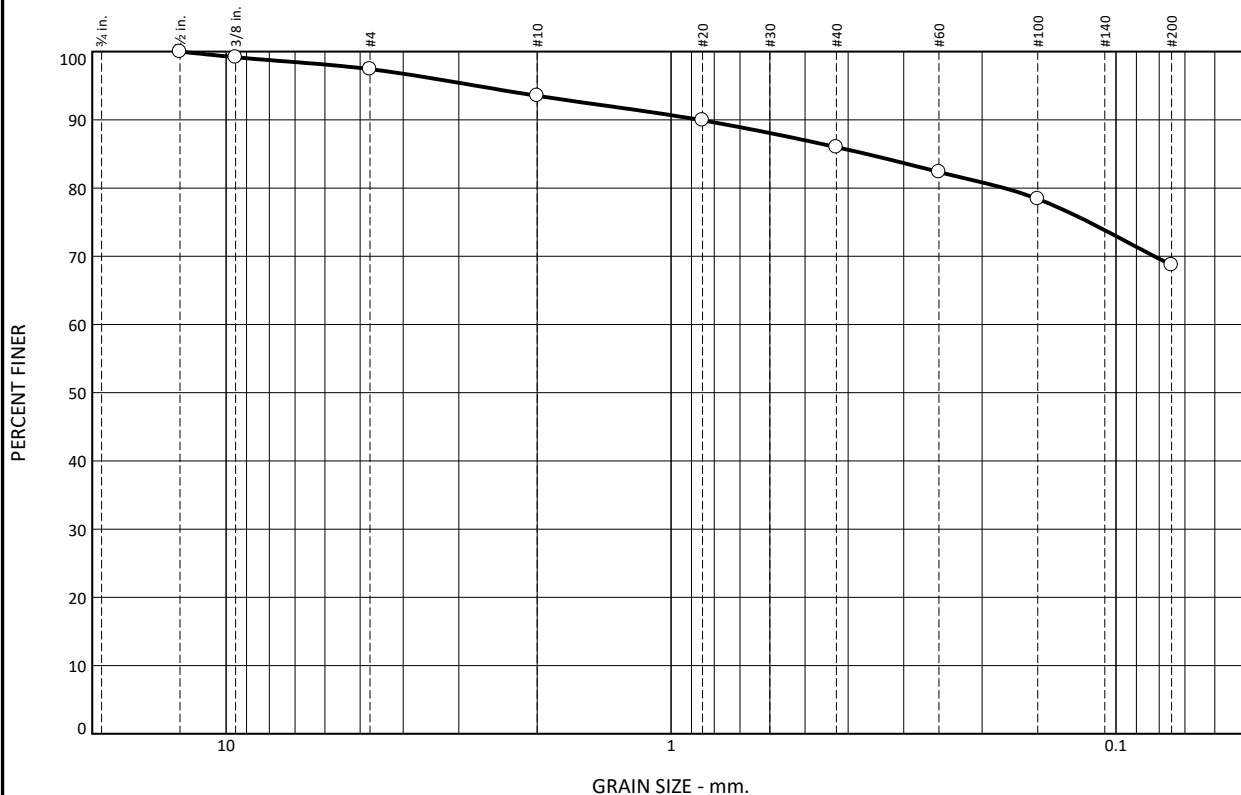
# Sieve Analysis Test Report

ASTM C117 & C136

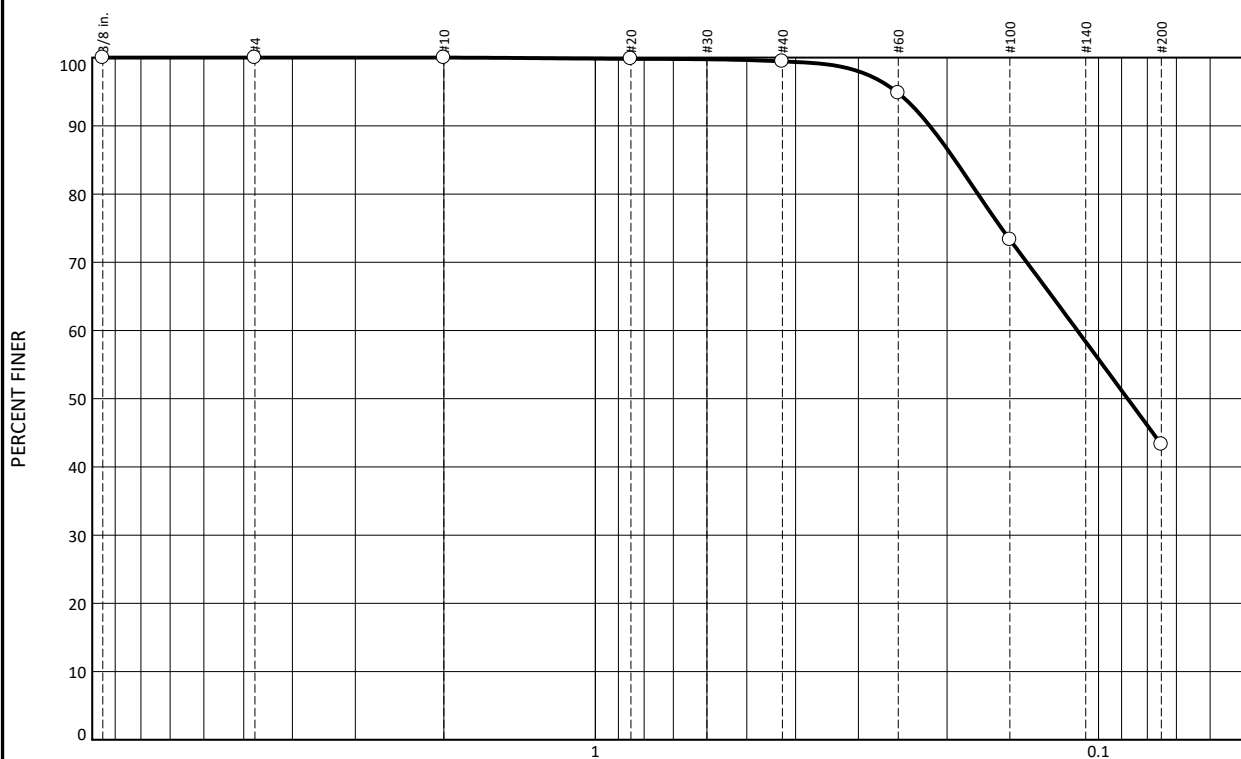
# Sieve Analysis Test Report

ASTM C117 & C136

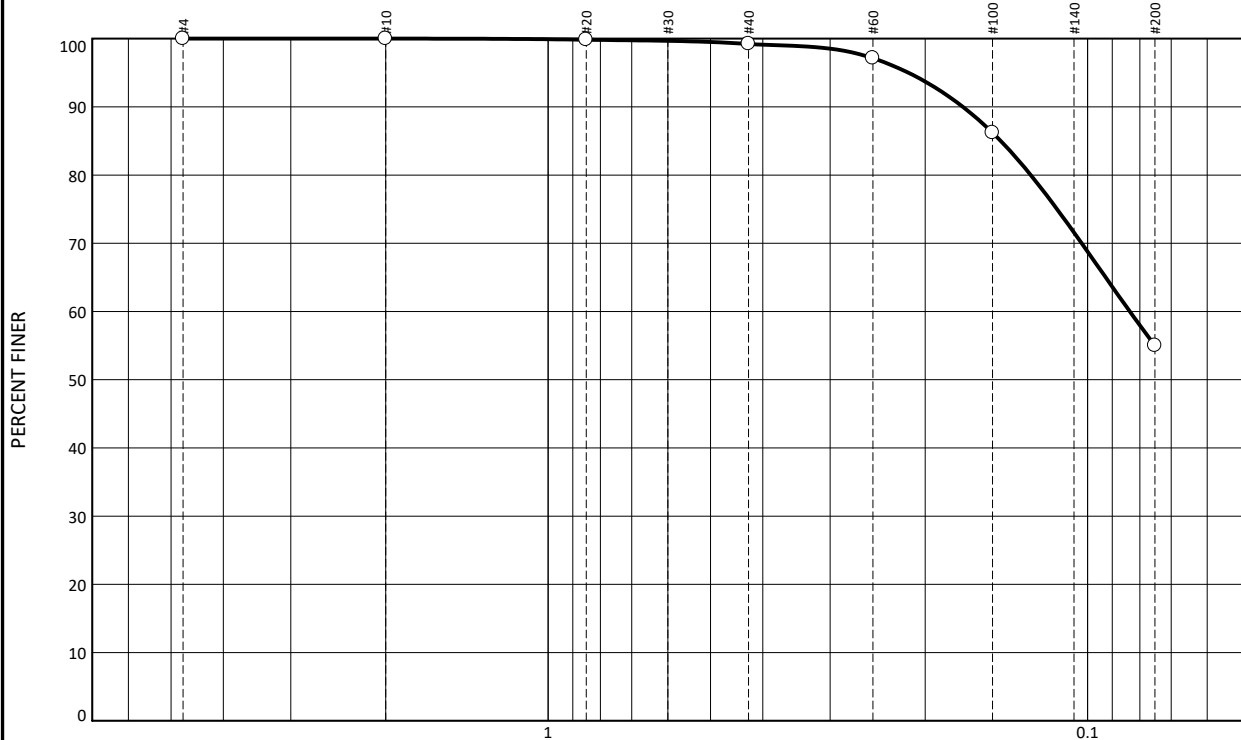
# Sieve Analysis Test Report

ASTM C117 & C136

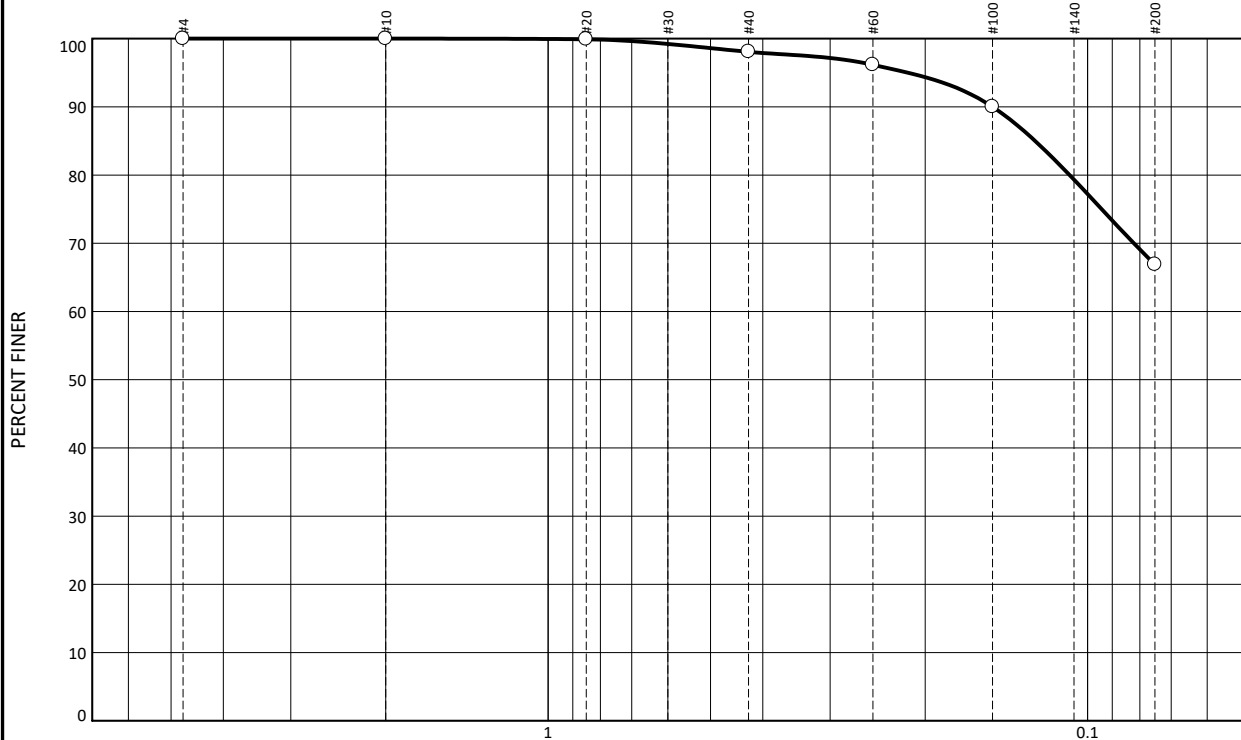
# Sieve Analysis Test Report

ASTM C117 & C136
