# **Sudden Valley Community Association**

## **Finance Committee Meeting**

## 10 Barn View Court Demolition Permit Shorelines Exemption Project Narrative

SUDDEN VALLEY COMMUNITY ASSOCIATION (SVCA)  
SITUATE IN A PORTION OF THE NE 1/4, SW 1/4 SECTION 5, TOWNSHIP 37 NORTH, RANGE 4 EAST OF W.M. SUDDEN VALLEY, WHATCOM COUNTY, WASHINGTON  
10 BARN VIEW COURT (BARN 6) DEMOLITION PERMIT (DEMO-XXXX)

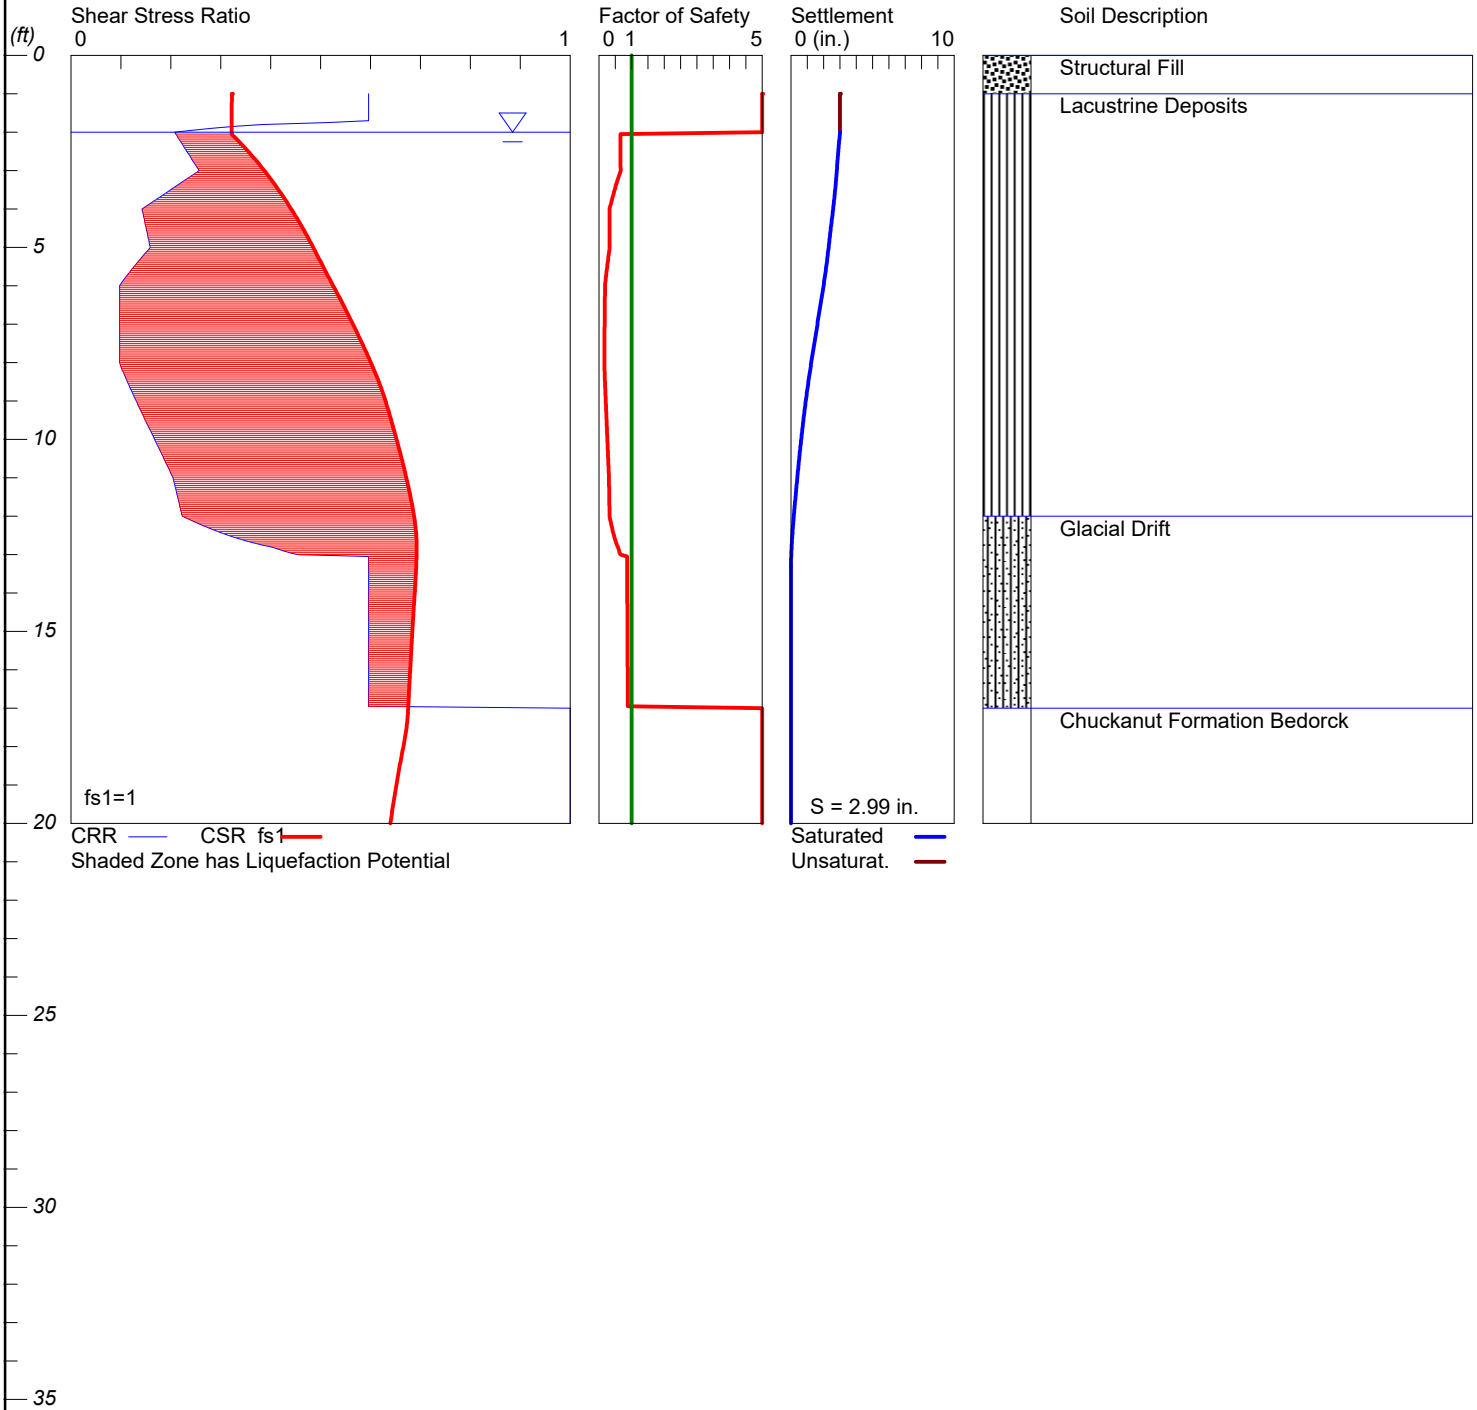
Hole No.=DCP-1 Water Depth=2 ft Surface Elev.=328

Magnitude=7  
Acceleration=0.497g

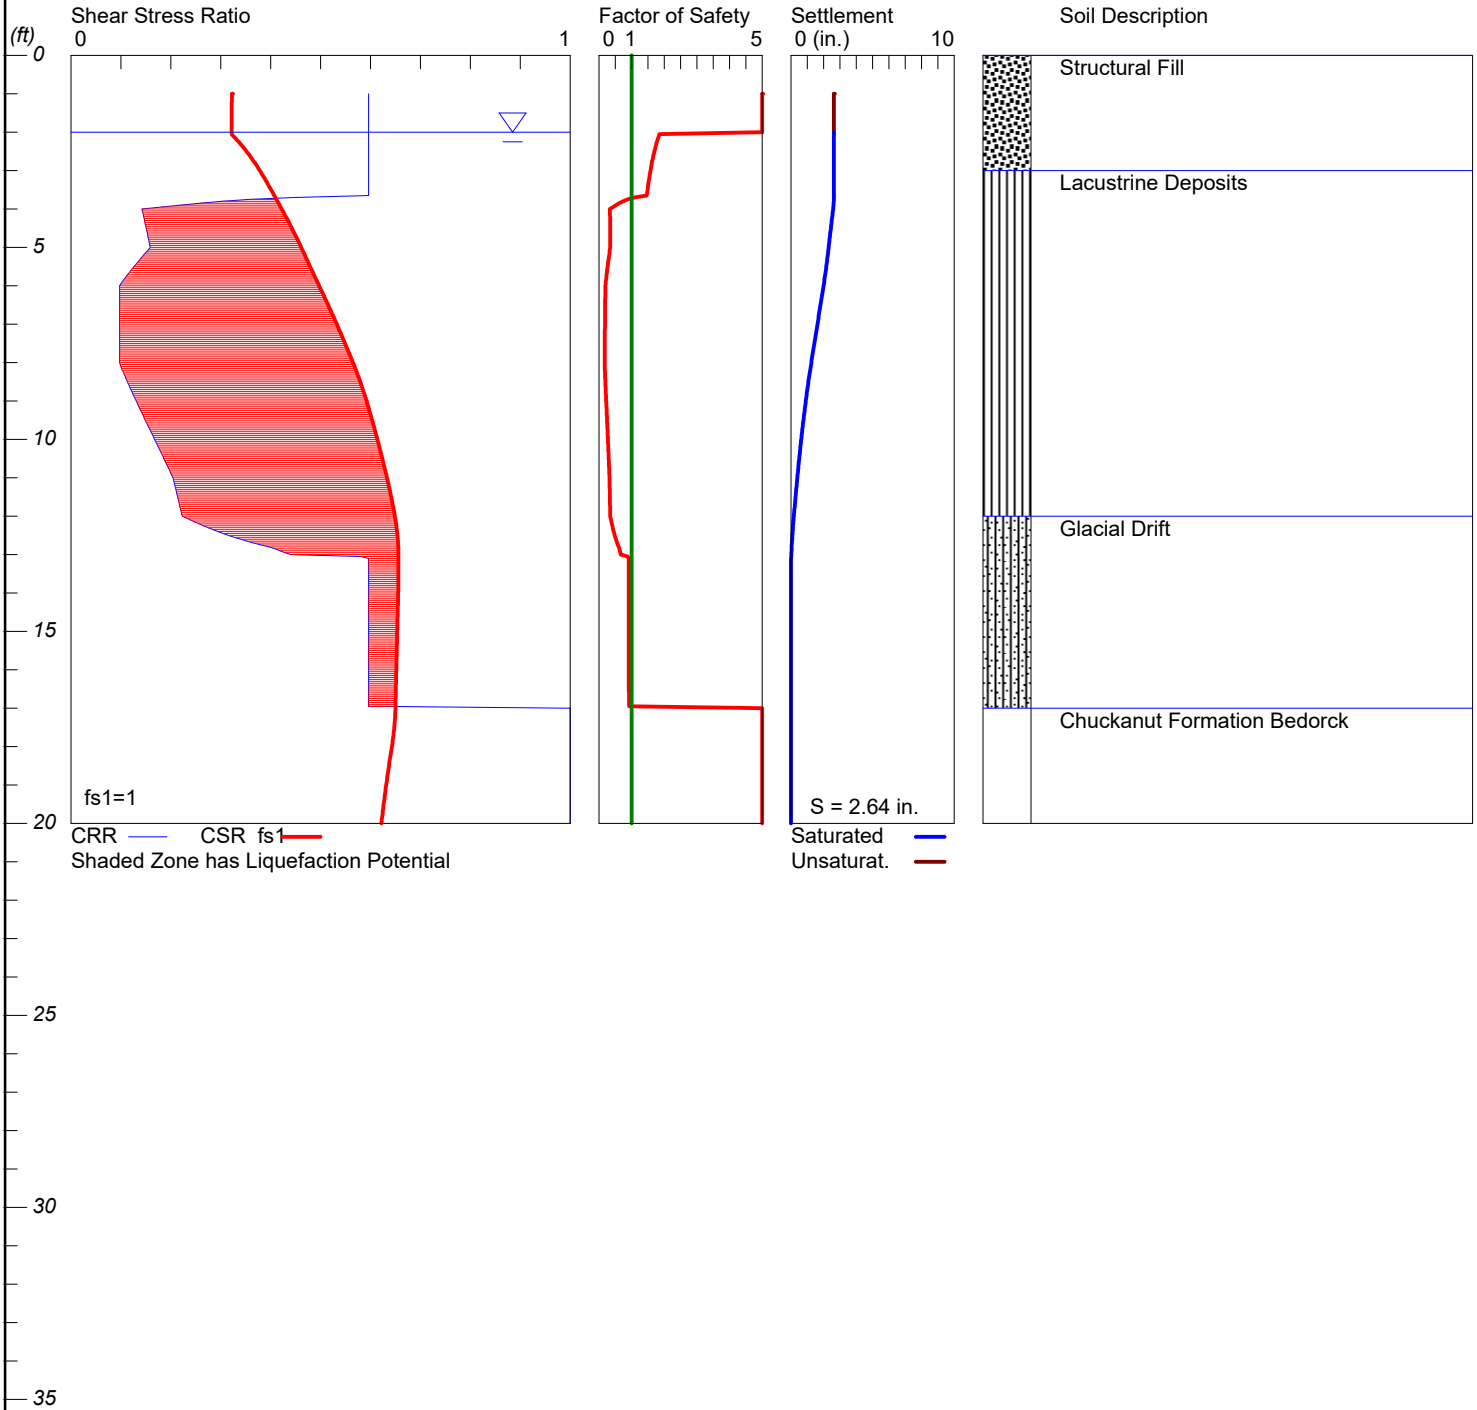
Hole No.=DCP-1 Water Depth=2 ft Surface Elev.=328

Magnitude=7  
Acceleration=0.497g

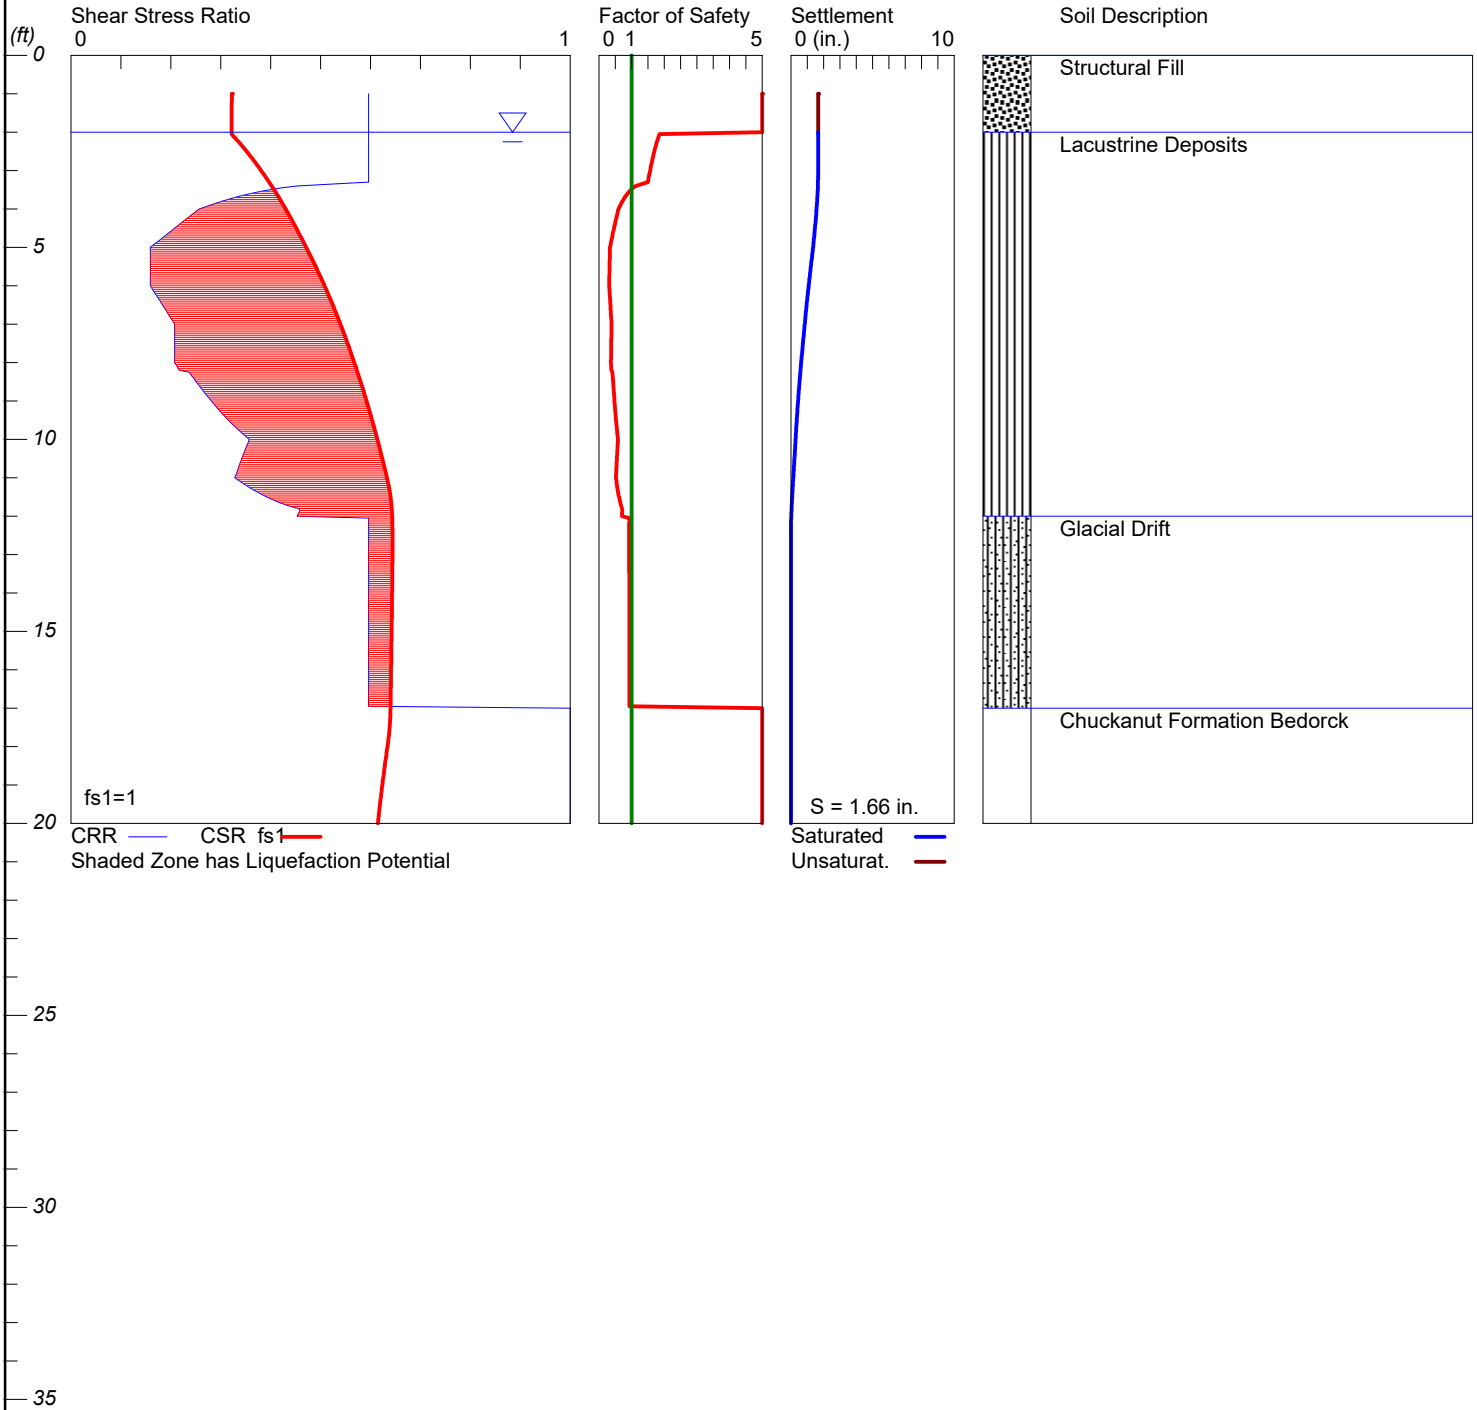
Hole No.=DCP-2 Water Depth=2 ft Surface Elev.=328

Magnitude=7  
Acceleration=0.497g

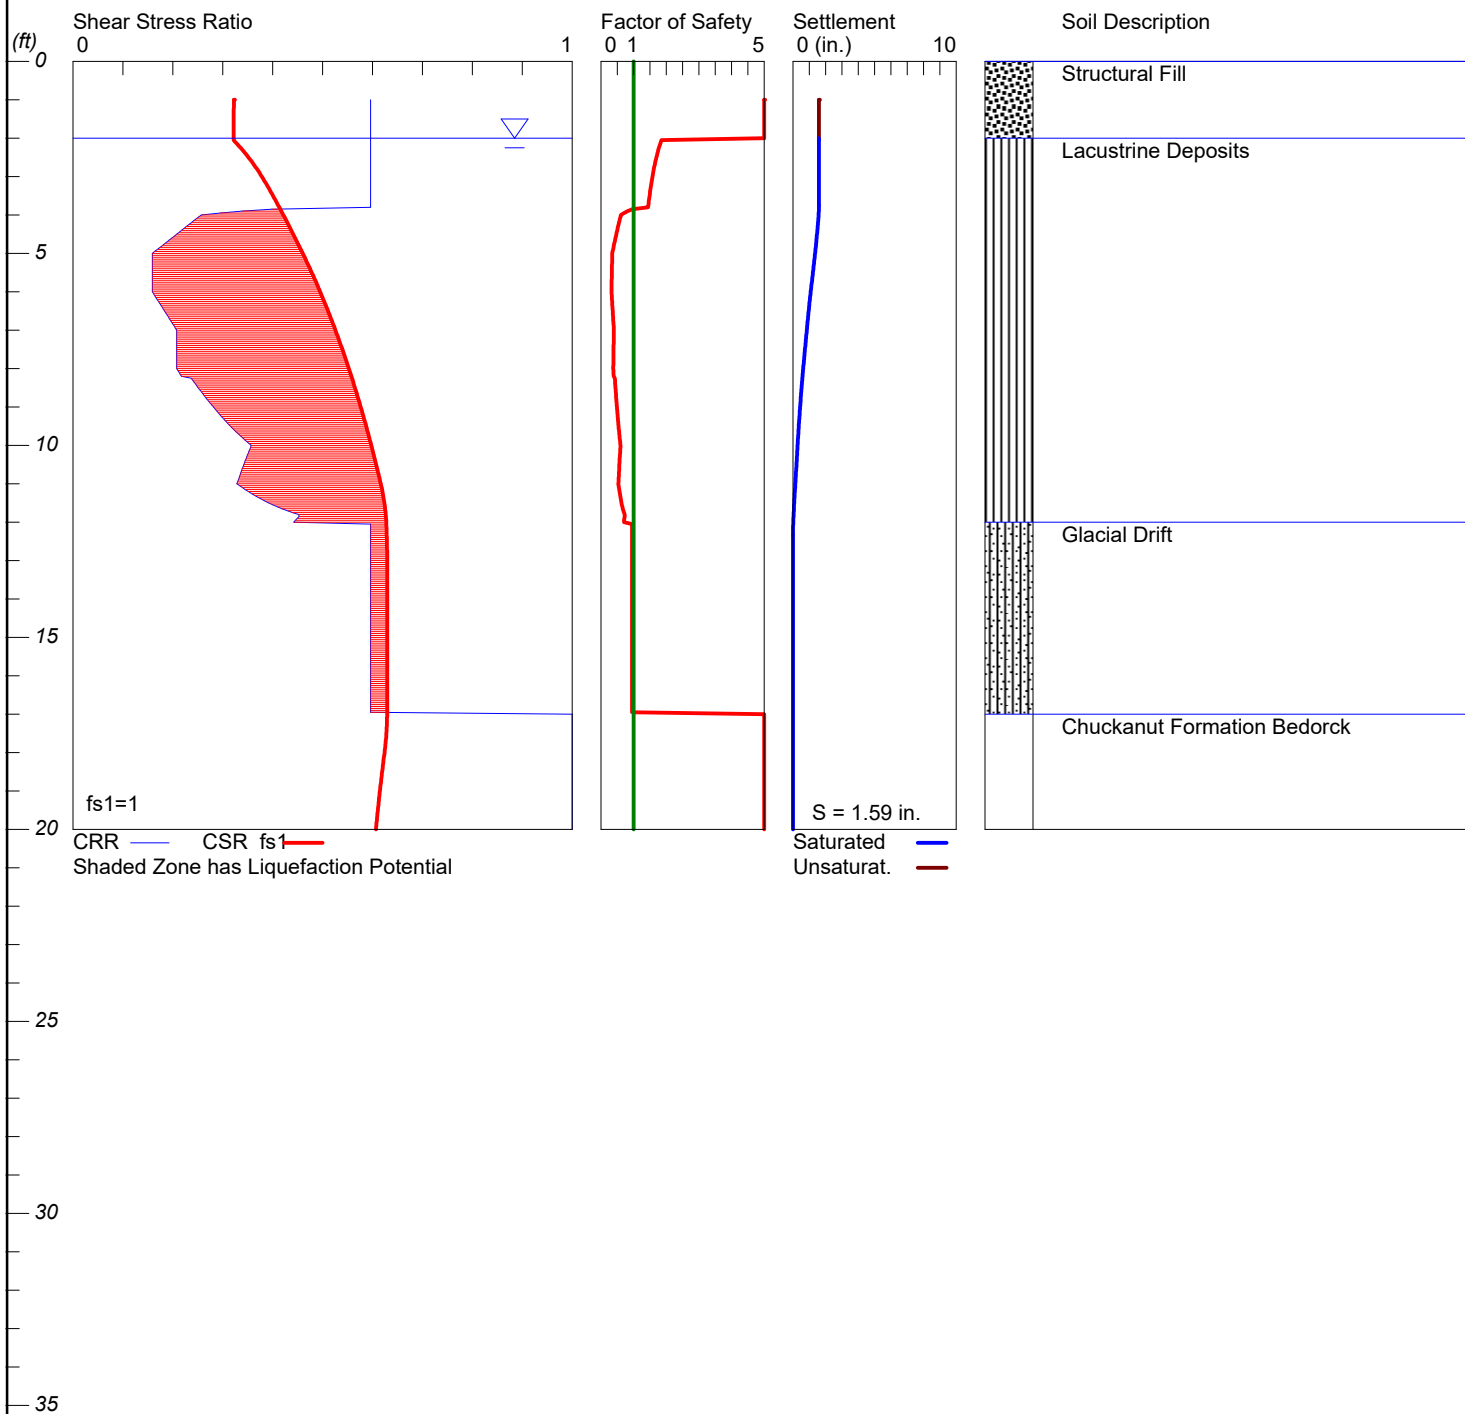
Hole No.=DCP-2 Water Depth=2 ft Surface Elev.=328

Magnitude=7  
Acceleration=0.497g

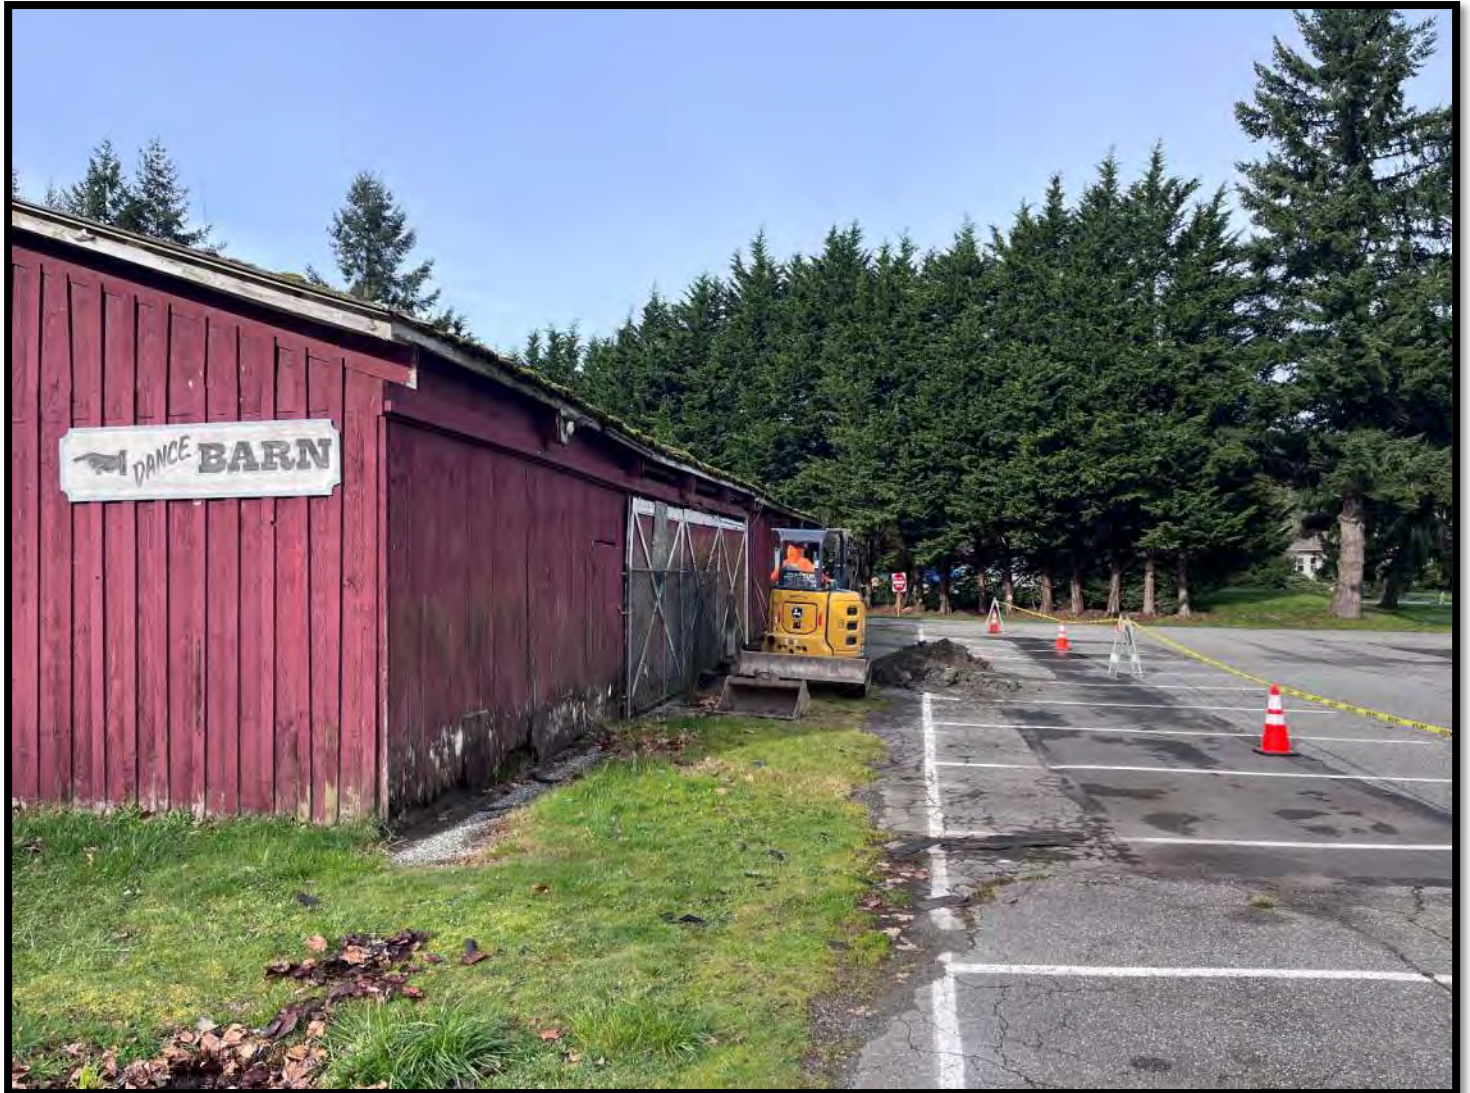
Photo 2: The N side of the barn with TP-1 in progress on March 27, 2026.

Photo 2: The N side of the barn with TP-1 in progress on March 27, 2026.

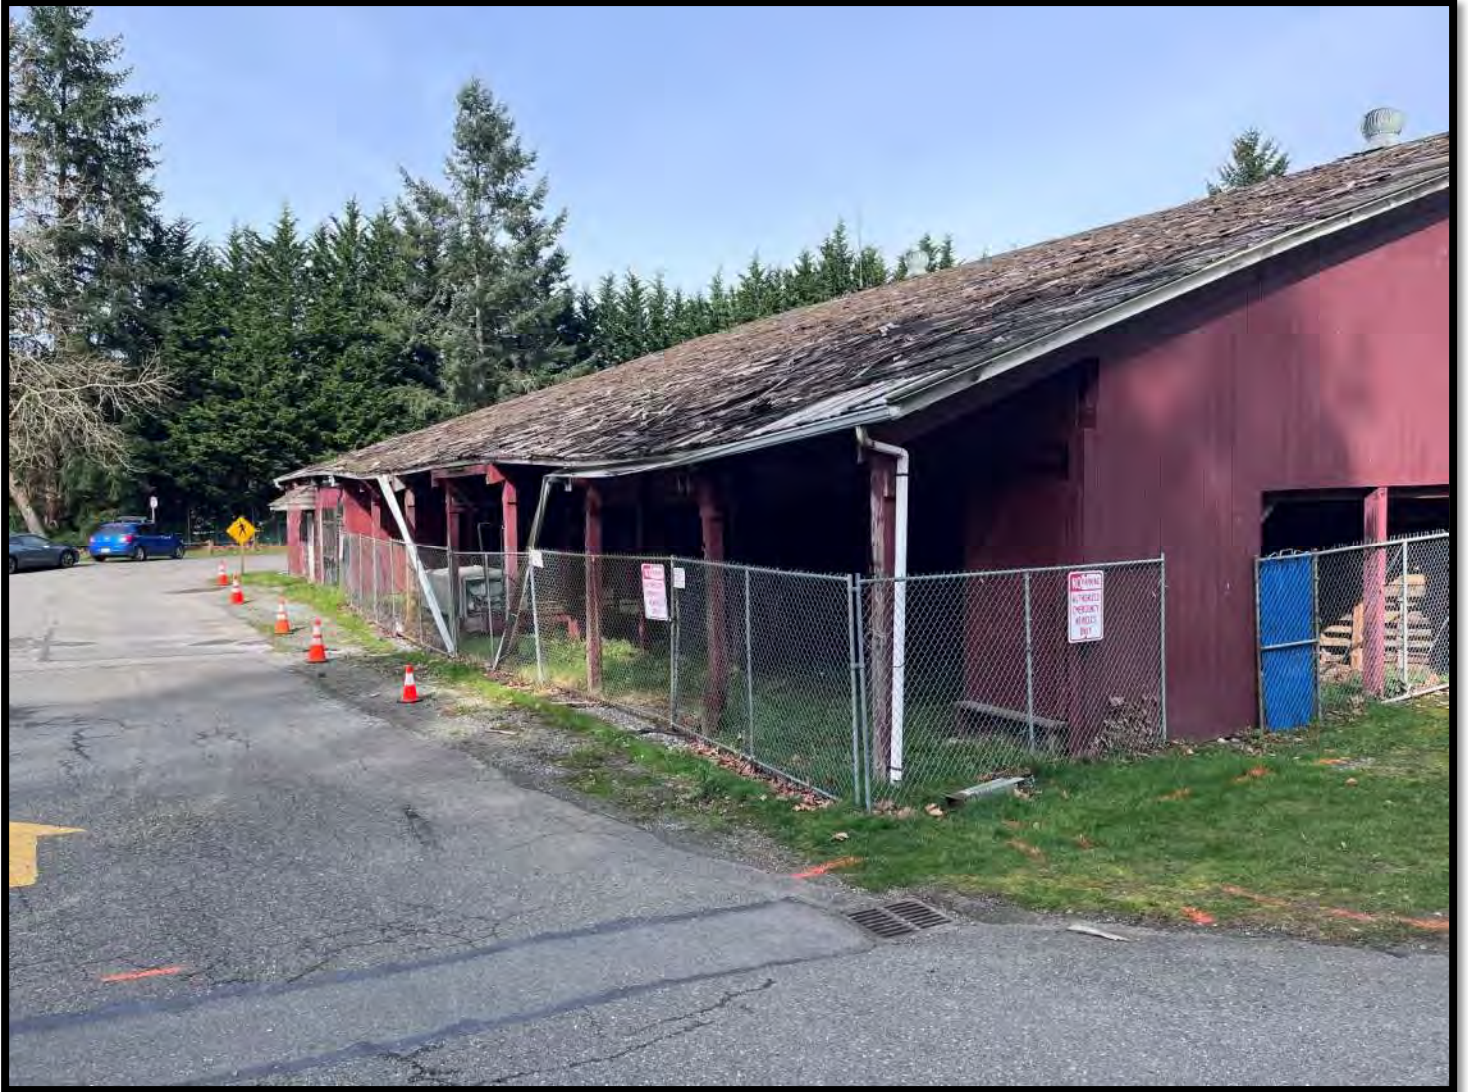
Photo 3: The S side of the barn, facing W on March 27, 2026.

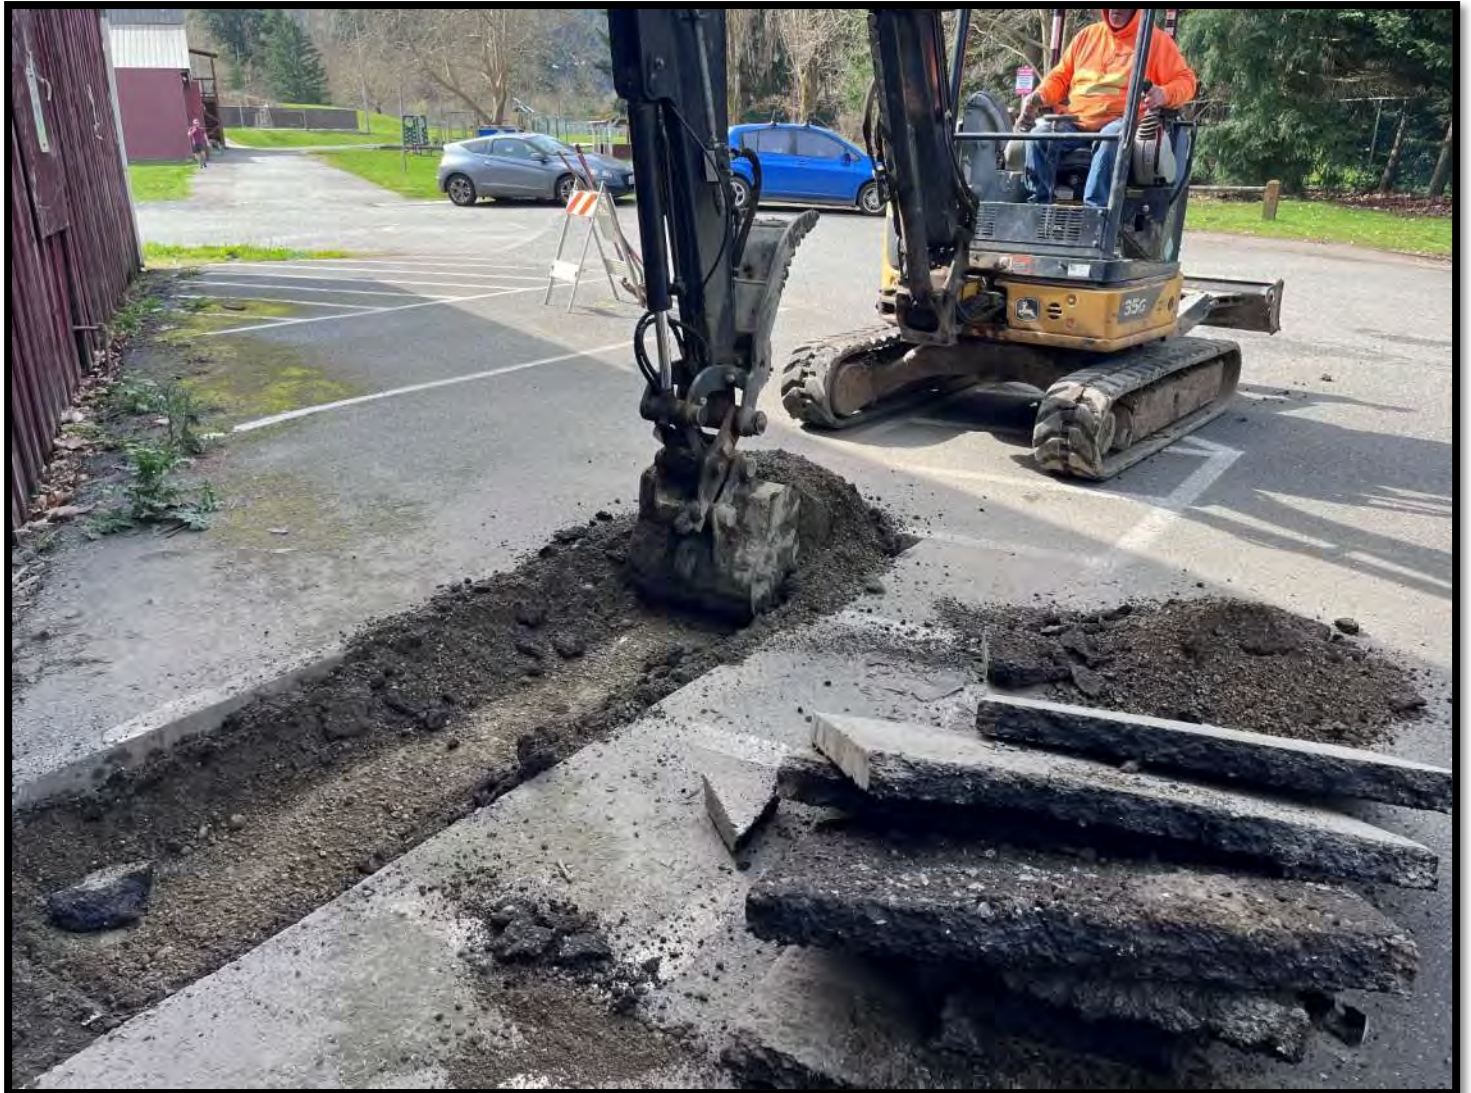
Photo 4: Test location TP-4 in progress on the W side of the barn. Facing S on March 27, 2026.

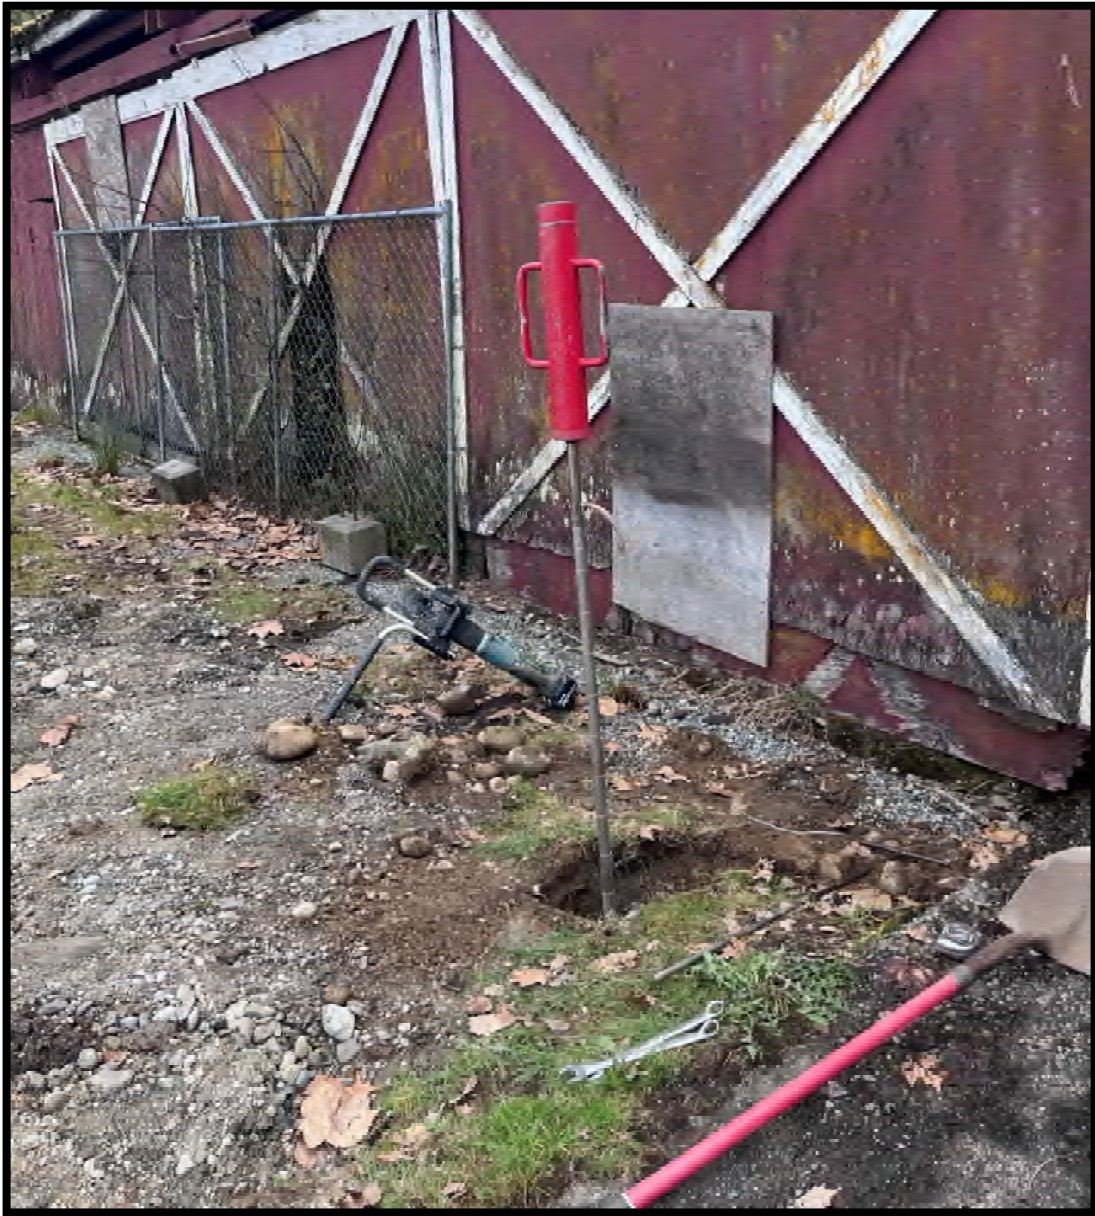
Photo 5: Test location DCP-1 in progress adjacent to TP-1. Facing SE on April 10, 2026.

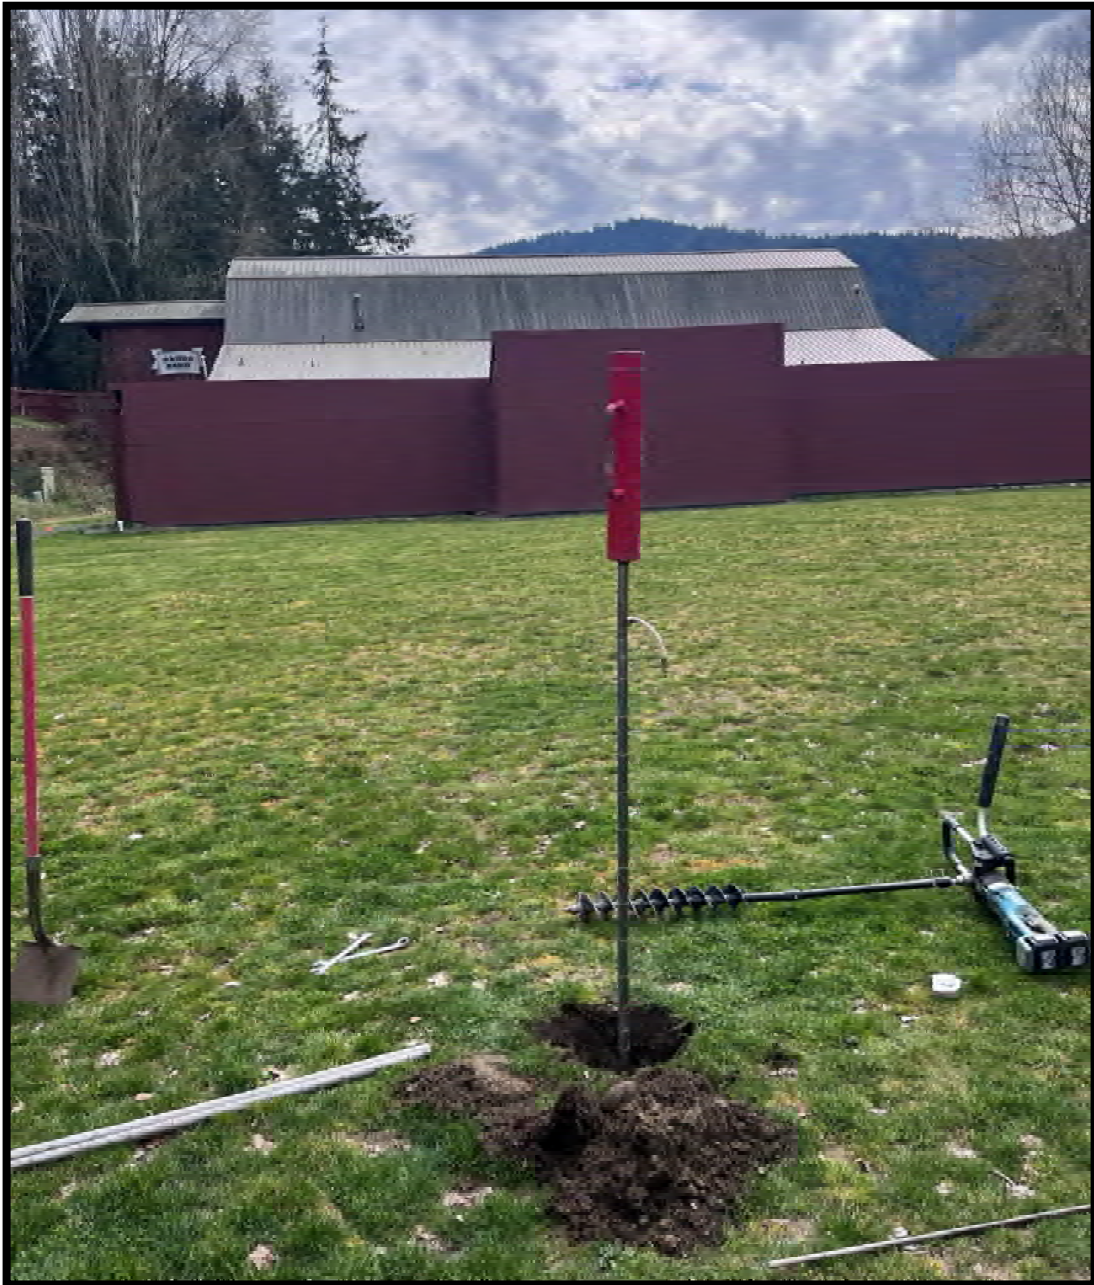
Photo 6: Test location DCP-2 in progress on the S side of the barn. Facing S on April 10, 2026.

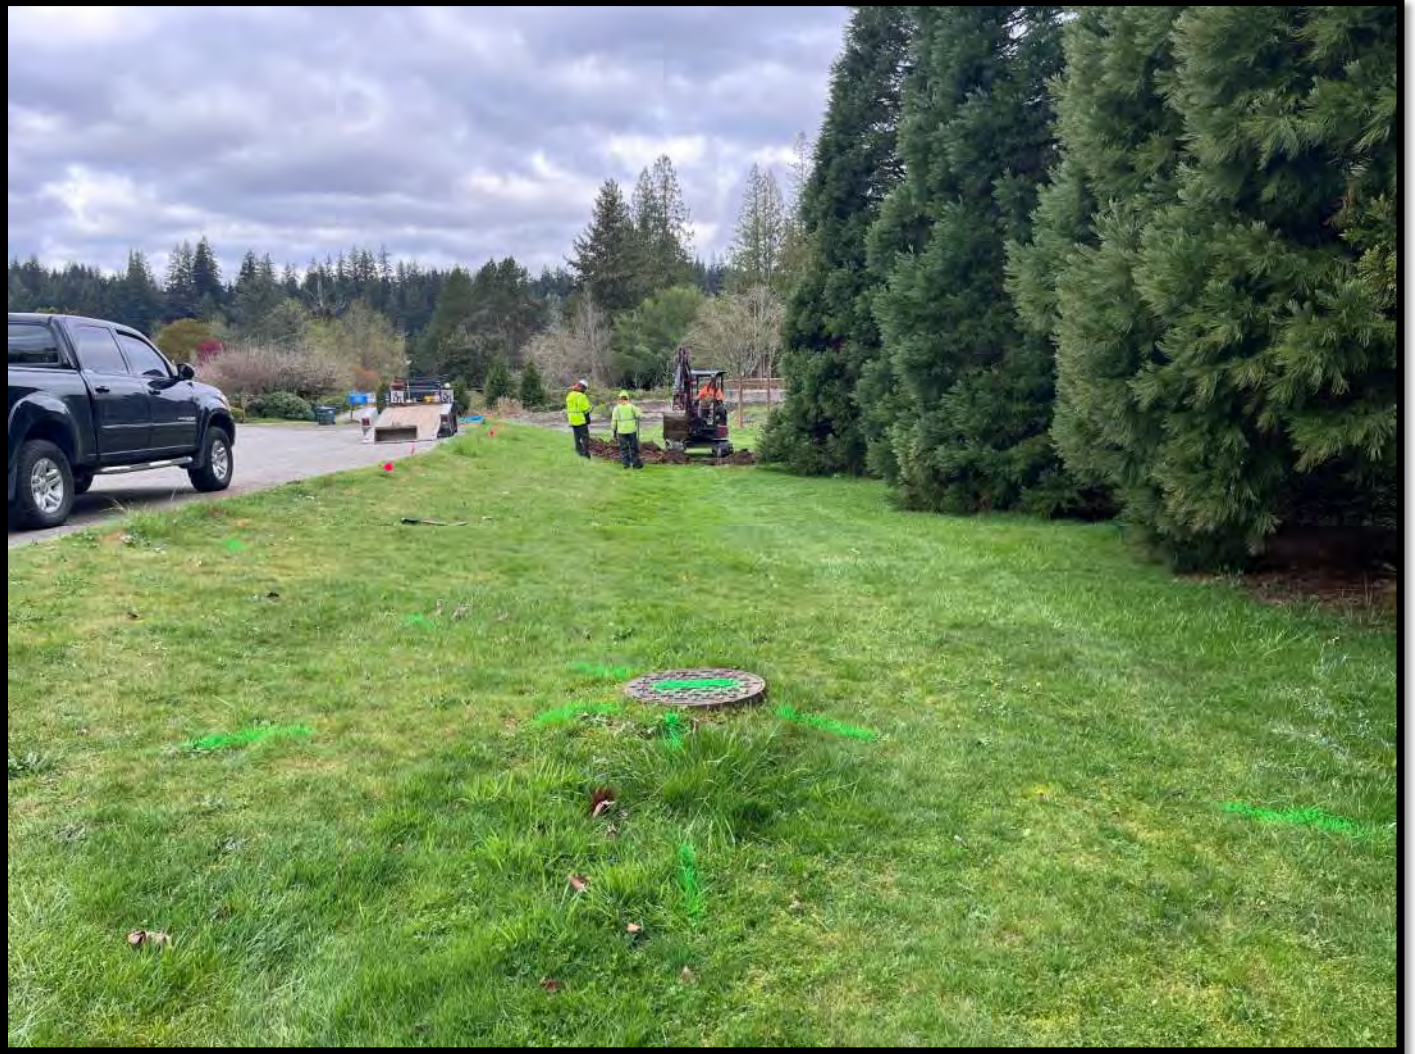
Photo 7: Test location TP-7 in progress N of the asphalt pavement and barn facility. Facing W on April 16, 2026.

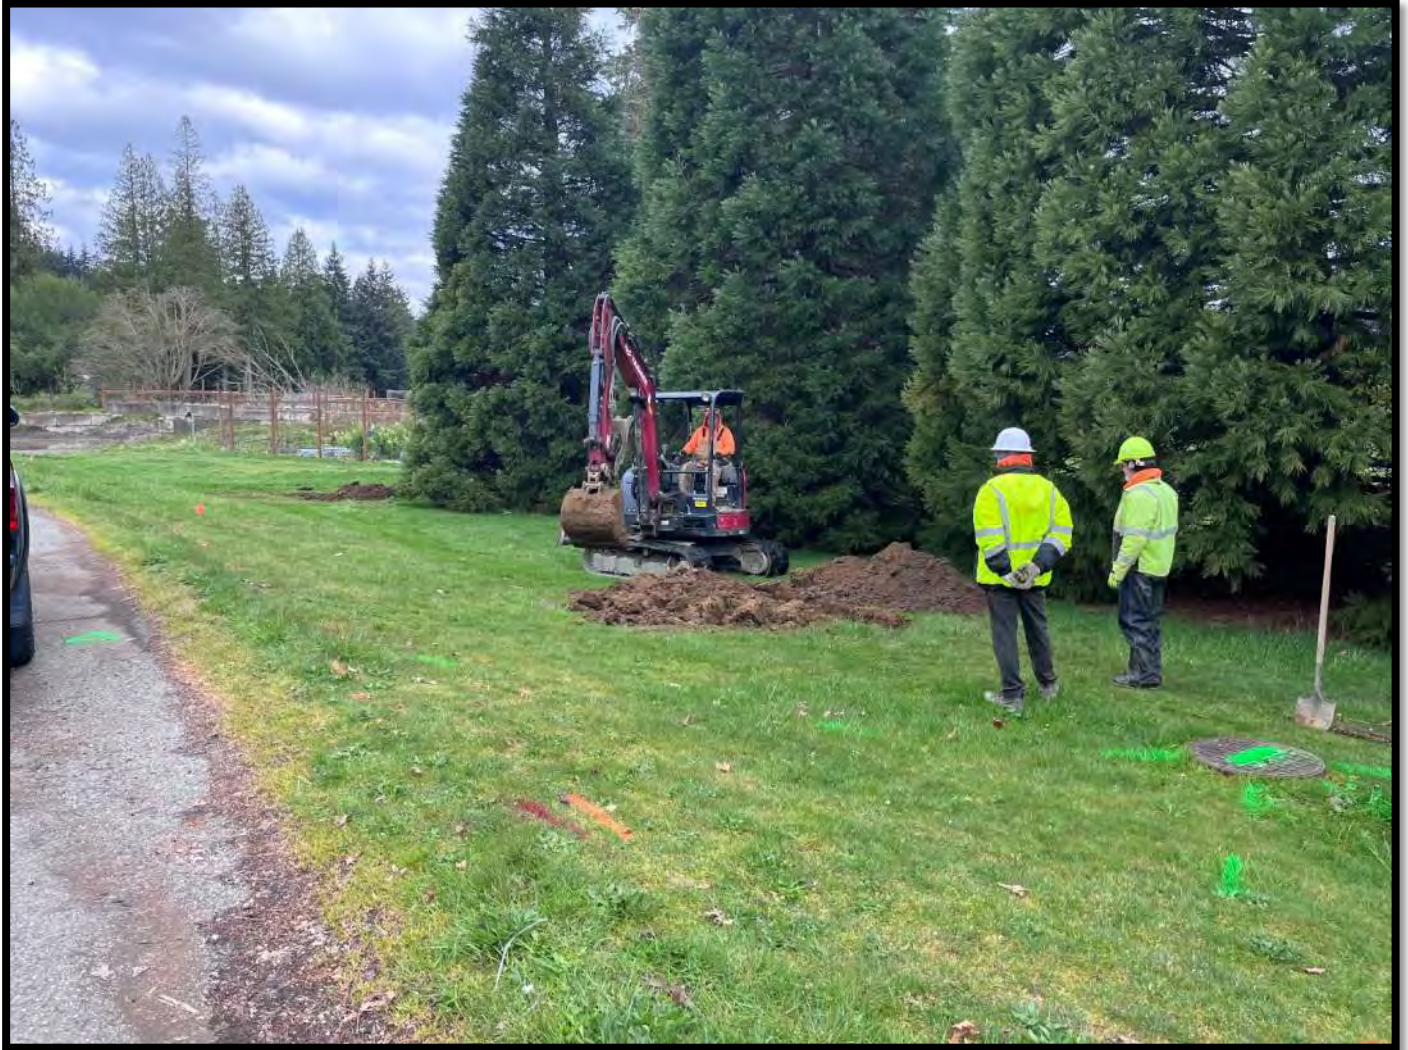
Photo 8: Test location TP-8 in progress N of the asphalt pavement and barn facility. Facing W on April 16, 2026.

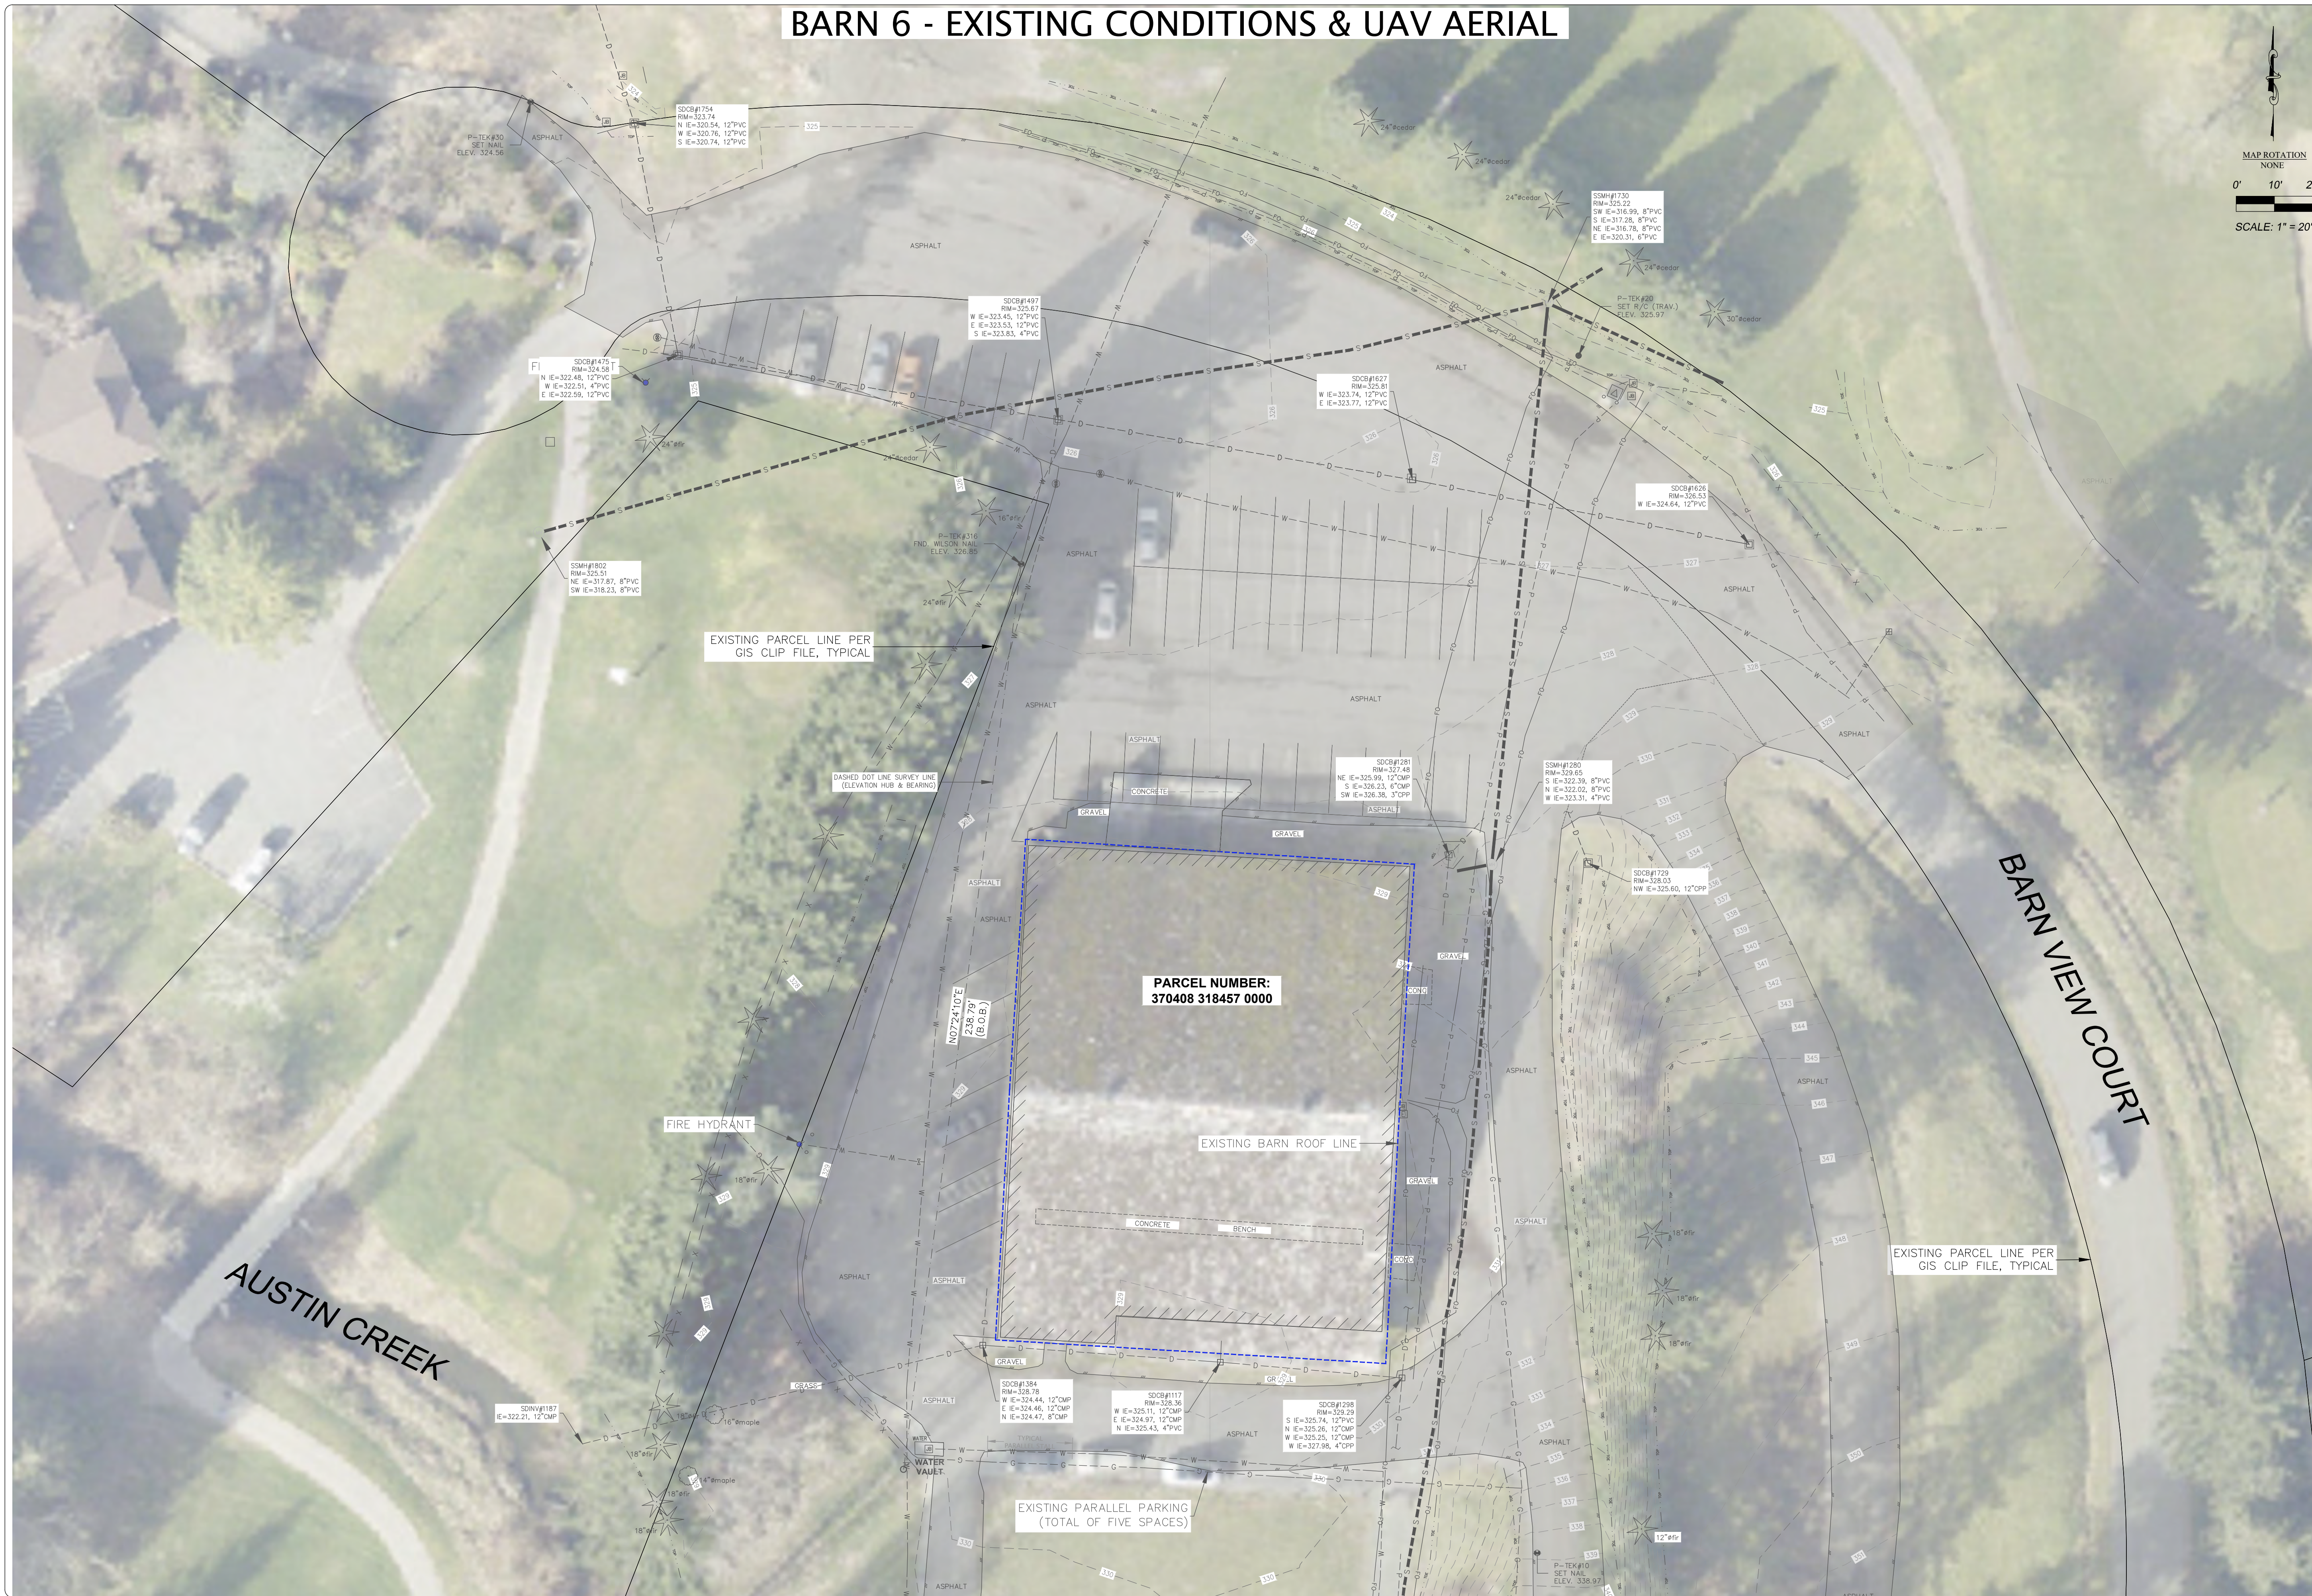
## BARN 6 - EXISTING CONDITIONS & UAV AERIAL

Red Box = Contractor Staging Area - Maintain Pedestrian & Vehicle Access Outside of Red Box
