# **Sudden Valley Community Association**

## **Finance Committee Meeting**

## 10 Barn View Court Demolition Permit Shorelines Exemption Project Narrative

SUDDEN VALLEY COMMUNITY ASSOCIATION (SVCA)  
SITUATE IN A PORTION OF THE NE 1/4, SW 1/4 SECTION 5, TOWNSHIP 37 NORTH, RANGE 4 EAST OF W.M. SUDDEN VALLEY, WHATCOM COUNTY, WASHINGTON  
10 BARN VIEW COURT (BARN 6) DEMOLITION PERMIT (DEMO-XXXX)

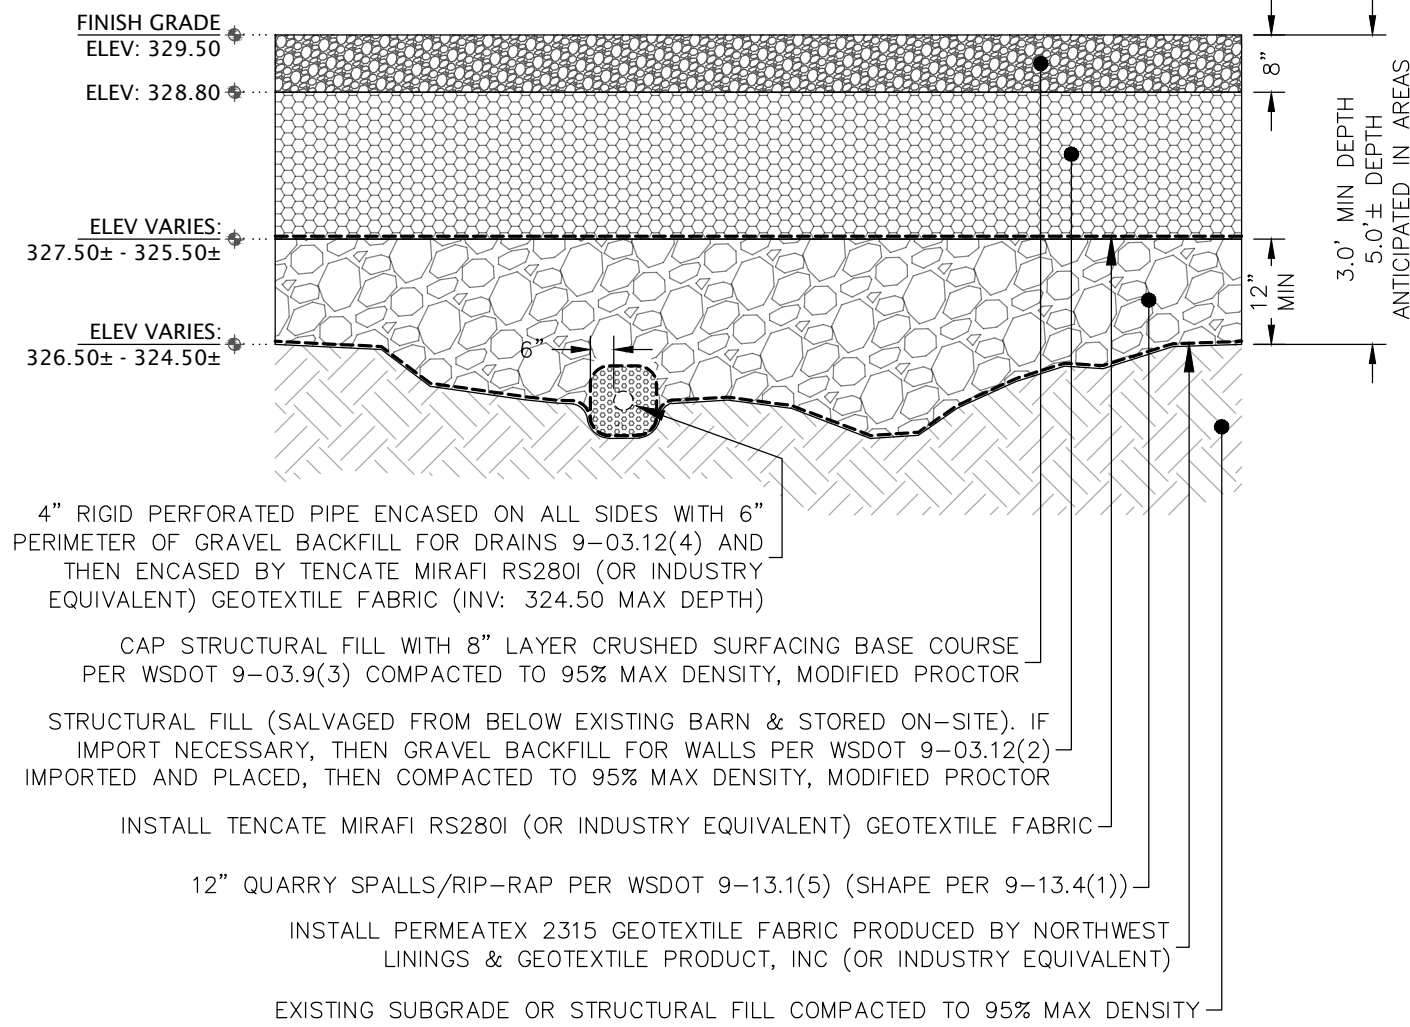
E BUILDING DEMOLITION STABILIZATION SECTION  
NTS

6. ASPHALT ADJACENT TO BARN DEMO PROJECT SHALL BE SAWCUT TO ESTABLISH A CLEAN, STRAIGHT EDGE OFFSET/SAWCUT LINE SHOWN 6.0' FROM FACE OF FUTURE BUILDING. PAVEMENT TO BE REMOVED AND STRUCTURAL FILL TO BE SALVAGED FOR REDISTRIBUTION.

7. EXISTING UTILITIES WITHIN THE EXCAVATION ZONE SHALL BE WORKED AROUND AND MAINTAINED TO GREATEST EXTENT PRACTICABLE.
8. ALL DEPTHS REPRESENT COMPACTED THICKNESSES.

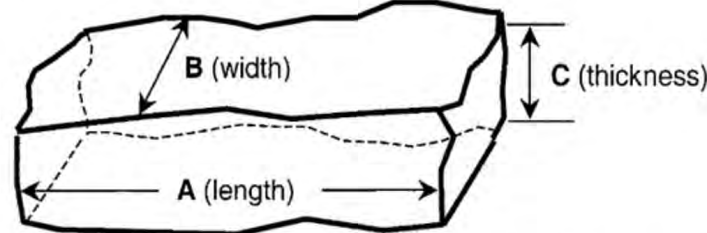
9-13.4(1) Suitable Shape of Rock for Erosion and Scour Protection

The Suitable Shape of these rocks shall be "Angular" (having sharply defined edges) to "Subangular" (having a shape in between Rounded and Angular) for a higher degree of interlocking to provide stability to the protected area. The use of round, thin, flat, or long and needle-like shapes is not allowed.

Suitable Shape can be determined by the ratio of the Length/Thickness, where the Length is the longest axis, Width is the second longest axis, and Thickness is the shortest. The Suitable Shape shall be the maximum of 3.0 using the following calculation:

$$\frac{A(\text{Length})}{C(\text{Thickness})} \leq 3.0$$

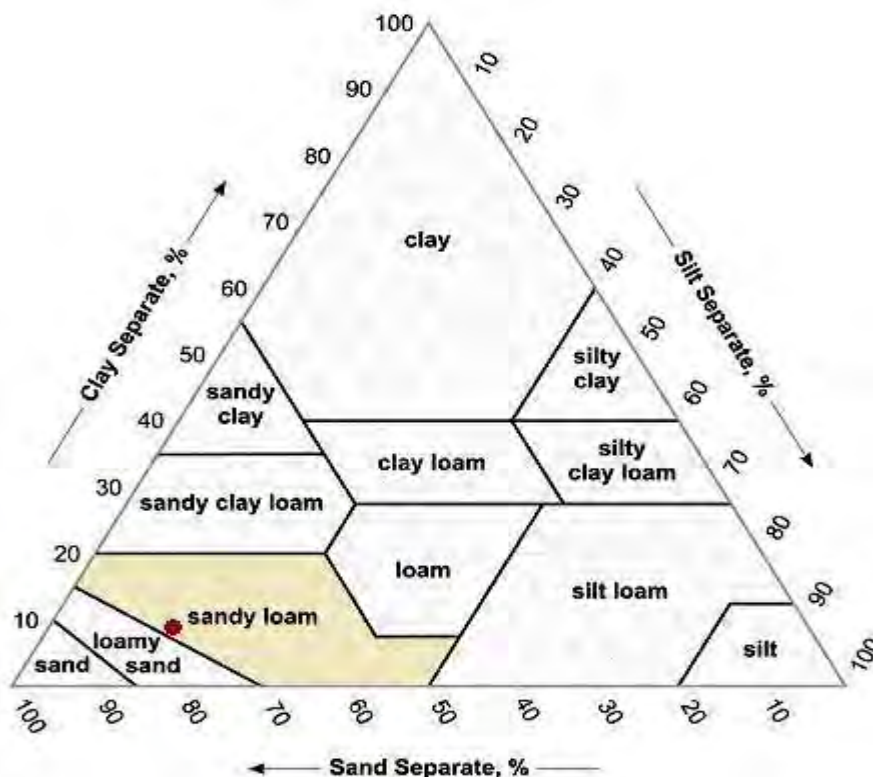
Date received: 03/31/26  
Report date: 04/07/26  
Sample reference # 18486  
Plant code: 00 - General / not specified  
Tests requested: Texture

Soil Texture Classification: **Sandy Loam**

Sand: 76%      Silt: 15%      Clay: 9%

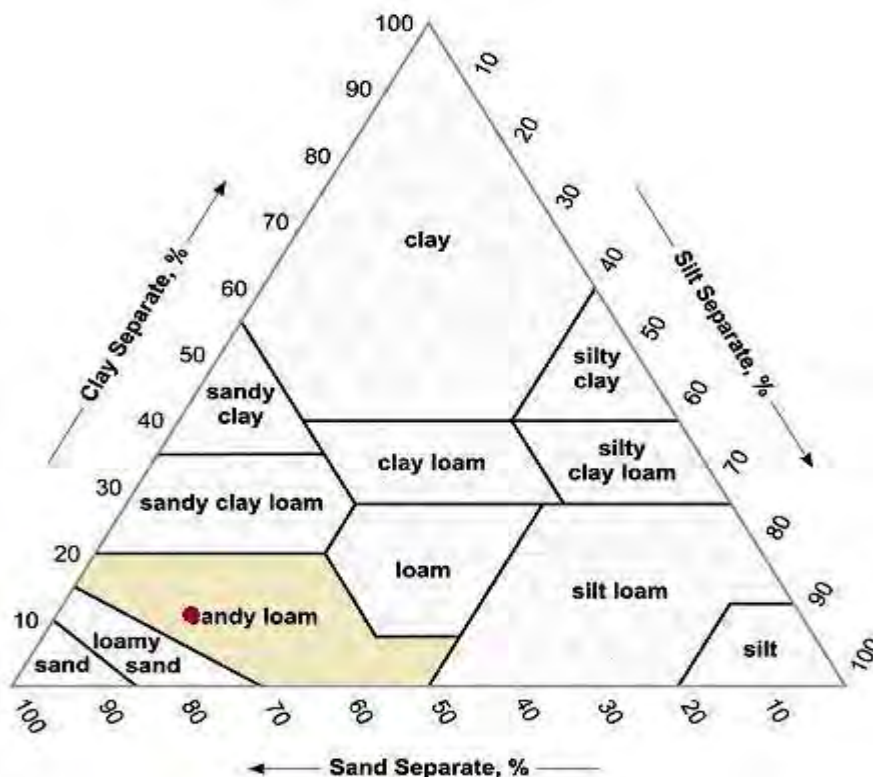
Date received: 03/31/26  
Report date: 04/07/26  
Sample reference # 18487  
Plant code: 00 - General / not specified  
Tests requested: Texture

Soil Texture Classification: **Sandy Loam**

Sand: 73%      Silt: 16%      Clay: 11%

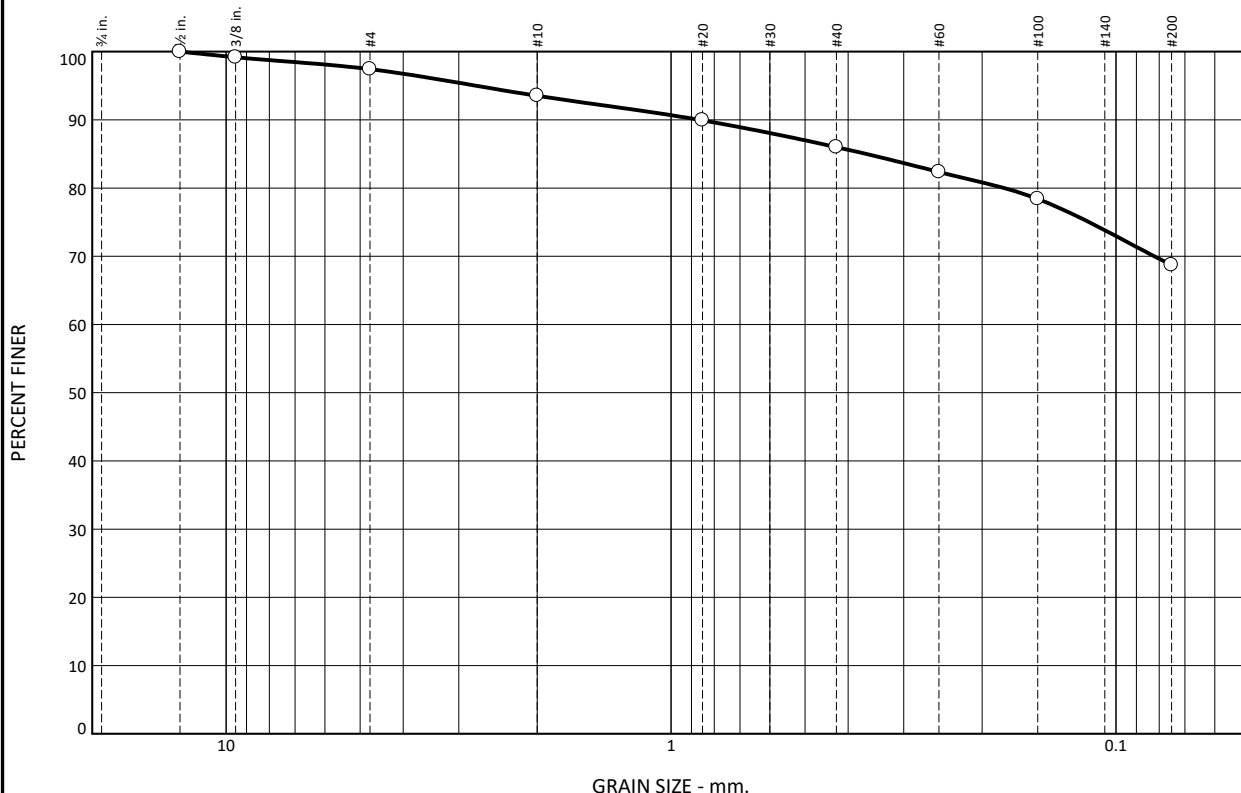
# Sieve Analysis Test Report

ASTM C117 & C136

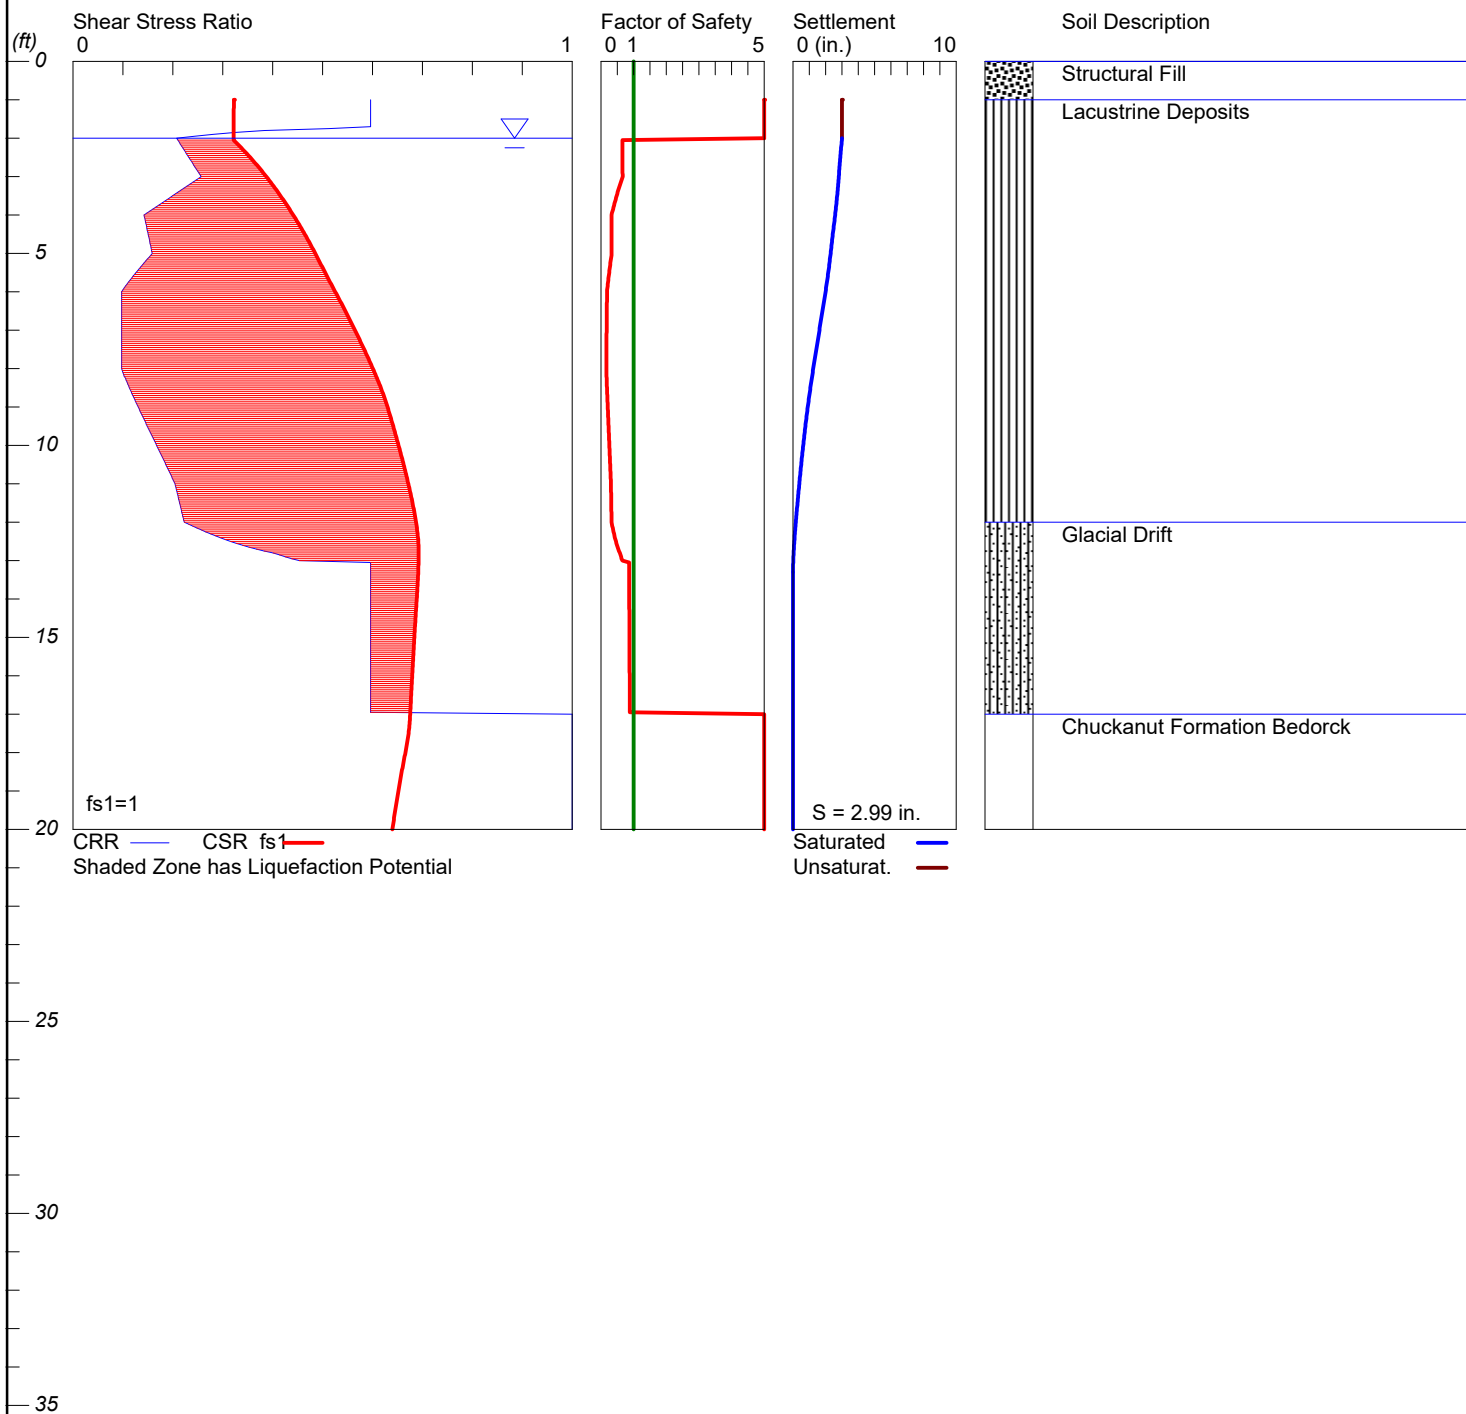
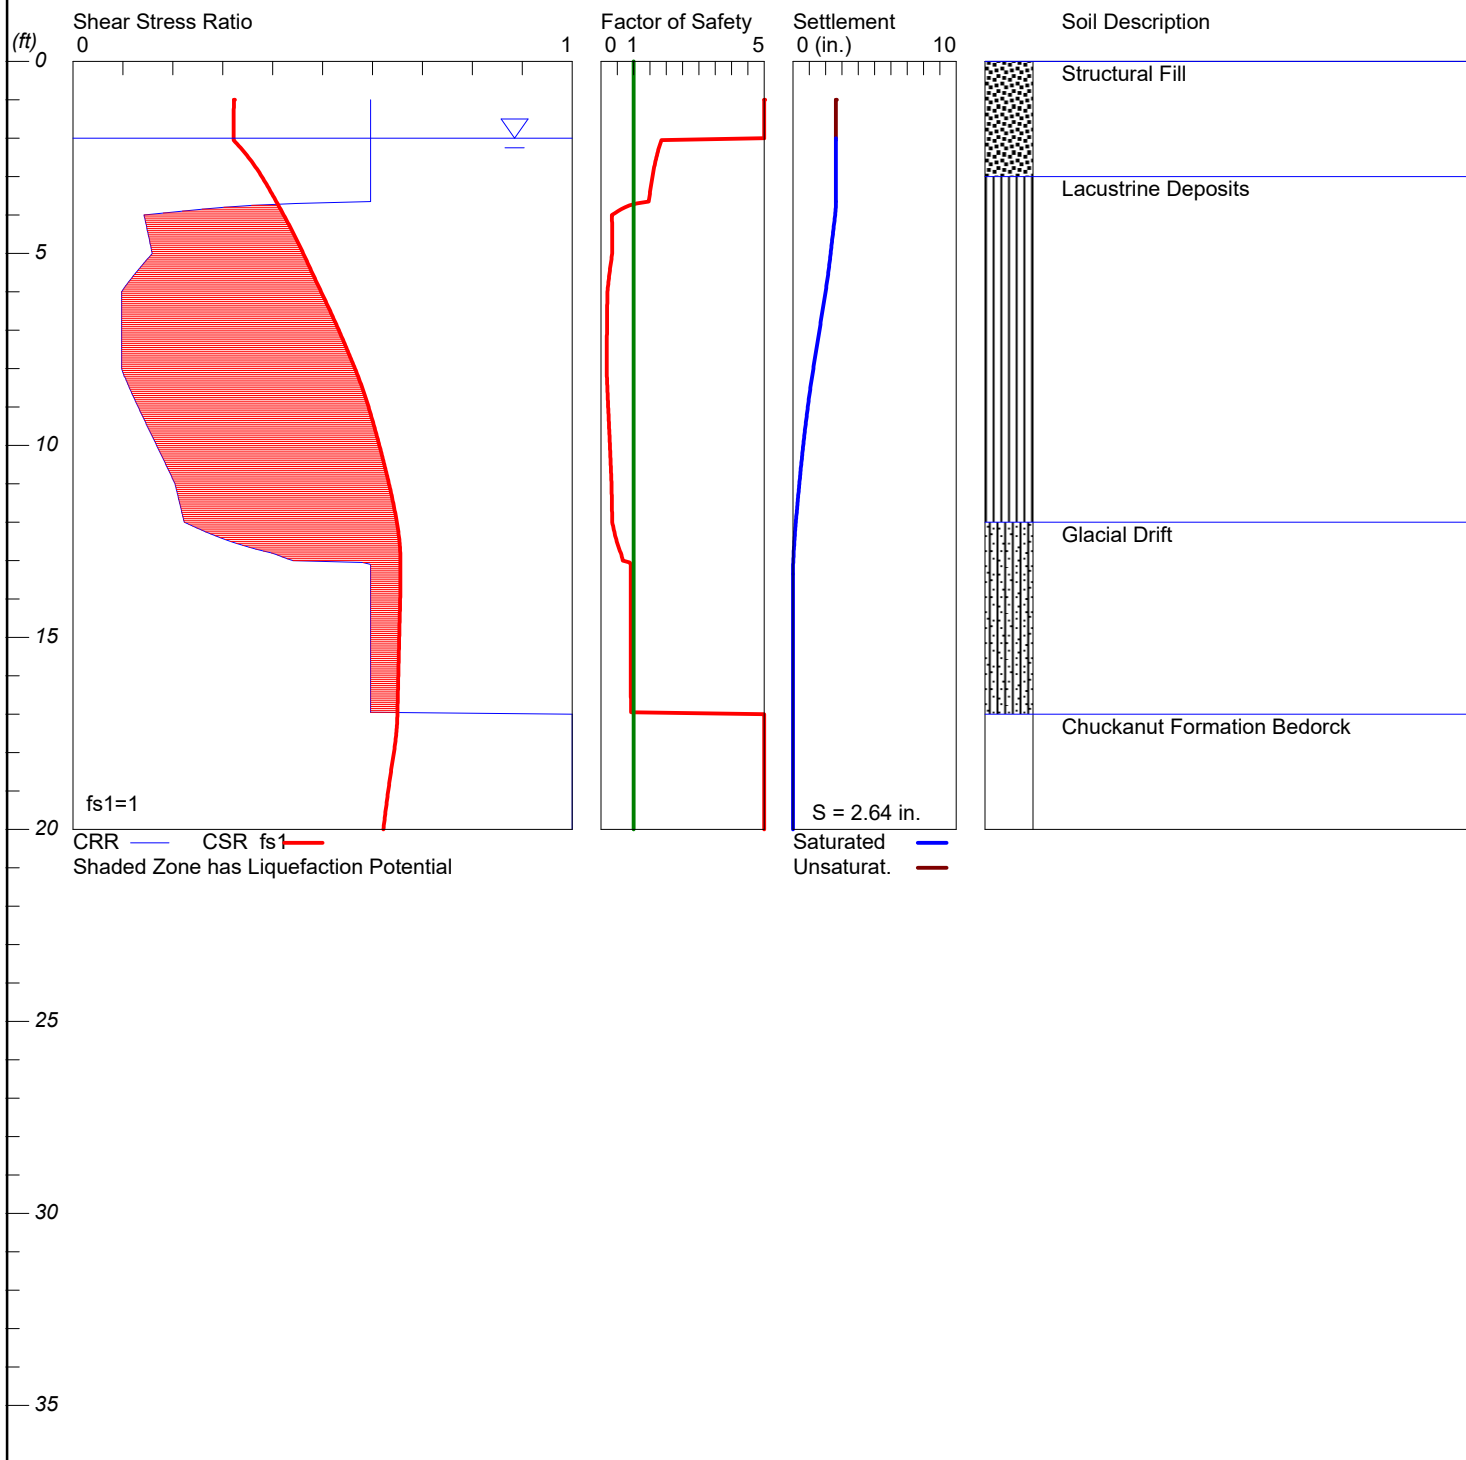
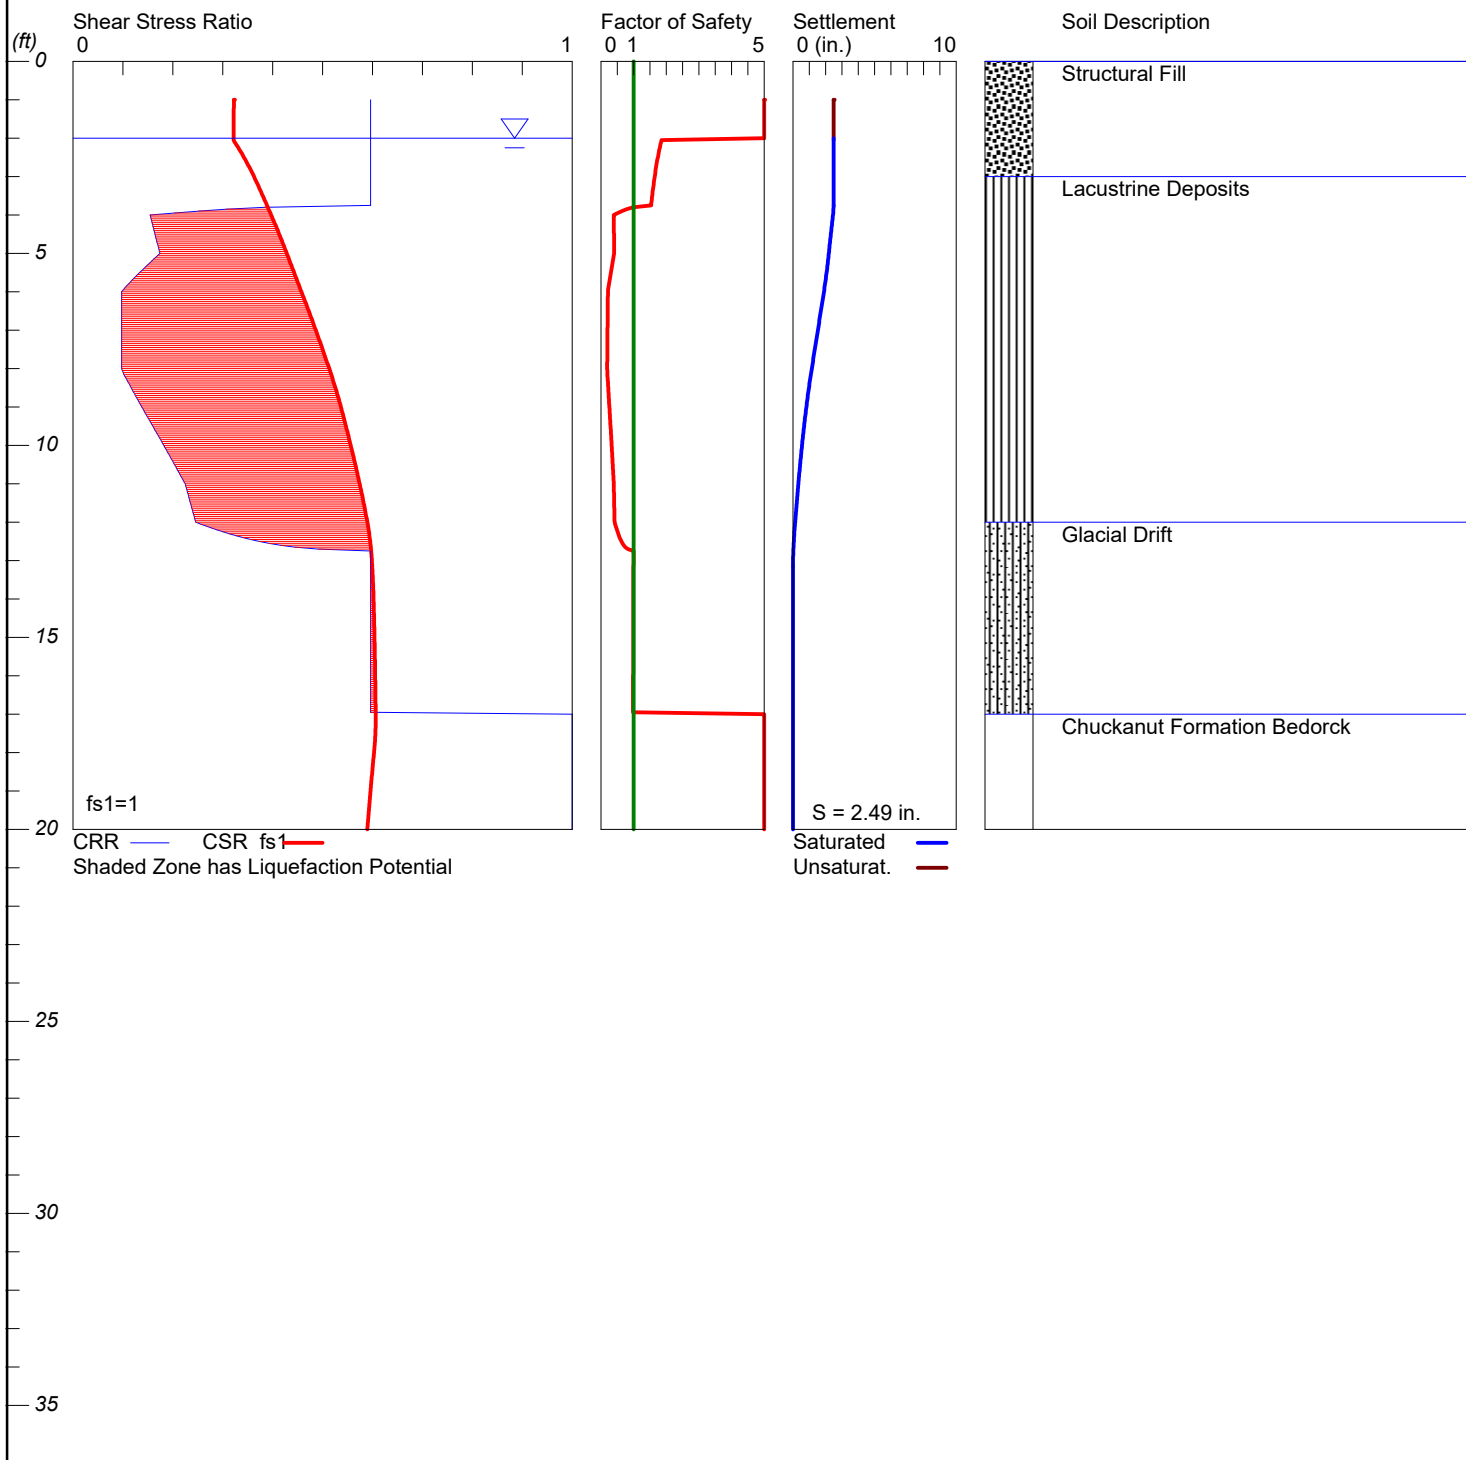
Hole No.=DCP-1 Water Depth=2 ft Surface Elev.=328

Magnitude=7  
Acceleration=0.497g

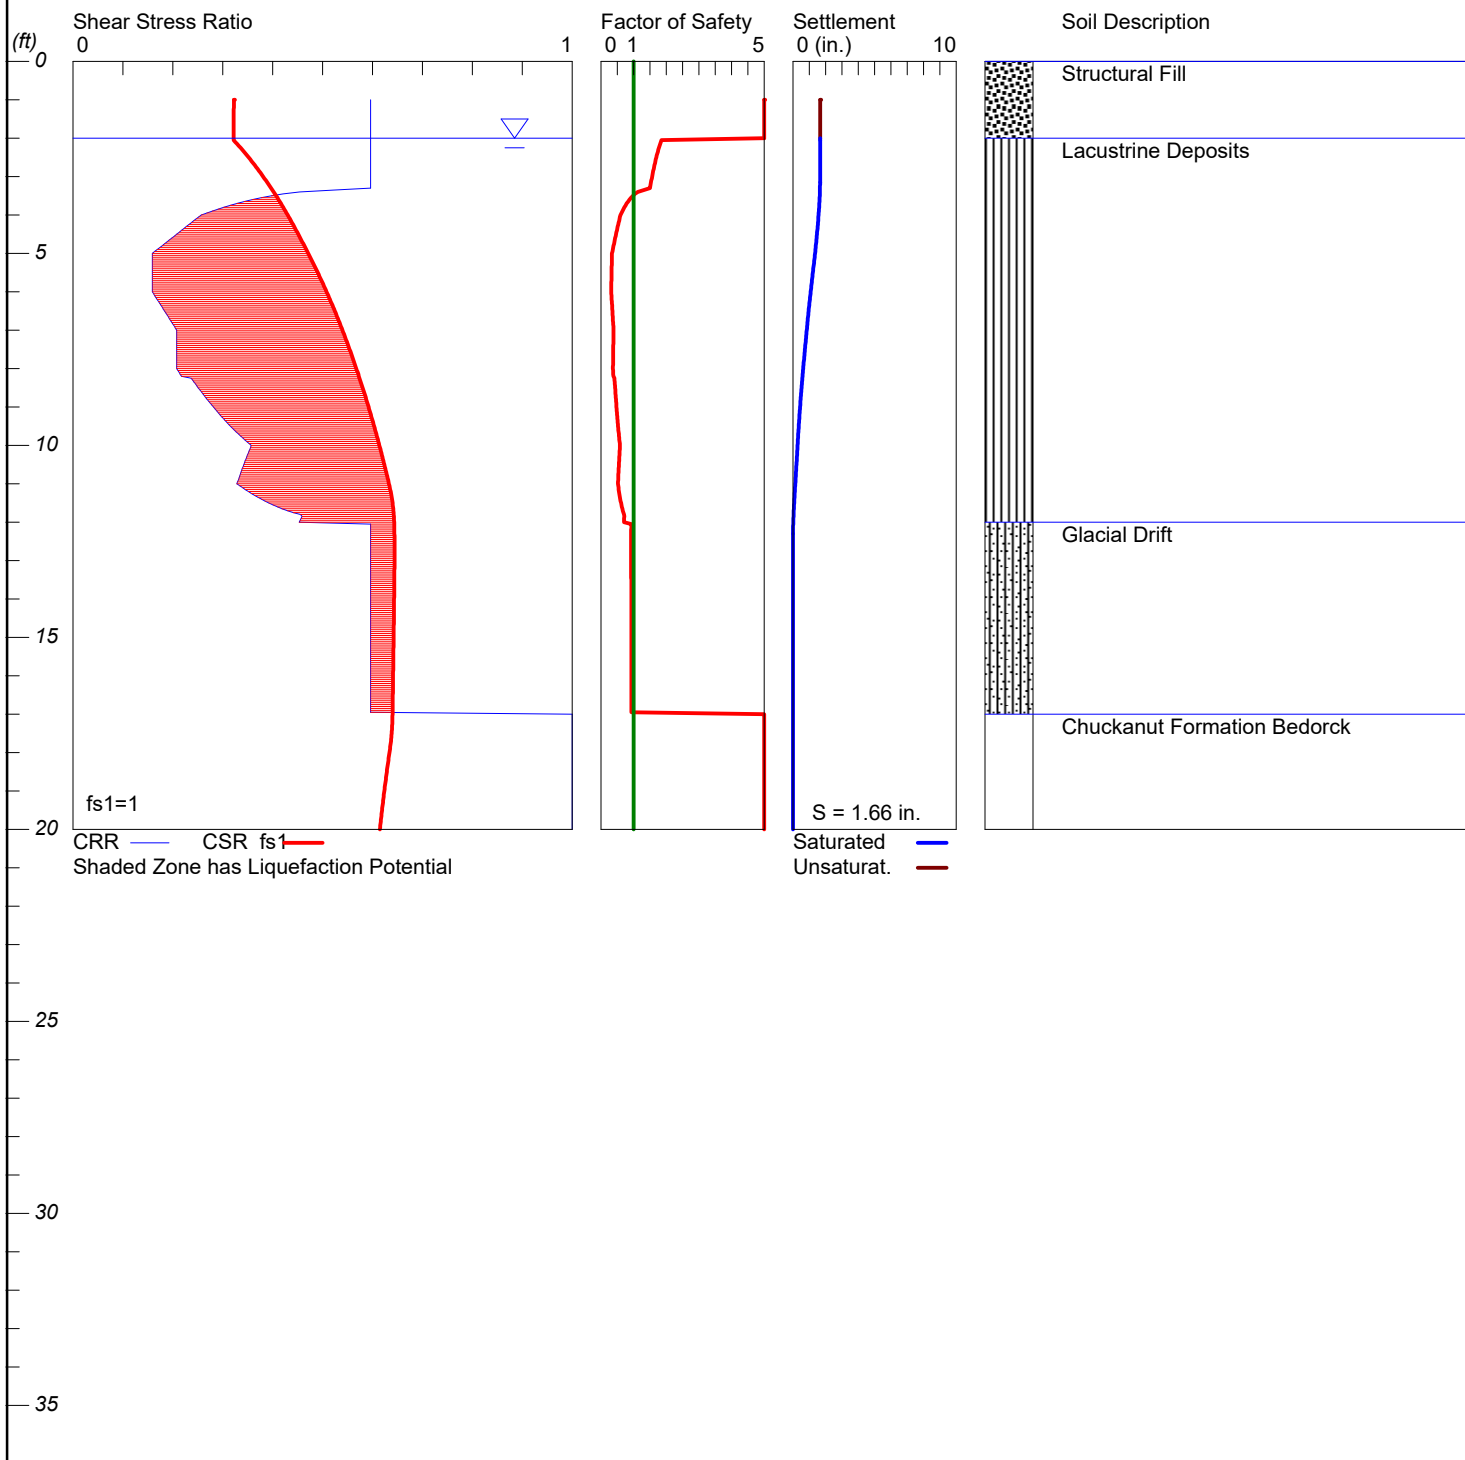
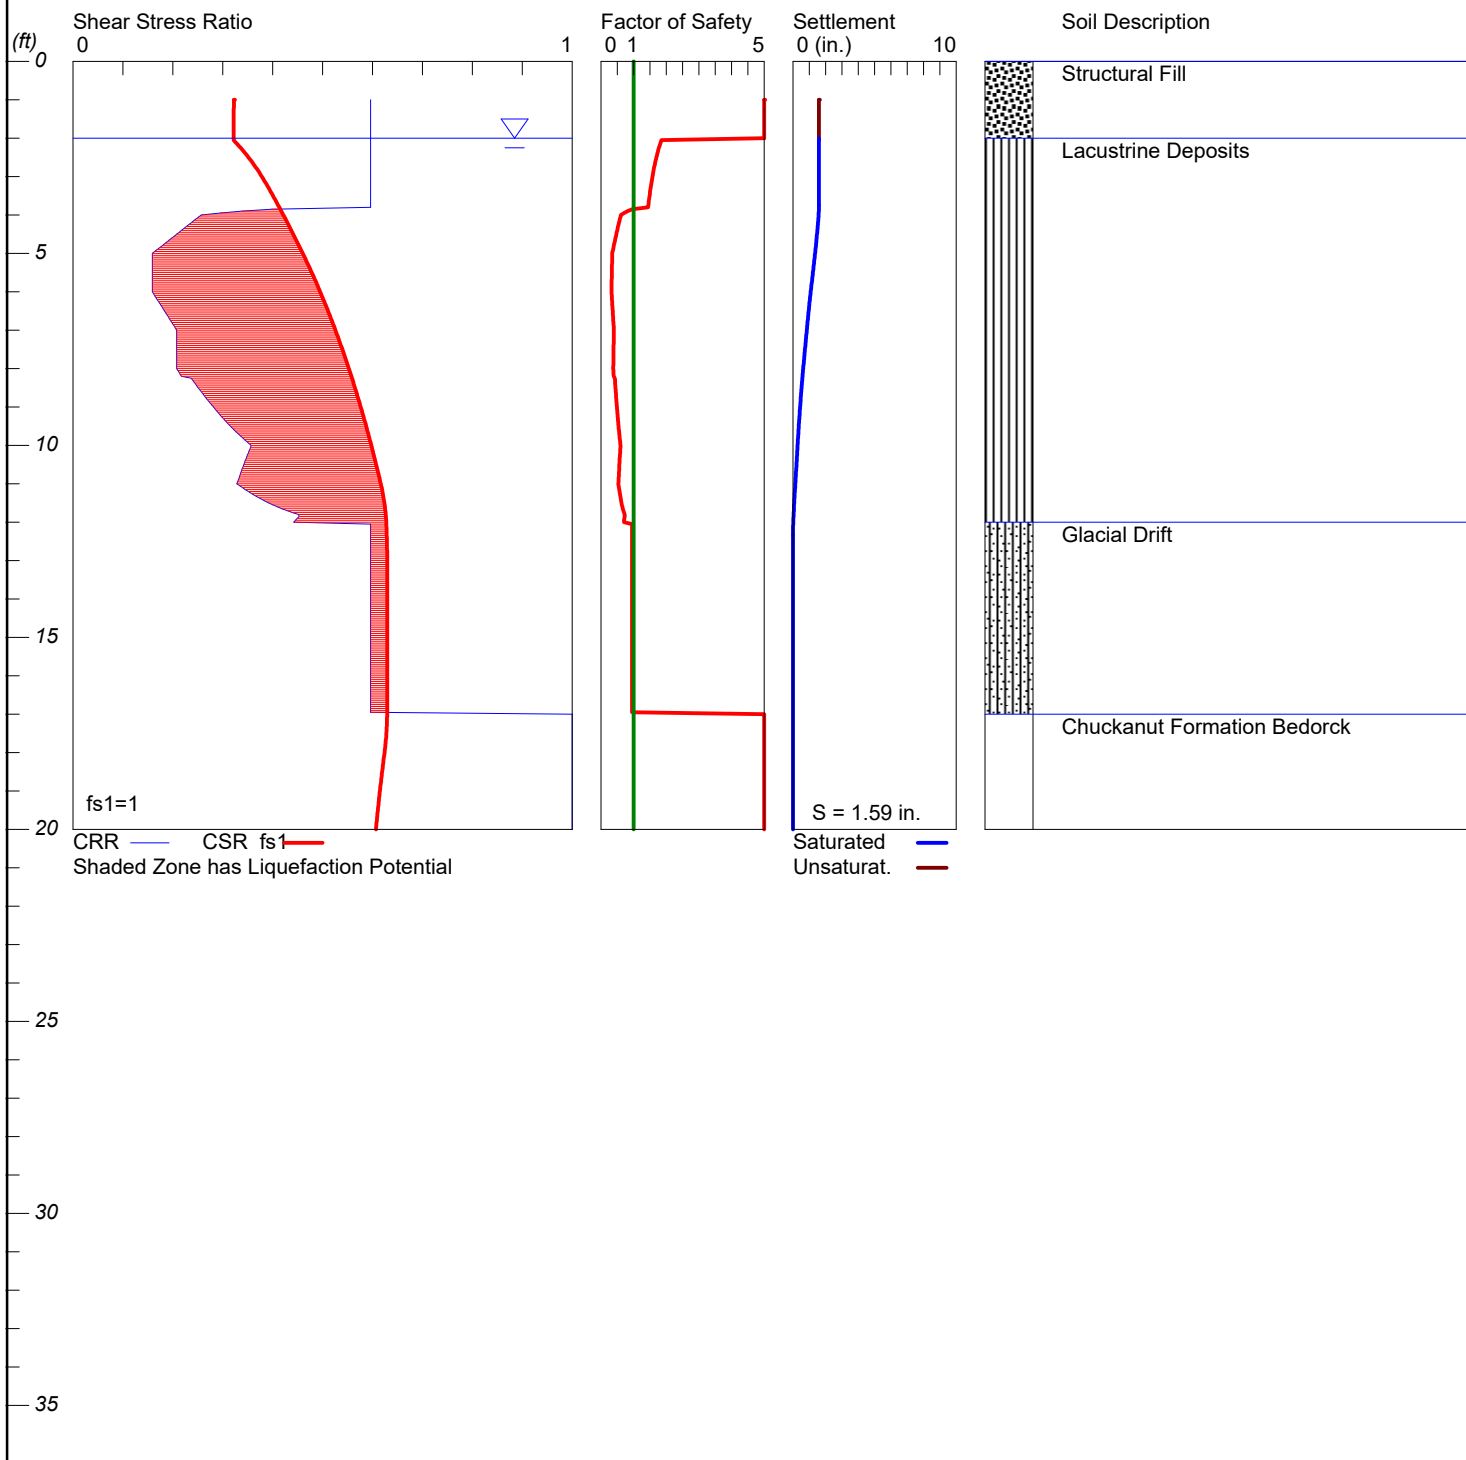
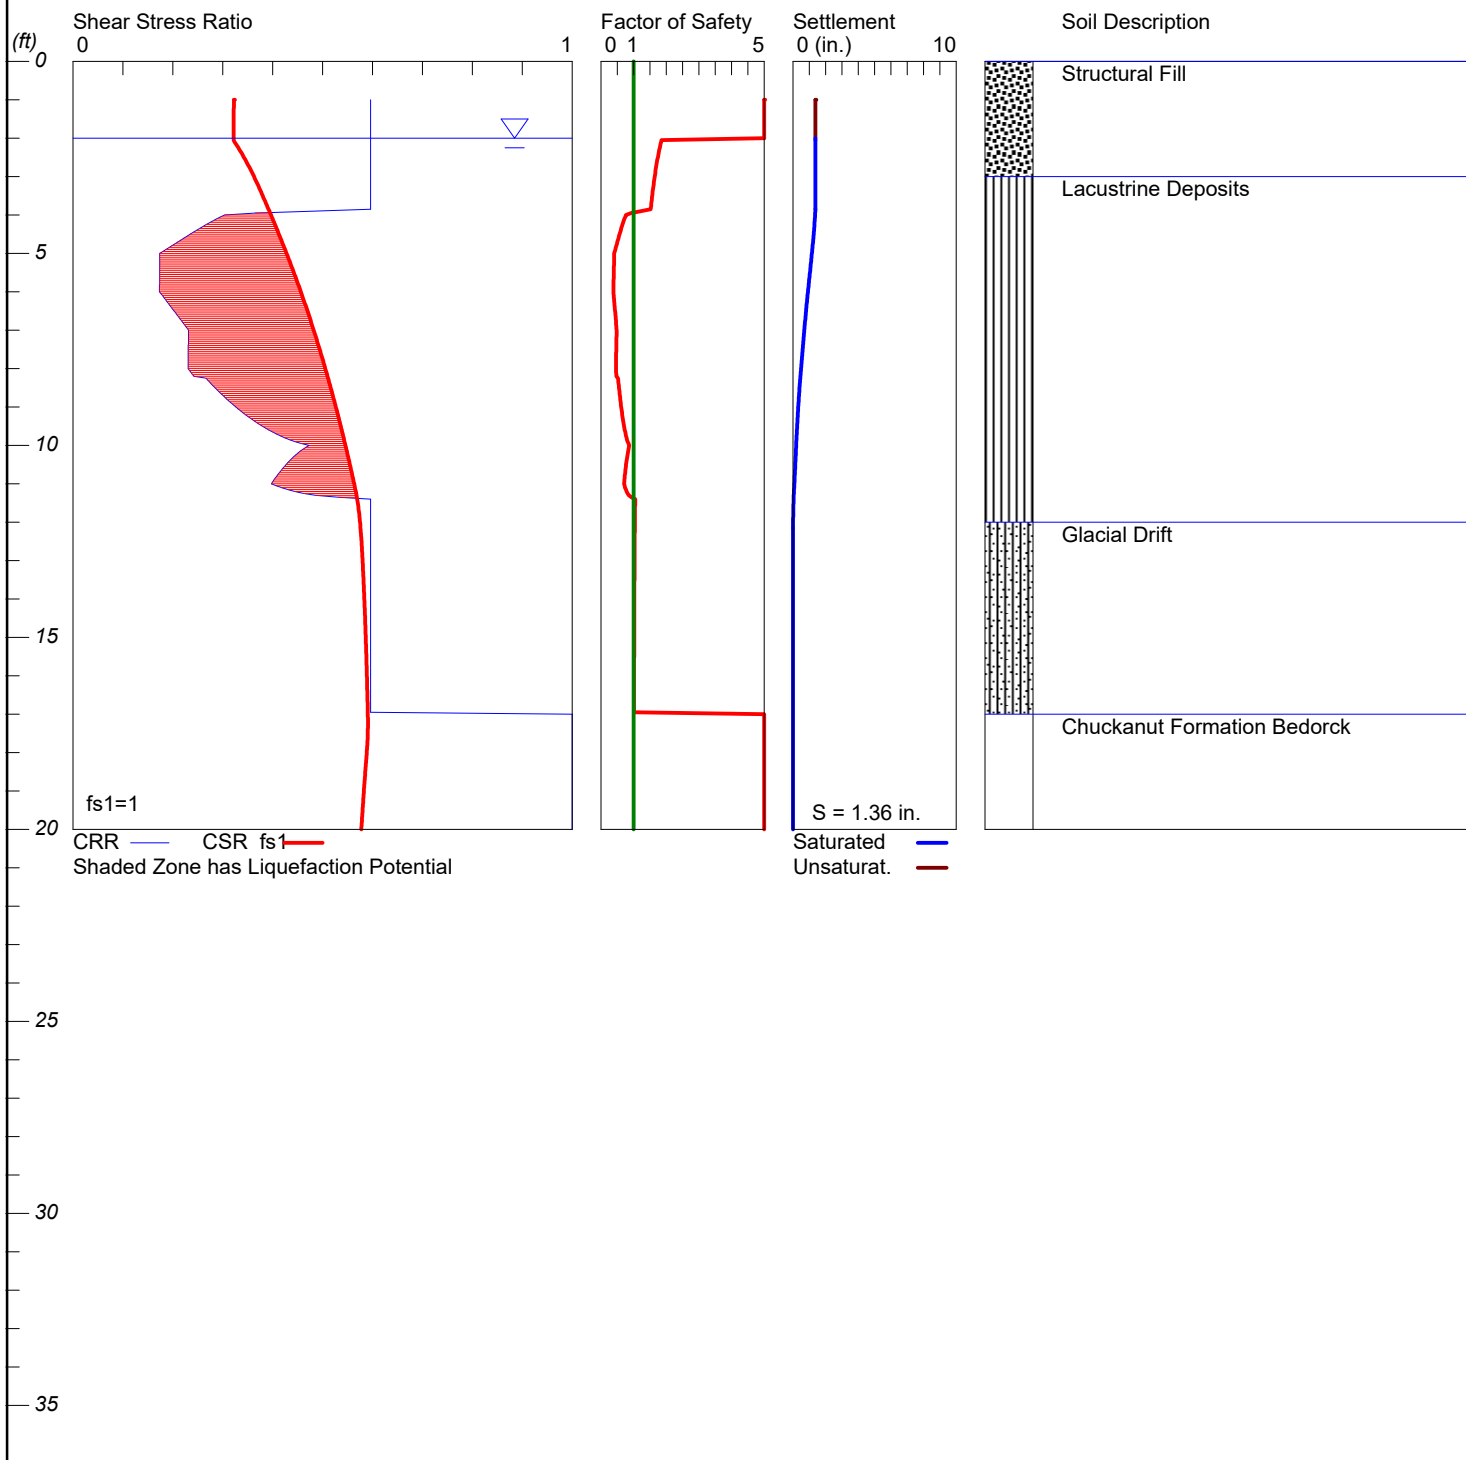
Hole No.=DCP-2 Water Depth=2 ft Surface Elev.=328

Magnitude=7  
Acceleration=0.497g

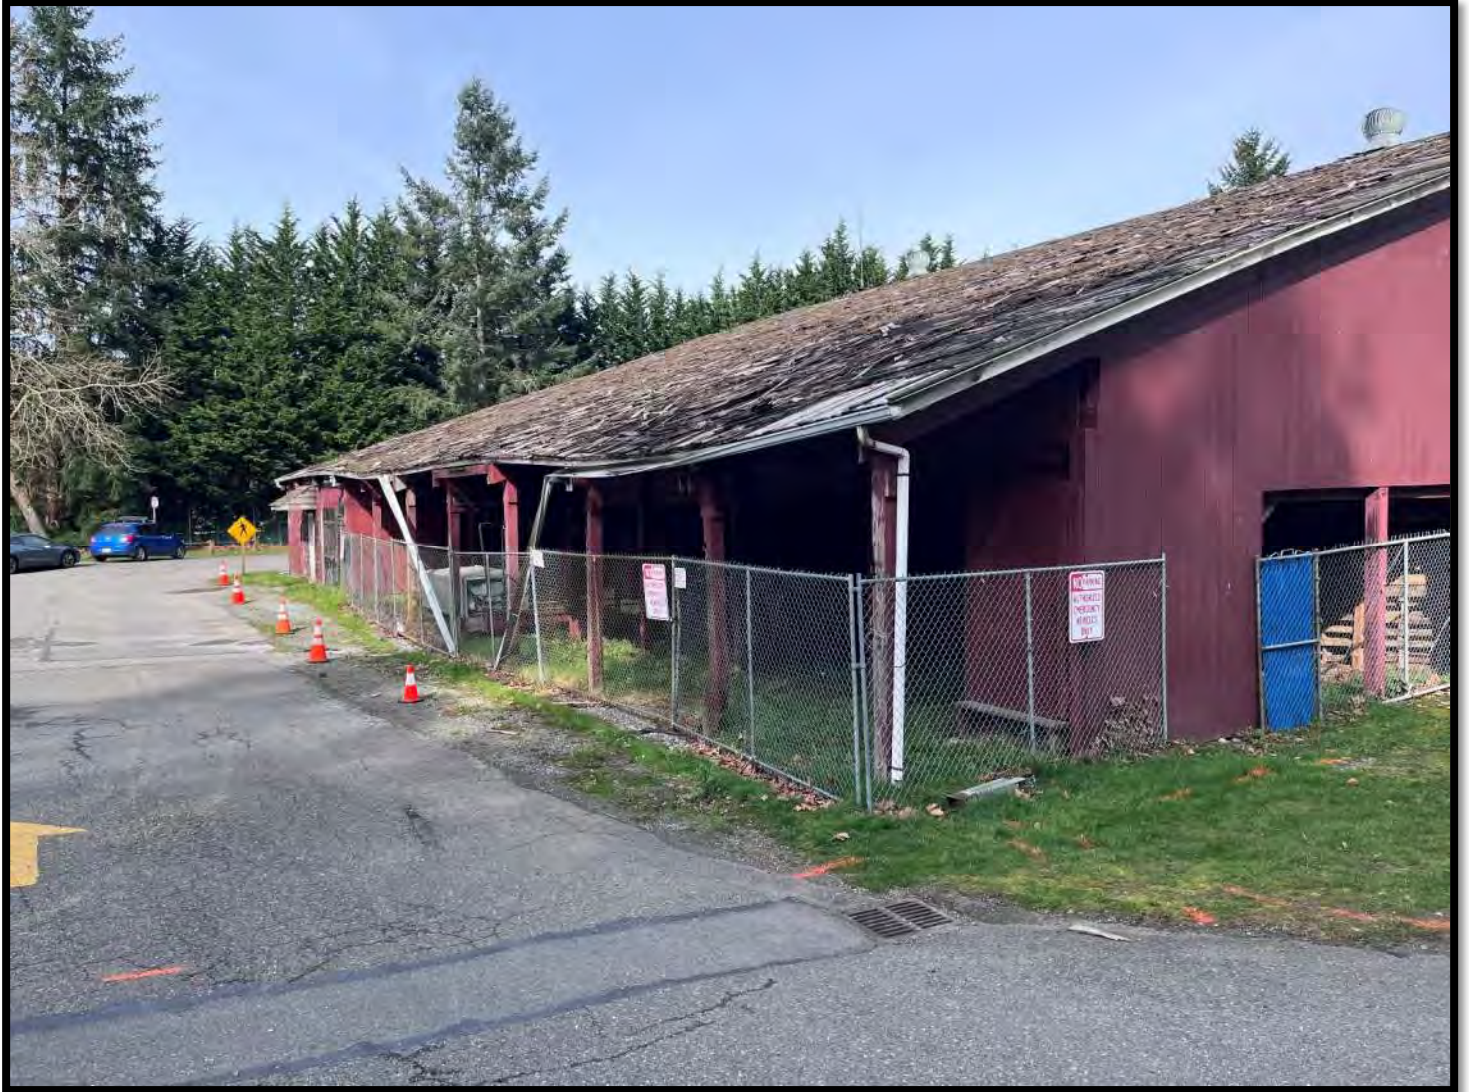
Photo 3: The S side of the barn, facing W on March 27, 2026.

Photo 3: The S side of the barn, facing W on March 27, 2026.

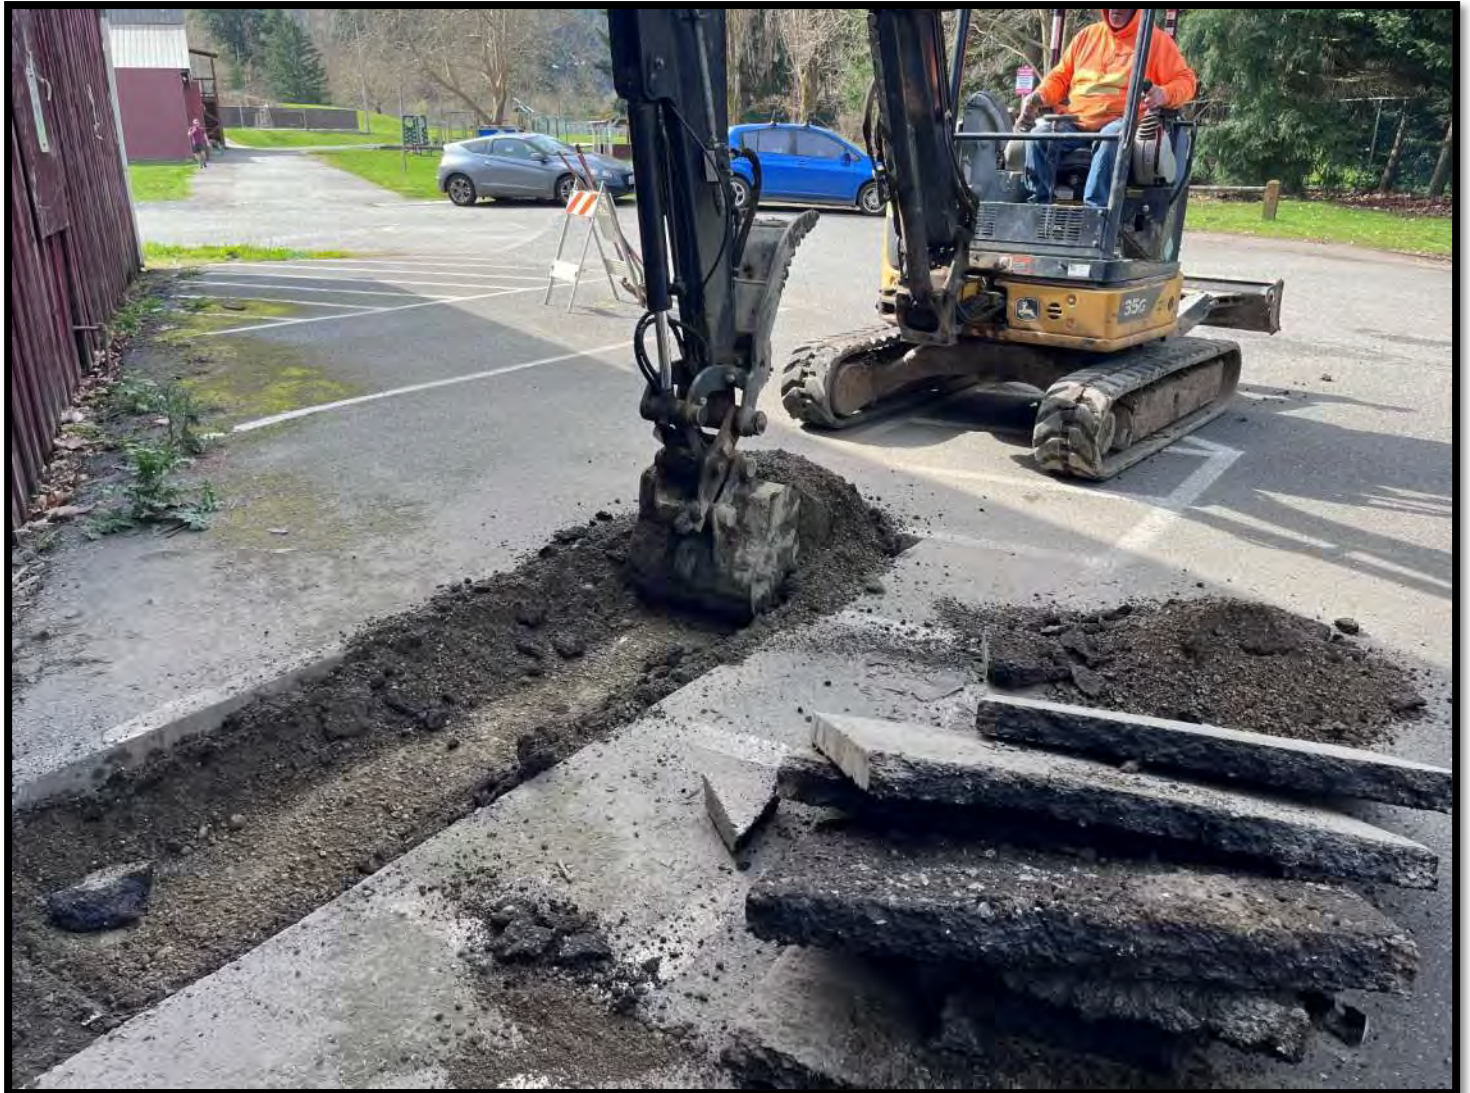
Photo 4: Test location TP-4 in progress on the W side of the barn. Facing S on March 27, 2026.

Photo 4: Test location TP-4 in progress on the W side of the barn. Facing S on March 27, 2026.

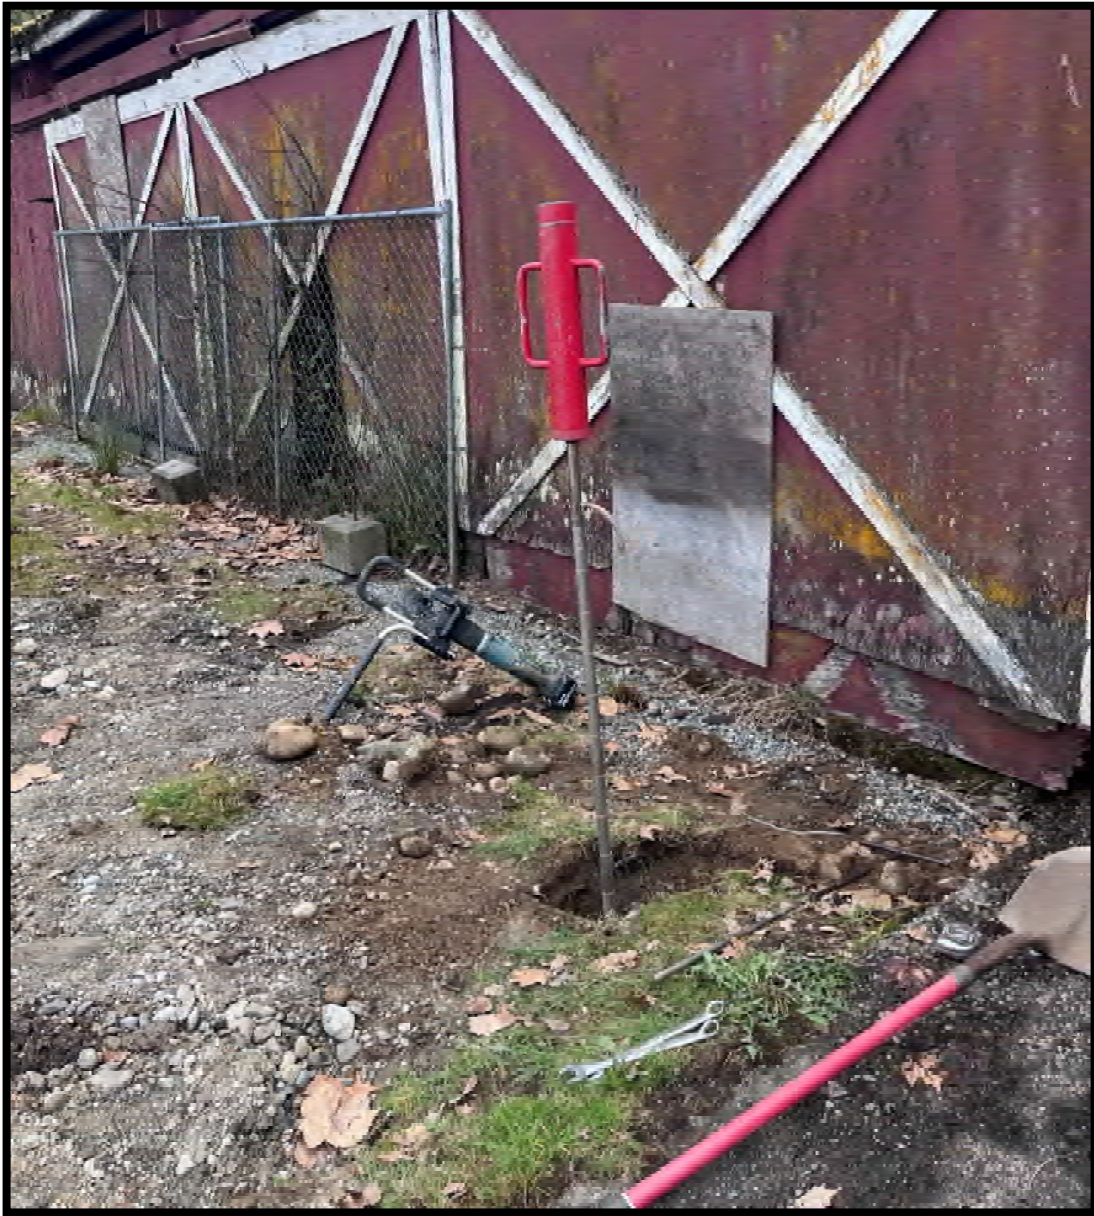
Photo 5: Test location DCP-1 in progress adjacent to TP-1. Facing SE on April 10, 2026.

Photo 5: Test location DCP-1 in progress adjacent to TP-1. Facing SE on April 10, 2026.
