# **Sudden Valley Community Association**

## **Finance Committee Meeting**

## 10 Barn View Court Demolition Permit Shorelines Exemption Project Narrative

SUDDEN VALLEY COMMUNITY ASSOCIATION (SVCA)  
SITUATE IN A PORTION OF THE NE 1/4, SW 1/4 SECTION 5, TOWNSHIP 37 NORTH, RANGE 4 EAST OF W.M. SUDDEN VALLEY, WHATCOM COUNTY, WASHINGTON  
10 BARN VIEW COURT (BARN 6) DEMOLITION PERMIT (DEMO-XXXX)

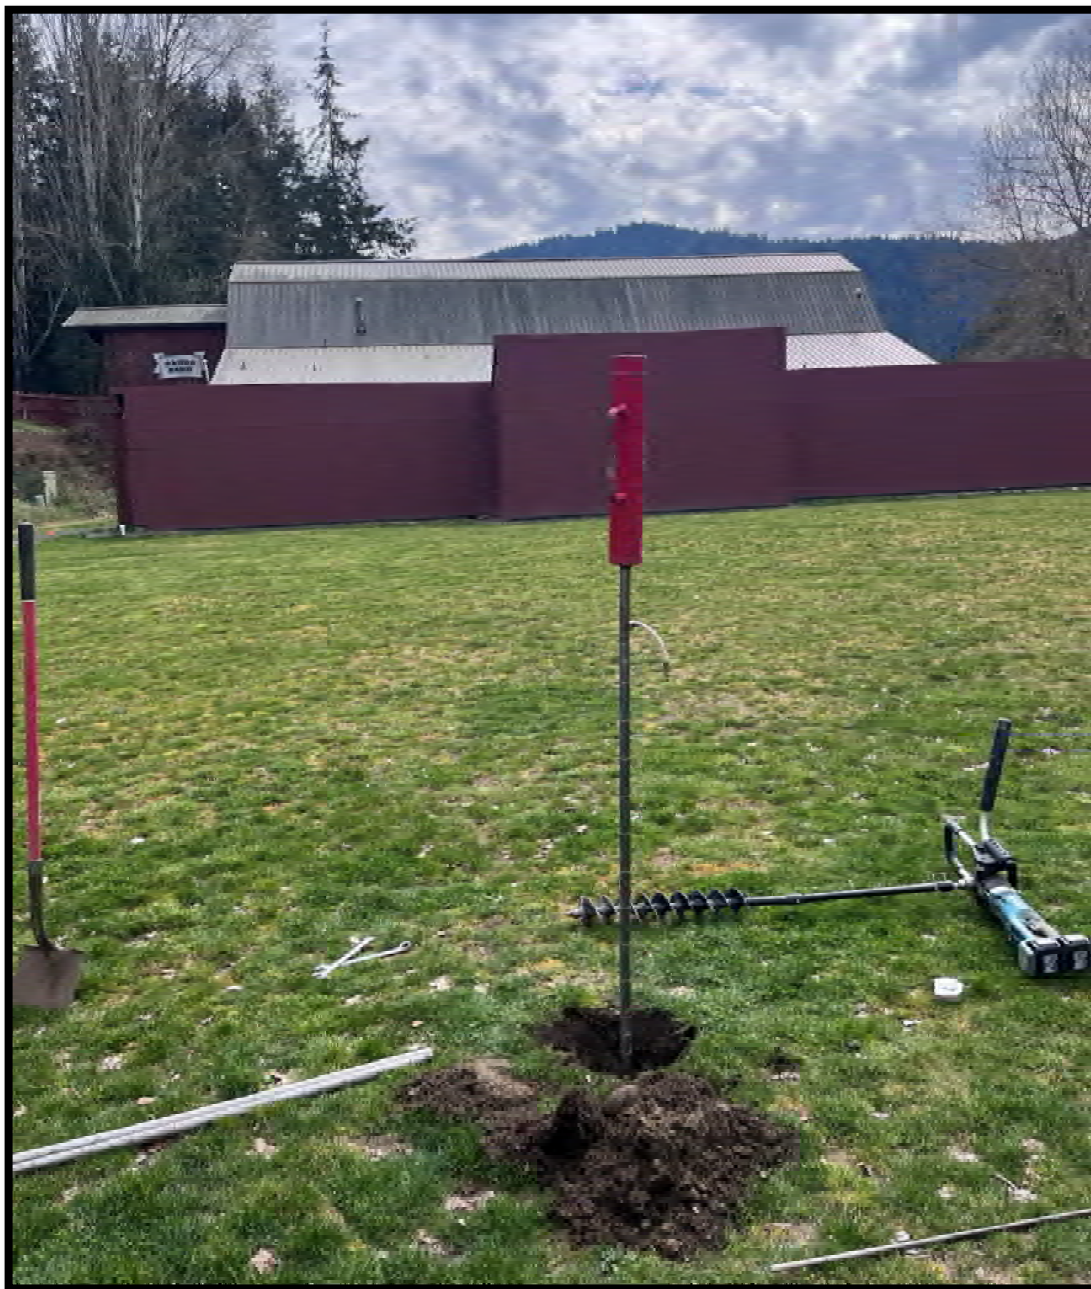
Photo 6: Test location DCP-2 in progress on the S side of the barn. Facing S on April 10, 2026.

Photo 6: Test location DCP-2 in progress on the S side of the barn. Facing S on April 10, 2026.

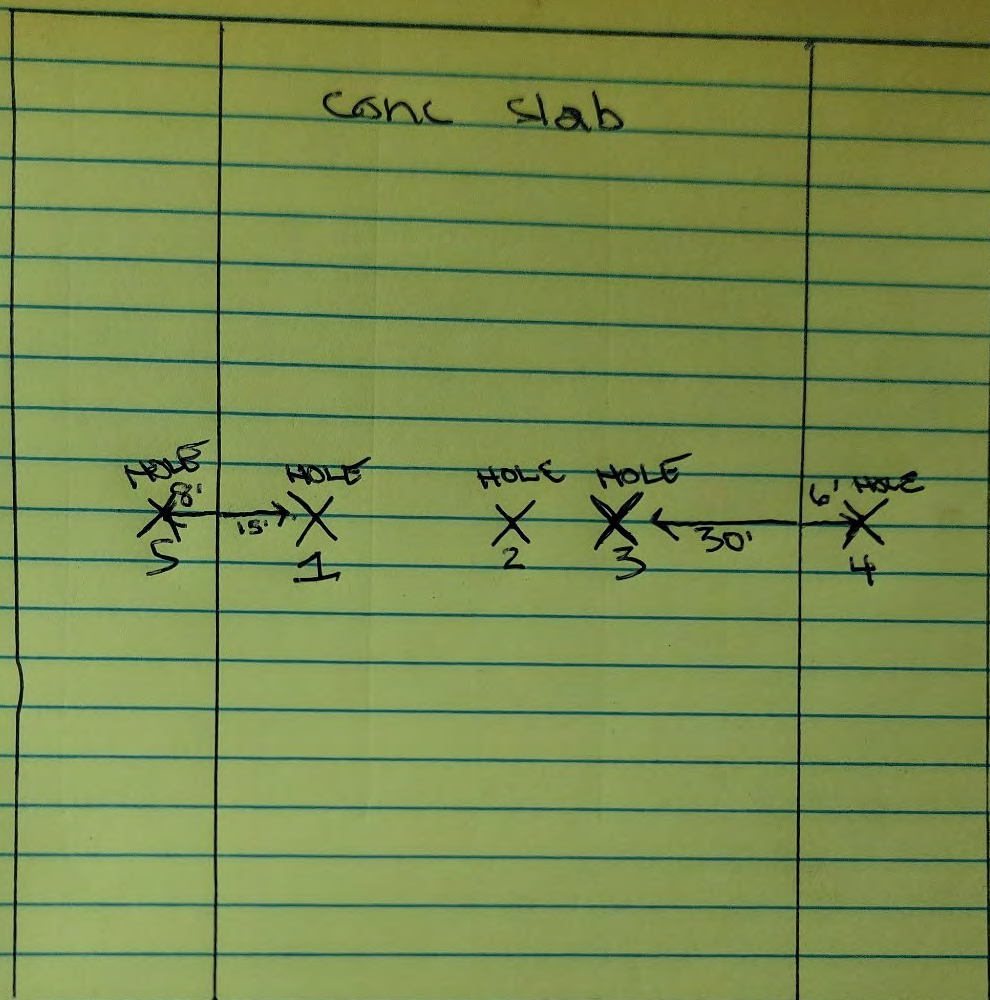
HOLE 1: 4.5" concrete, 3" foam paneling, 6" washed rock, 4" native/gravel fill

HOLE 2: Same results as above

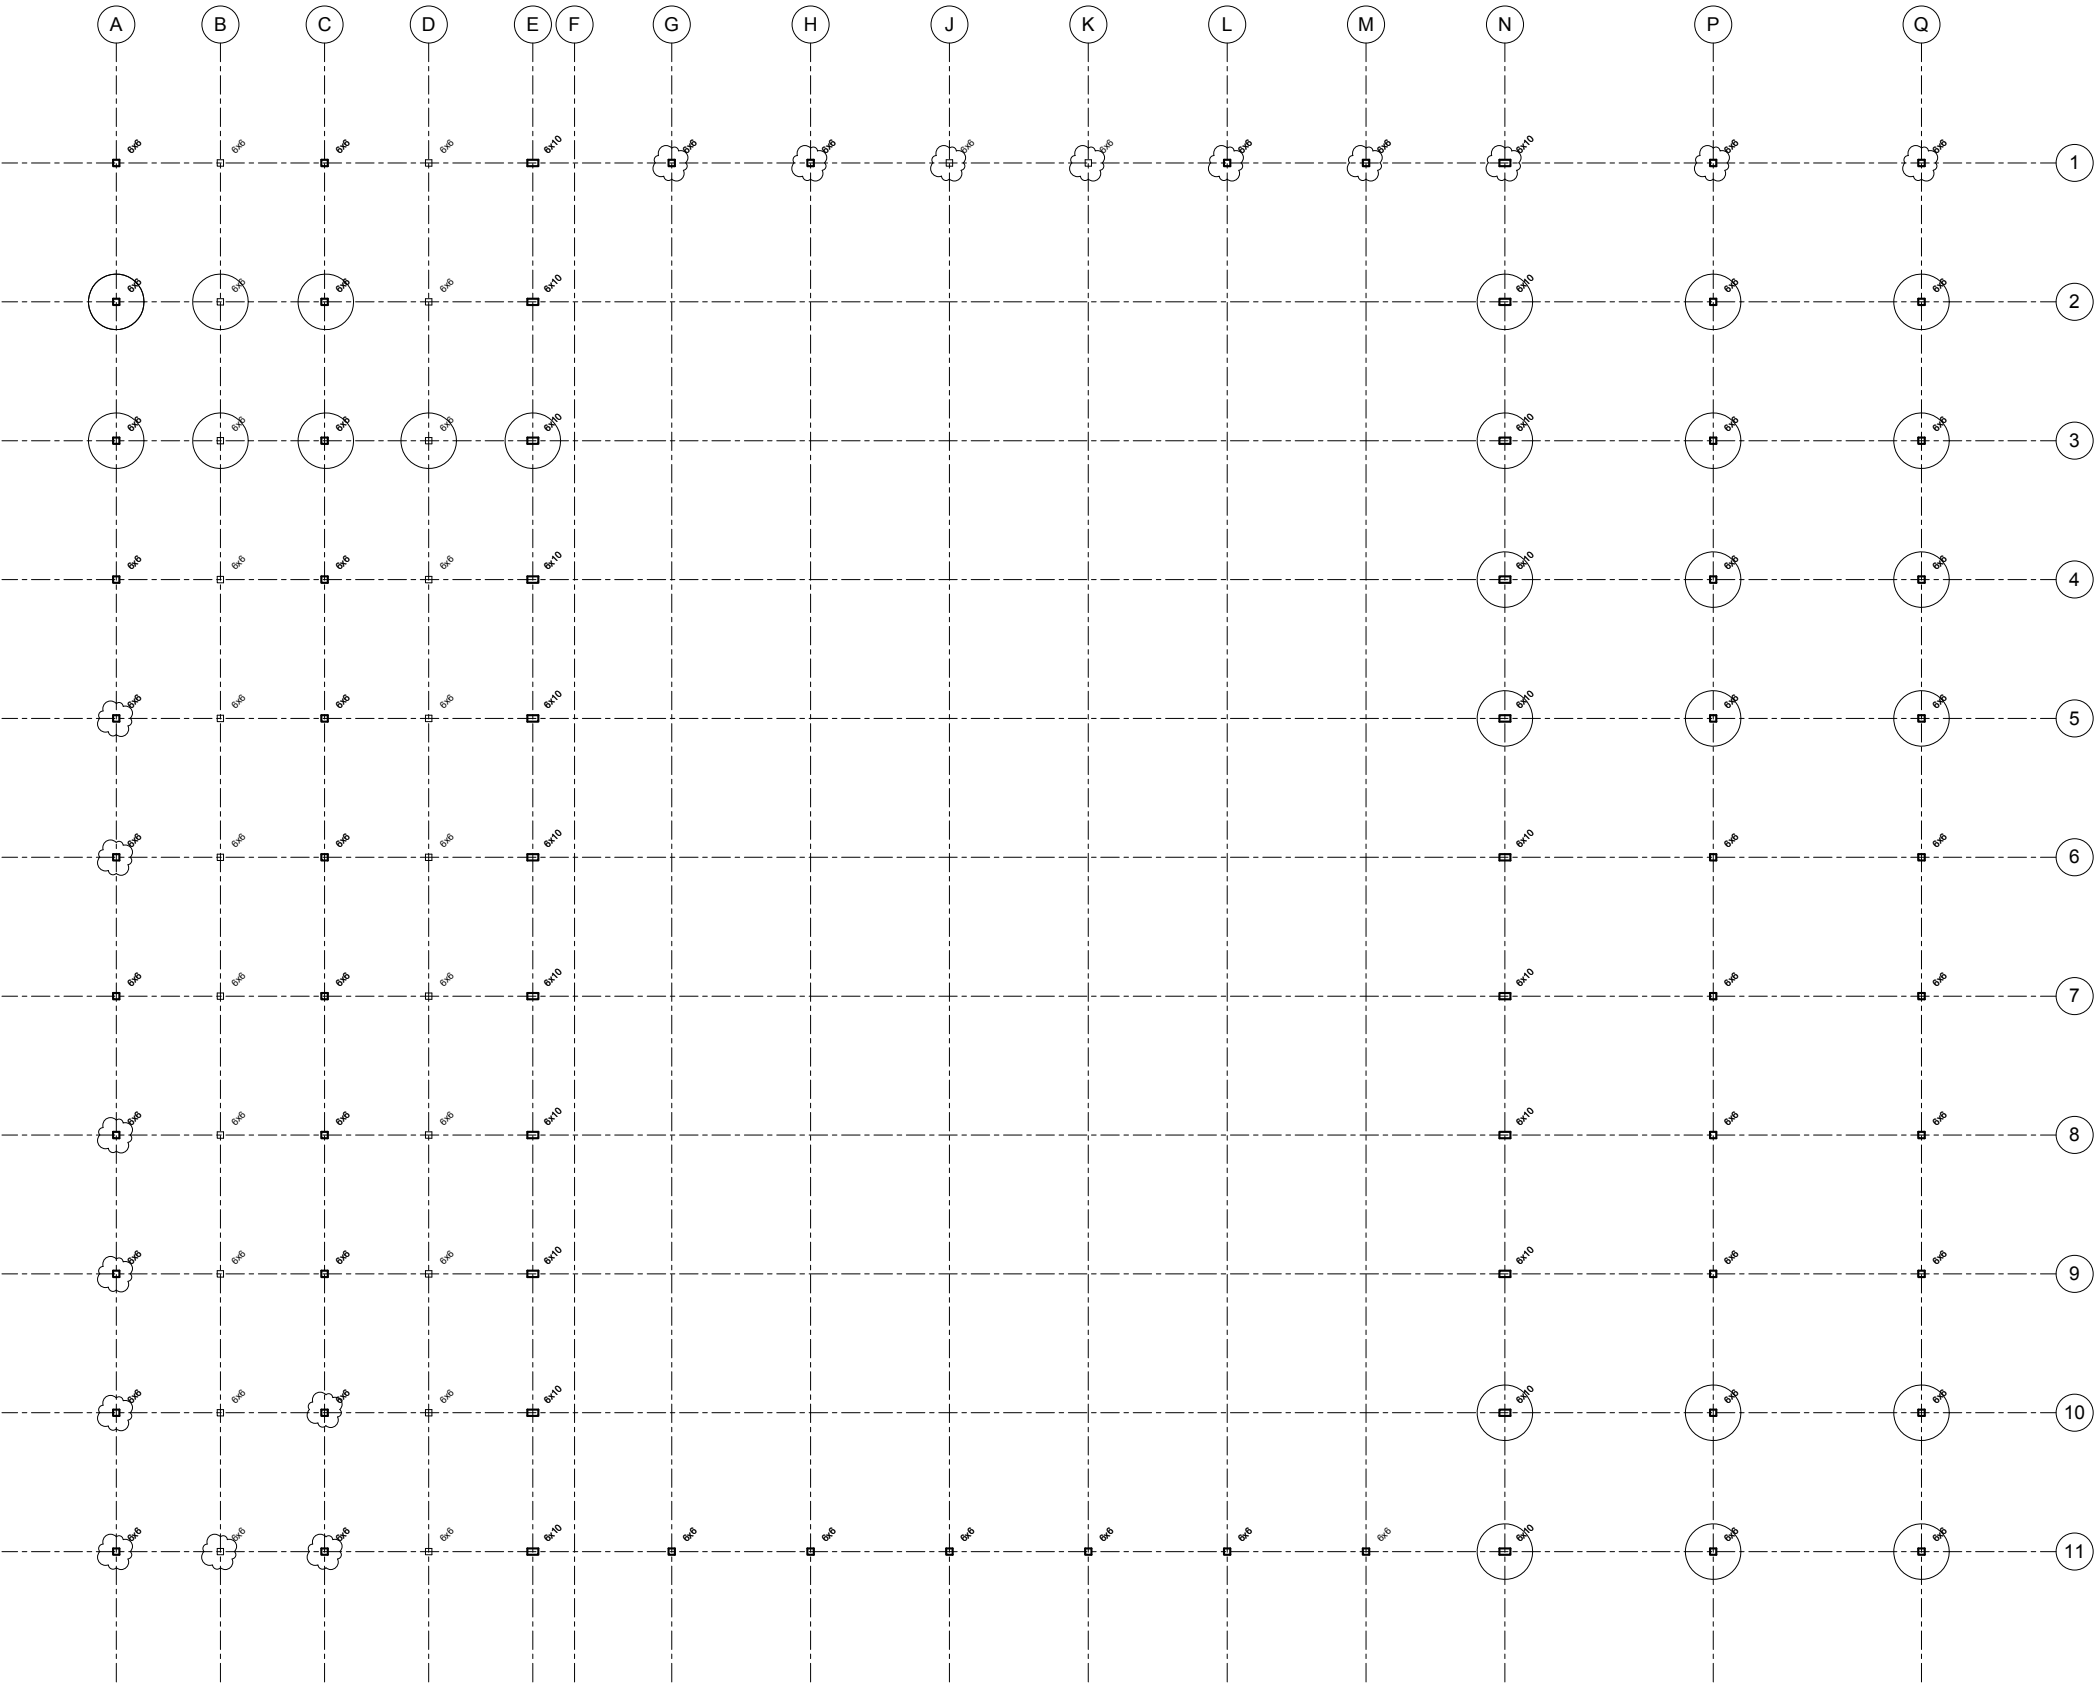
NOT CHECKED

NEED REPLACEMENT

1. Of approximately 100 posts, a total of 18 wood posts along the west end wall and the south side wall were observed to have substantial areas of rot. 26 existing posts were concealed by finishes and could not be checked.
2. The leaking roof may have caused rot or corrosion damage to the roof framing that could not be observed. It is our understanding that a tear off and re-roof is pending and that the roof framing will be inspected and replaced in kind if damage is discovered.

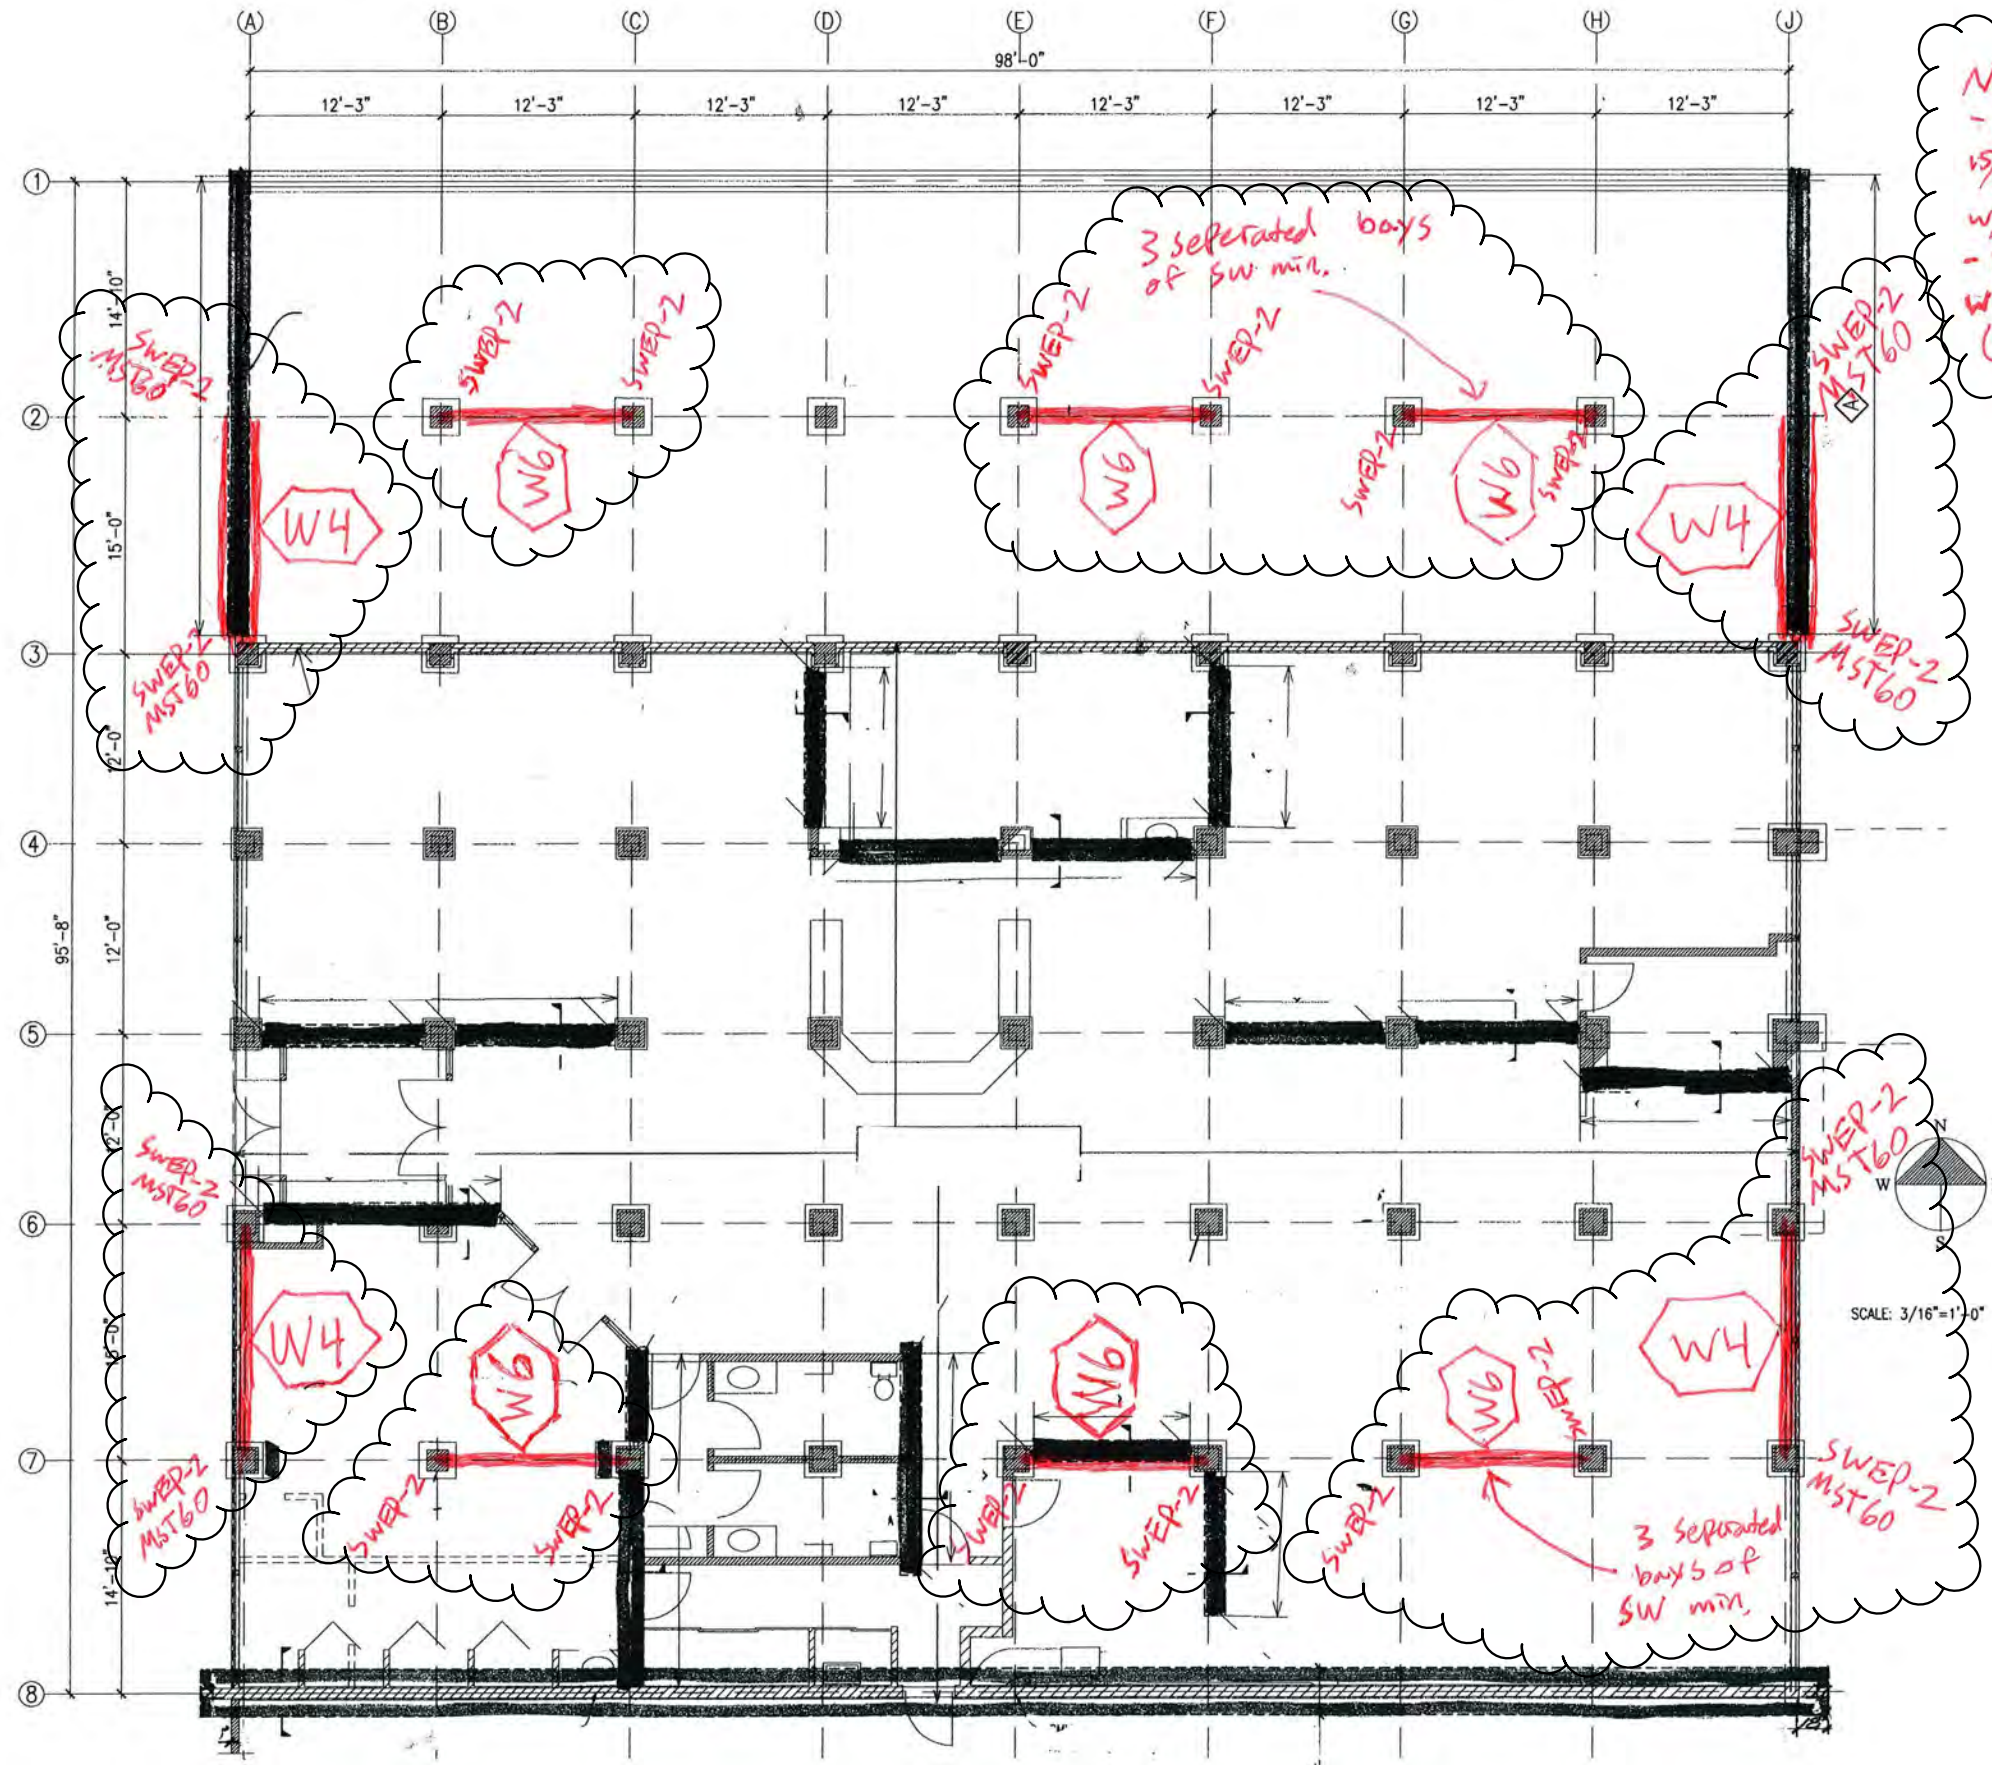
| <b>kingworks</b><br>CONSULTING ENGINEERS, PLLC<br>600 DUPONT STREET, SUITE B<br>BELLINGHAM, WA 98225<br>360-714-8260<br>www.king-works.com | <b>2nd Floor Shear Walls:</b> | | |

Note:  
- All shearwalls use 15/32 structural sheathing w/ 10d common nails.  
- provide dbl stud endpost where no post is present (SWEP-2).

The clouded footings along grids 6 and 7 need to be enlarged if the 2nd floor is to be used as office space.

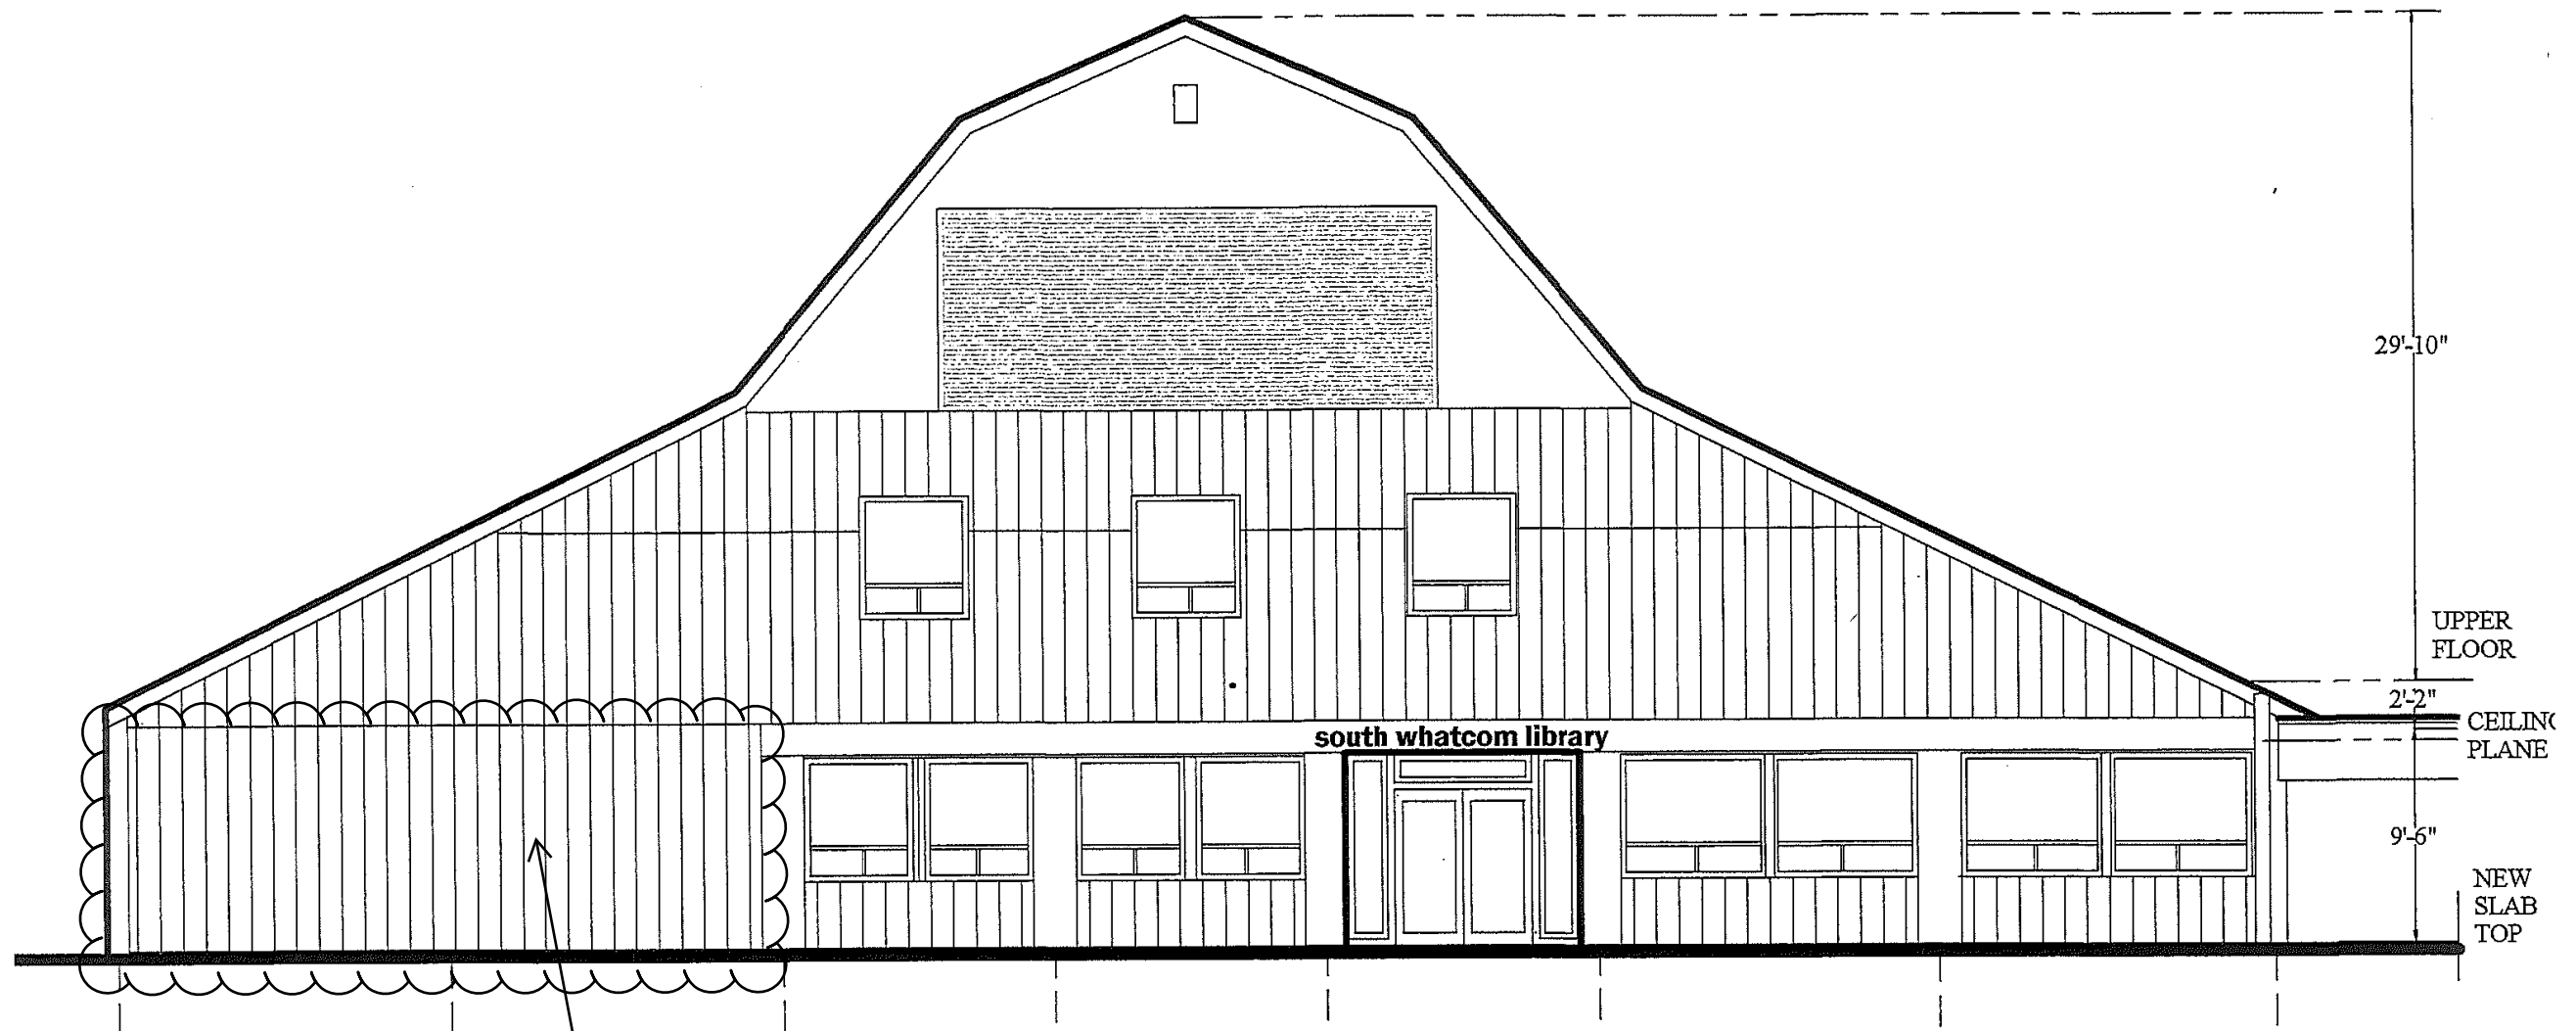
**WEST ENTRY ELEVATION #2**  
 3/32" = 1' - 0" 1/26/2014  
 David Hamilton, Architect, AIA

Shear walls and foundations to be completed per Harezlak's original report on both end walls.

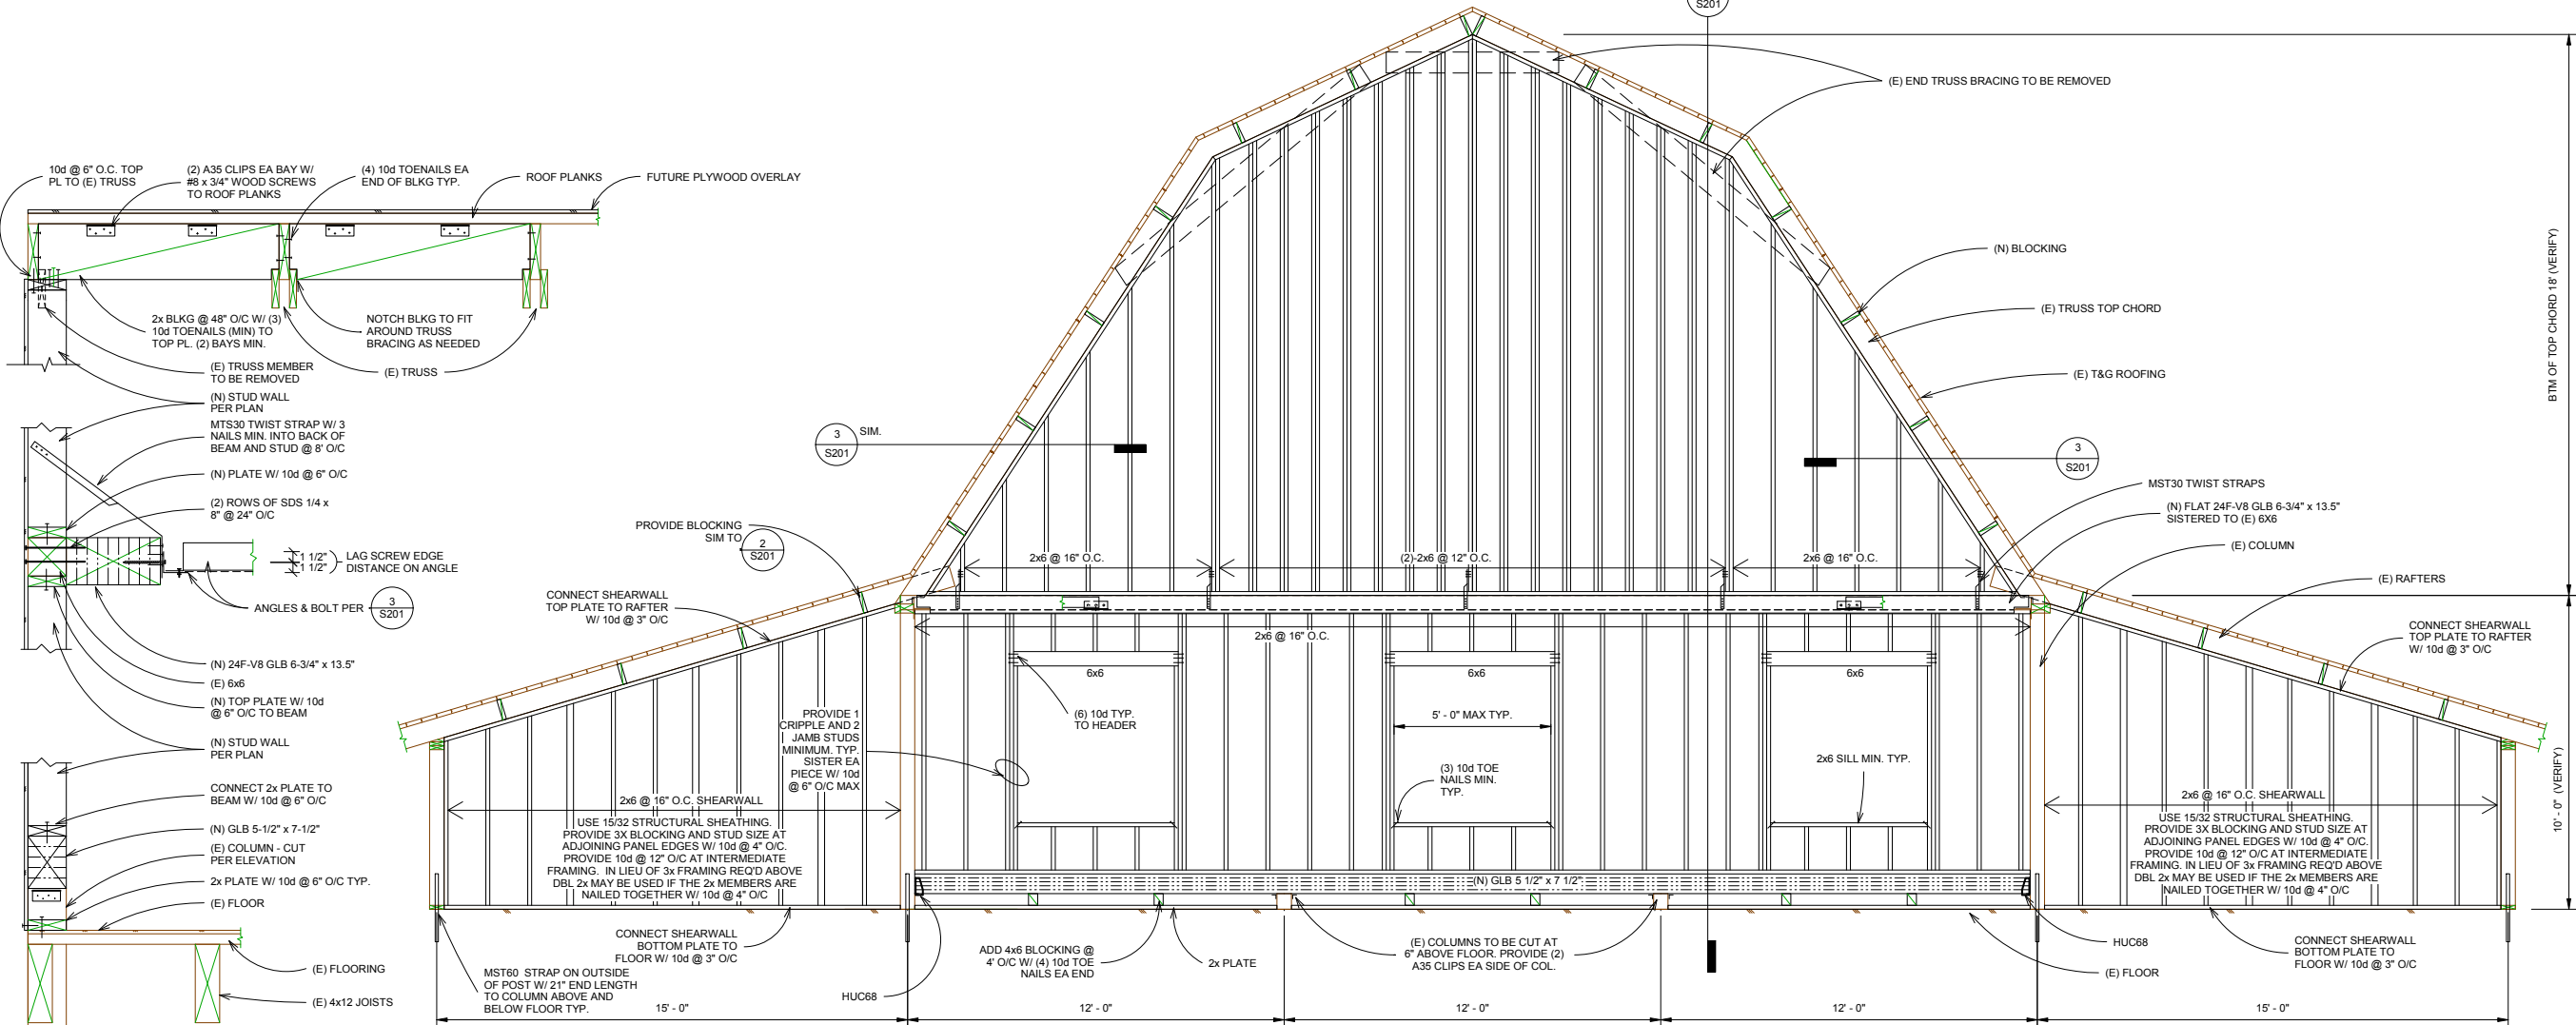
2 WALL SECTION  
1" = 1'-0"

1 FRAMING ELEVATION  
3/8" = 1'-0"
